**Eurobodalla Catchments**

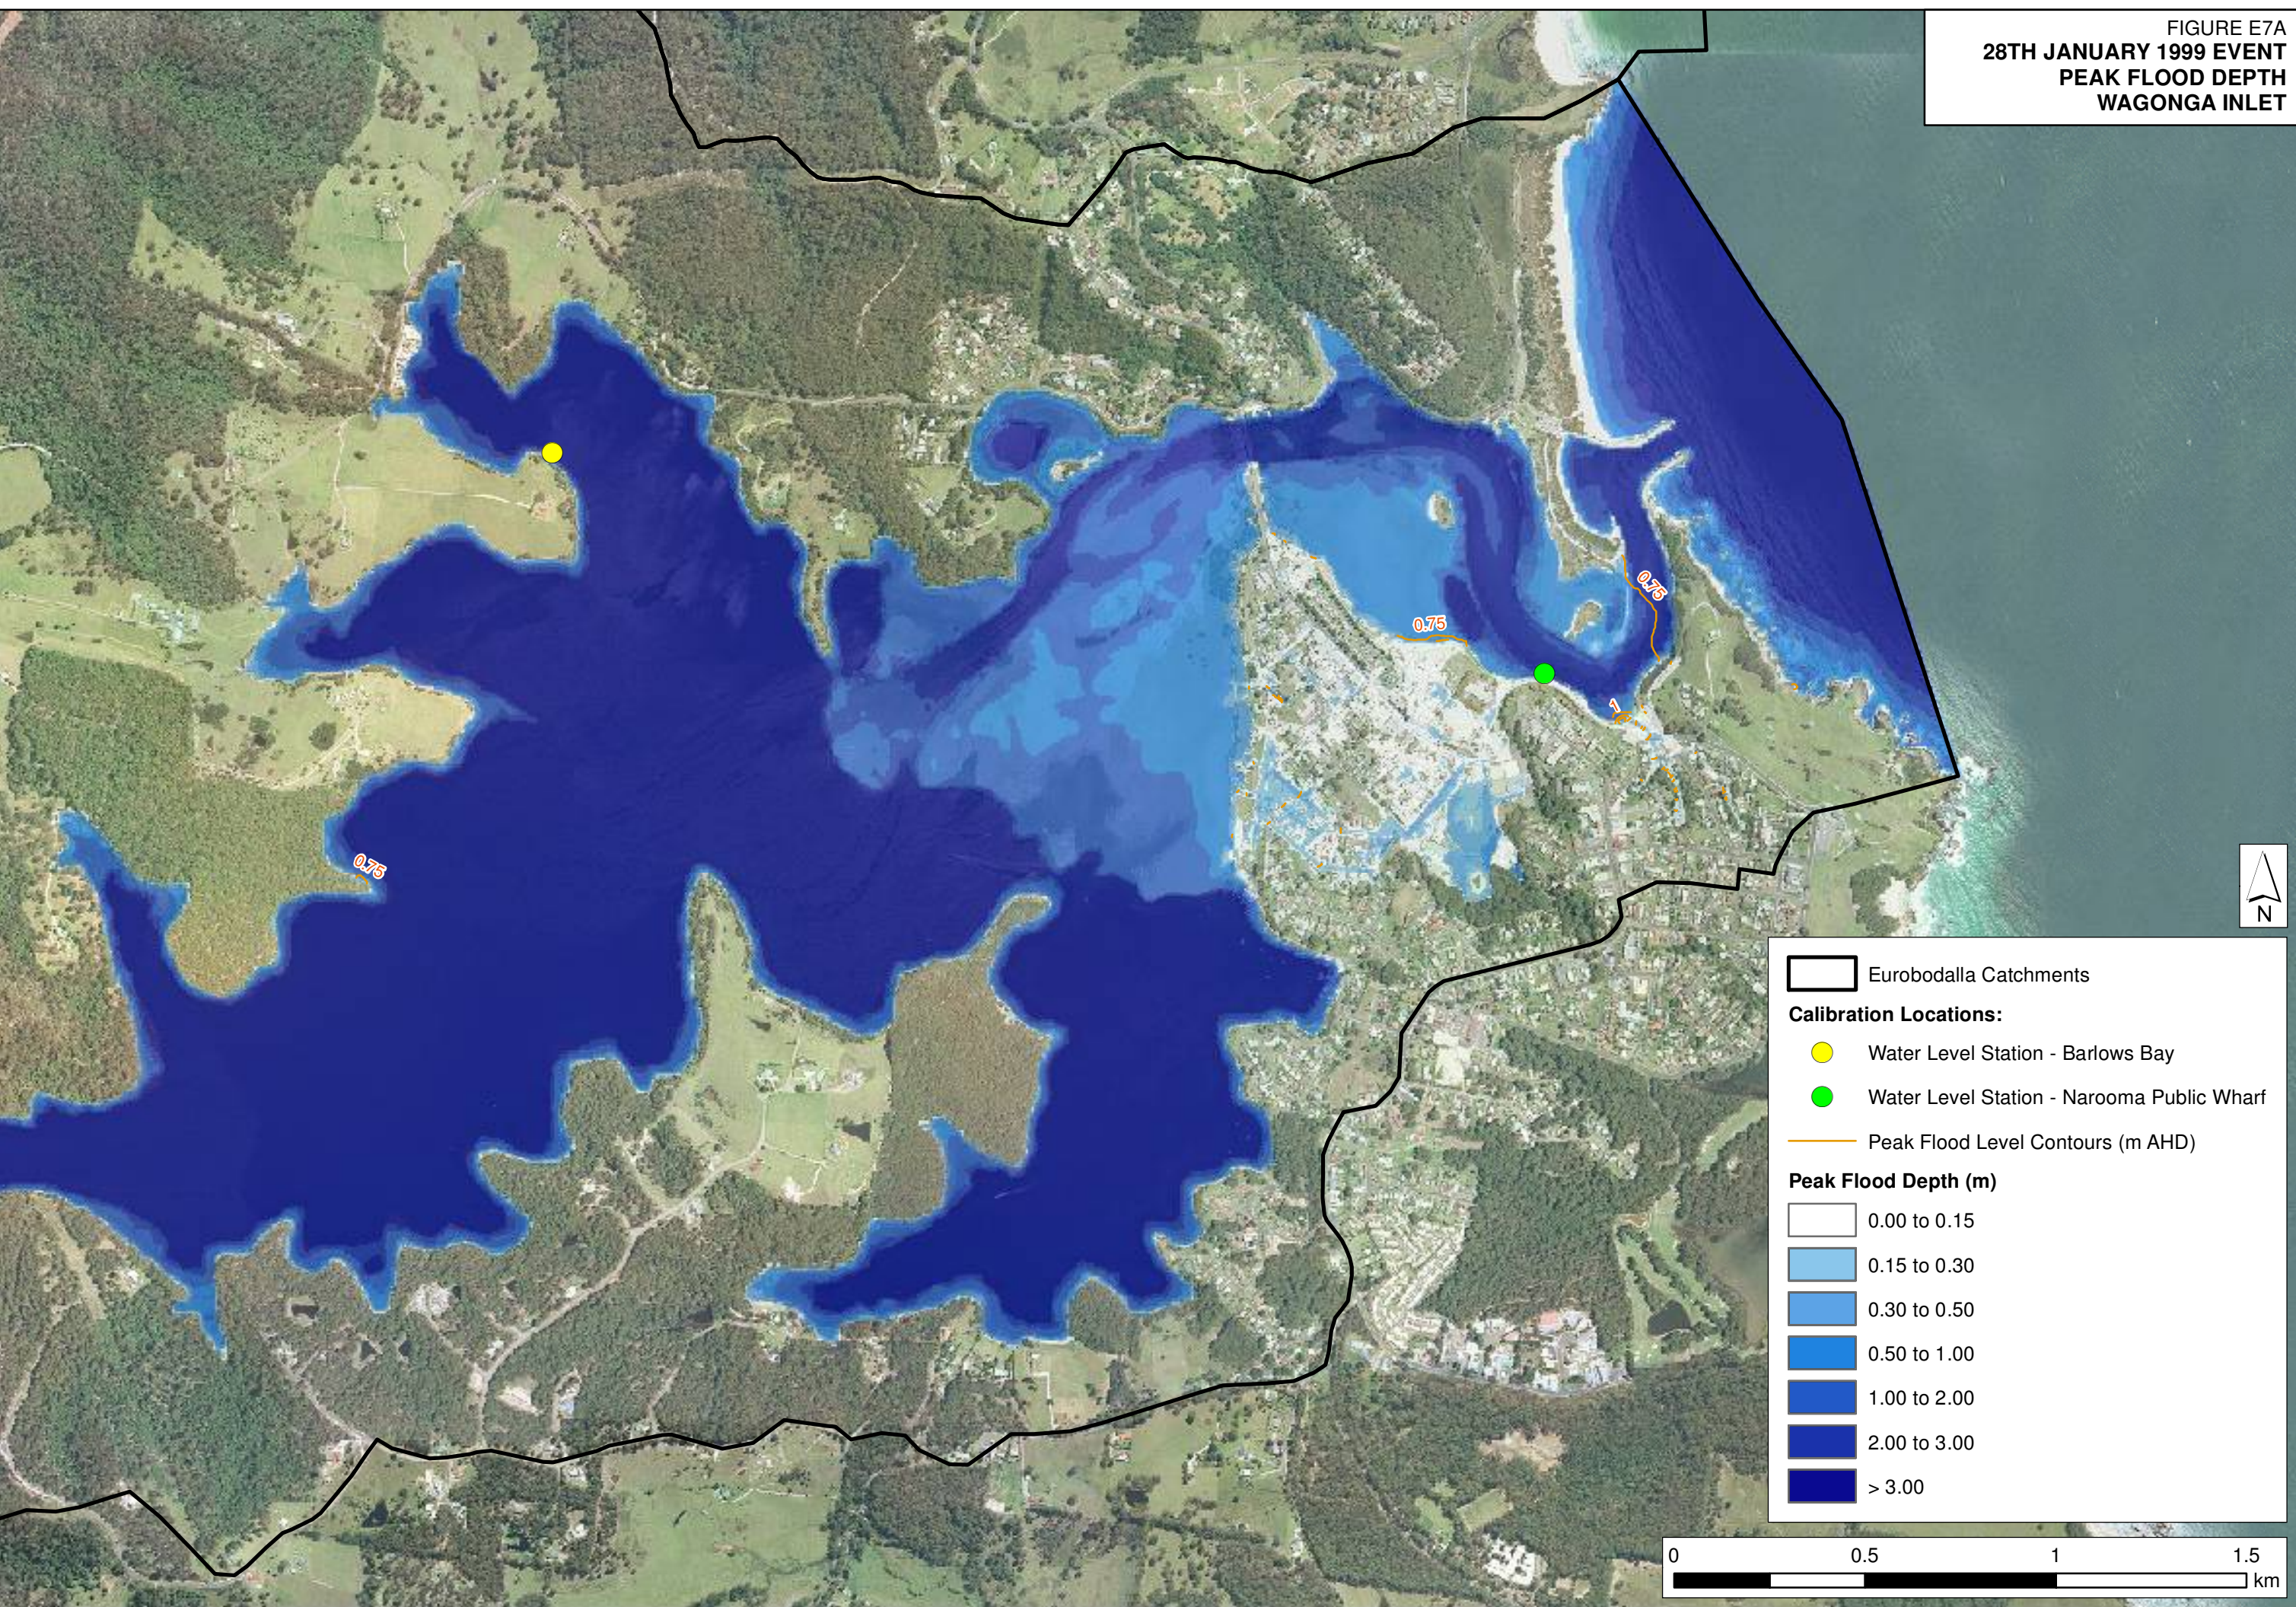
FIGURE E7A  
28TH JANUARY 1999 EVENT  
PEAK FLOOD DEPTH  
WAGONGA INLET

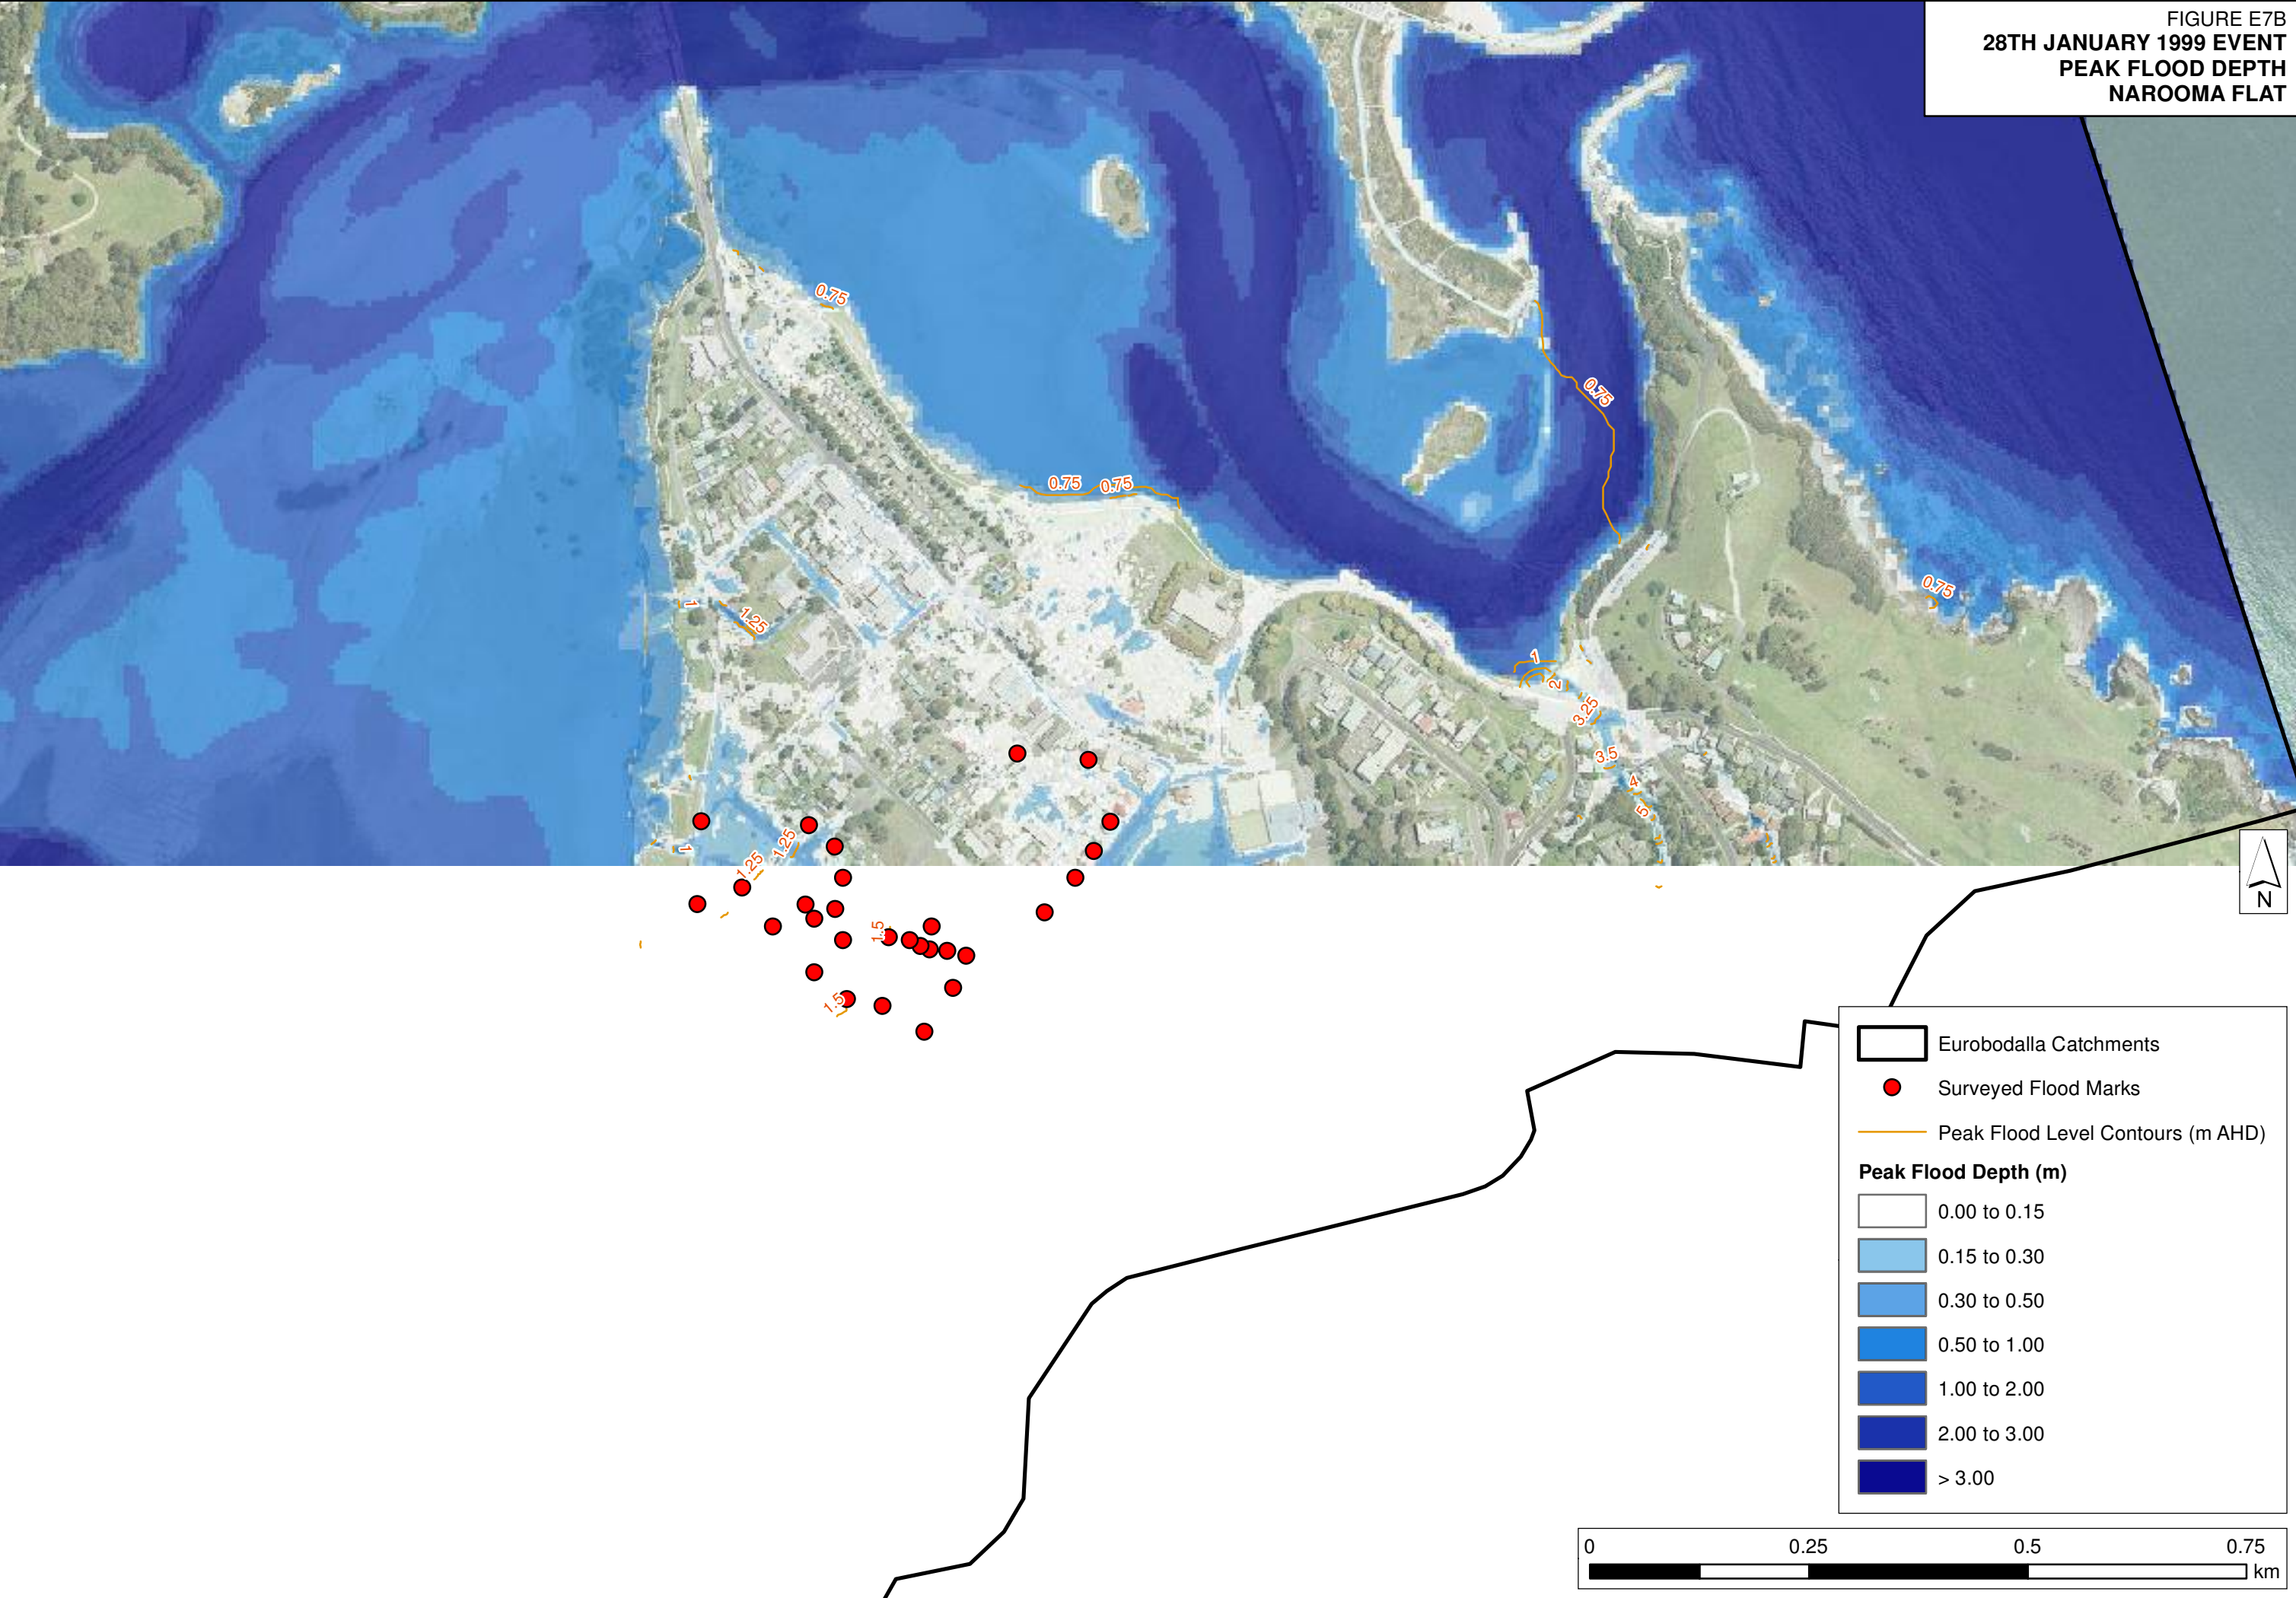
FIGURE E7B  
28TH JANUARY 1999 EVENT  
PEAK FLOOD DEPTH  
NAROOMA FLAT

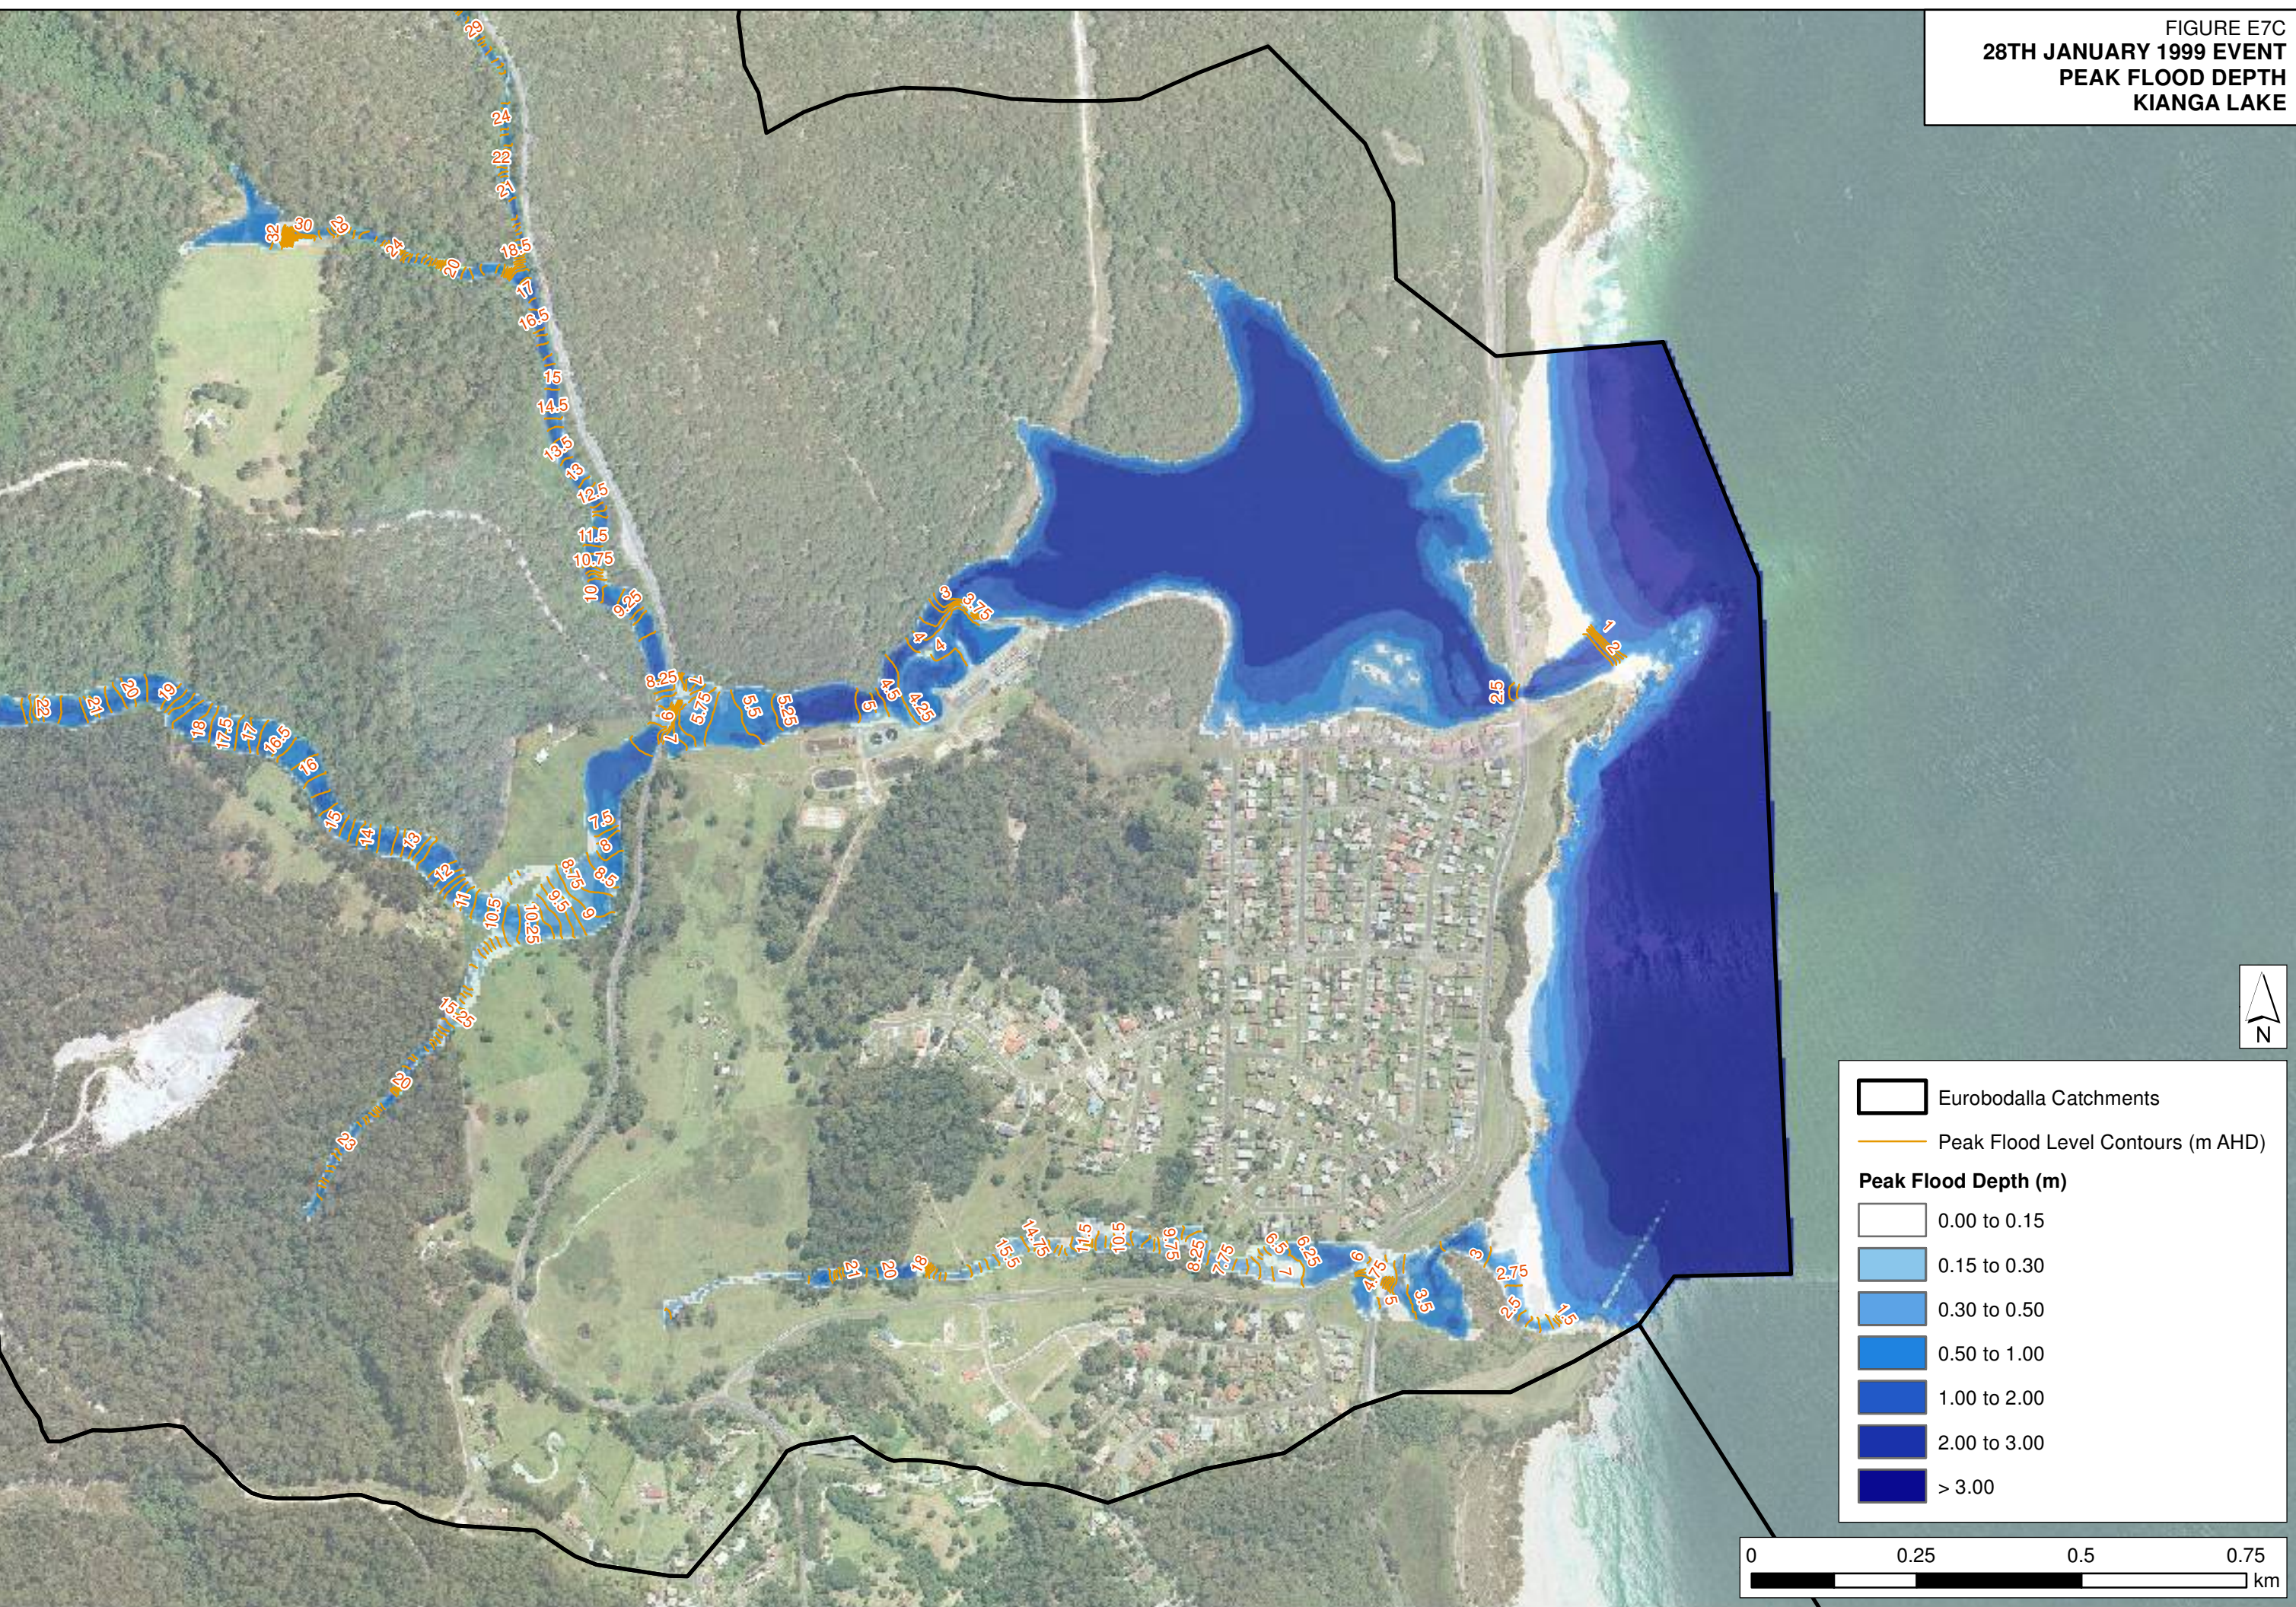
FIGURE E7C  
28TH JANUARY 1999 EVENT  
PEAK FLOOD DEPTH  
KIANGA LAKE

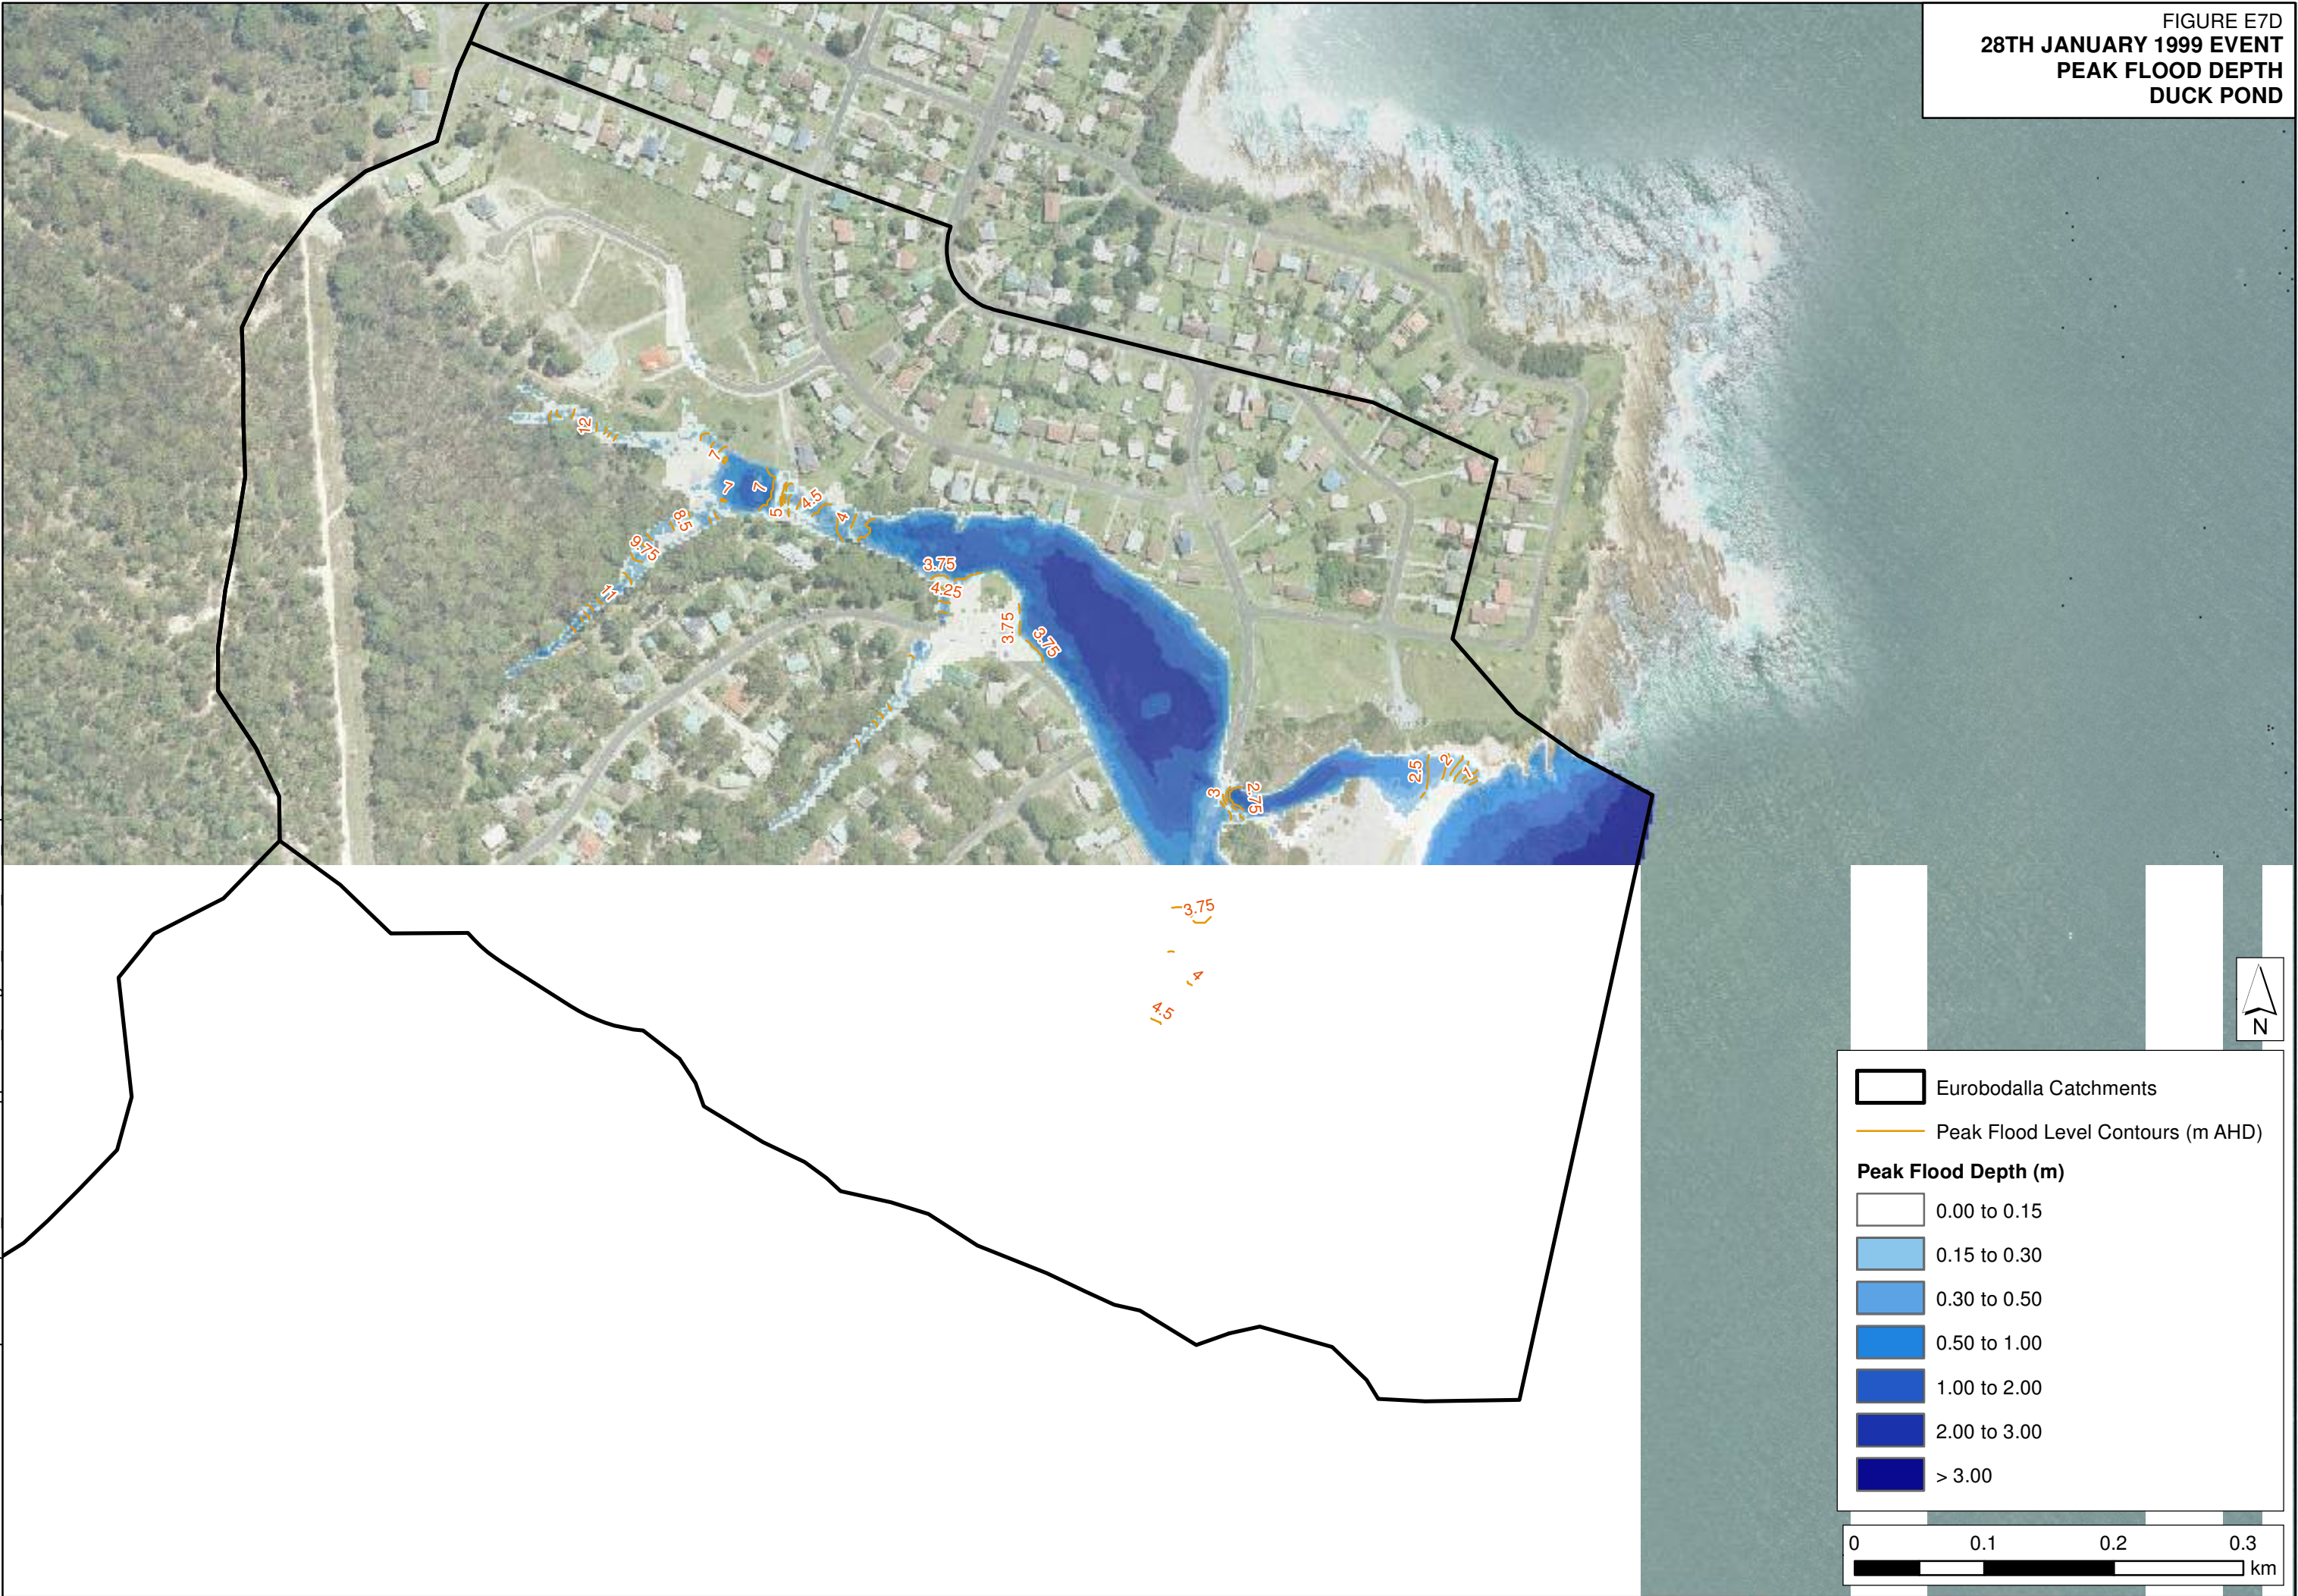
FIGURE E7D  
28TH JANUARY 1999 EVENT  
PEAK FLOOD DEPTH  
DUCK POND

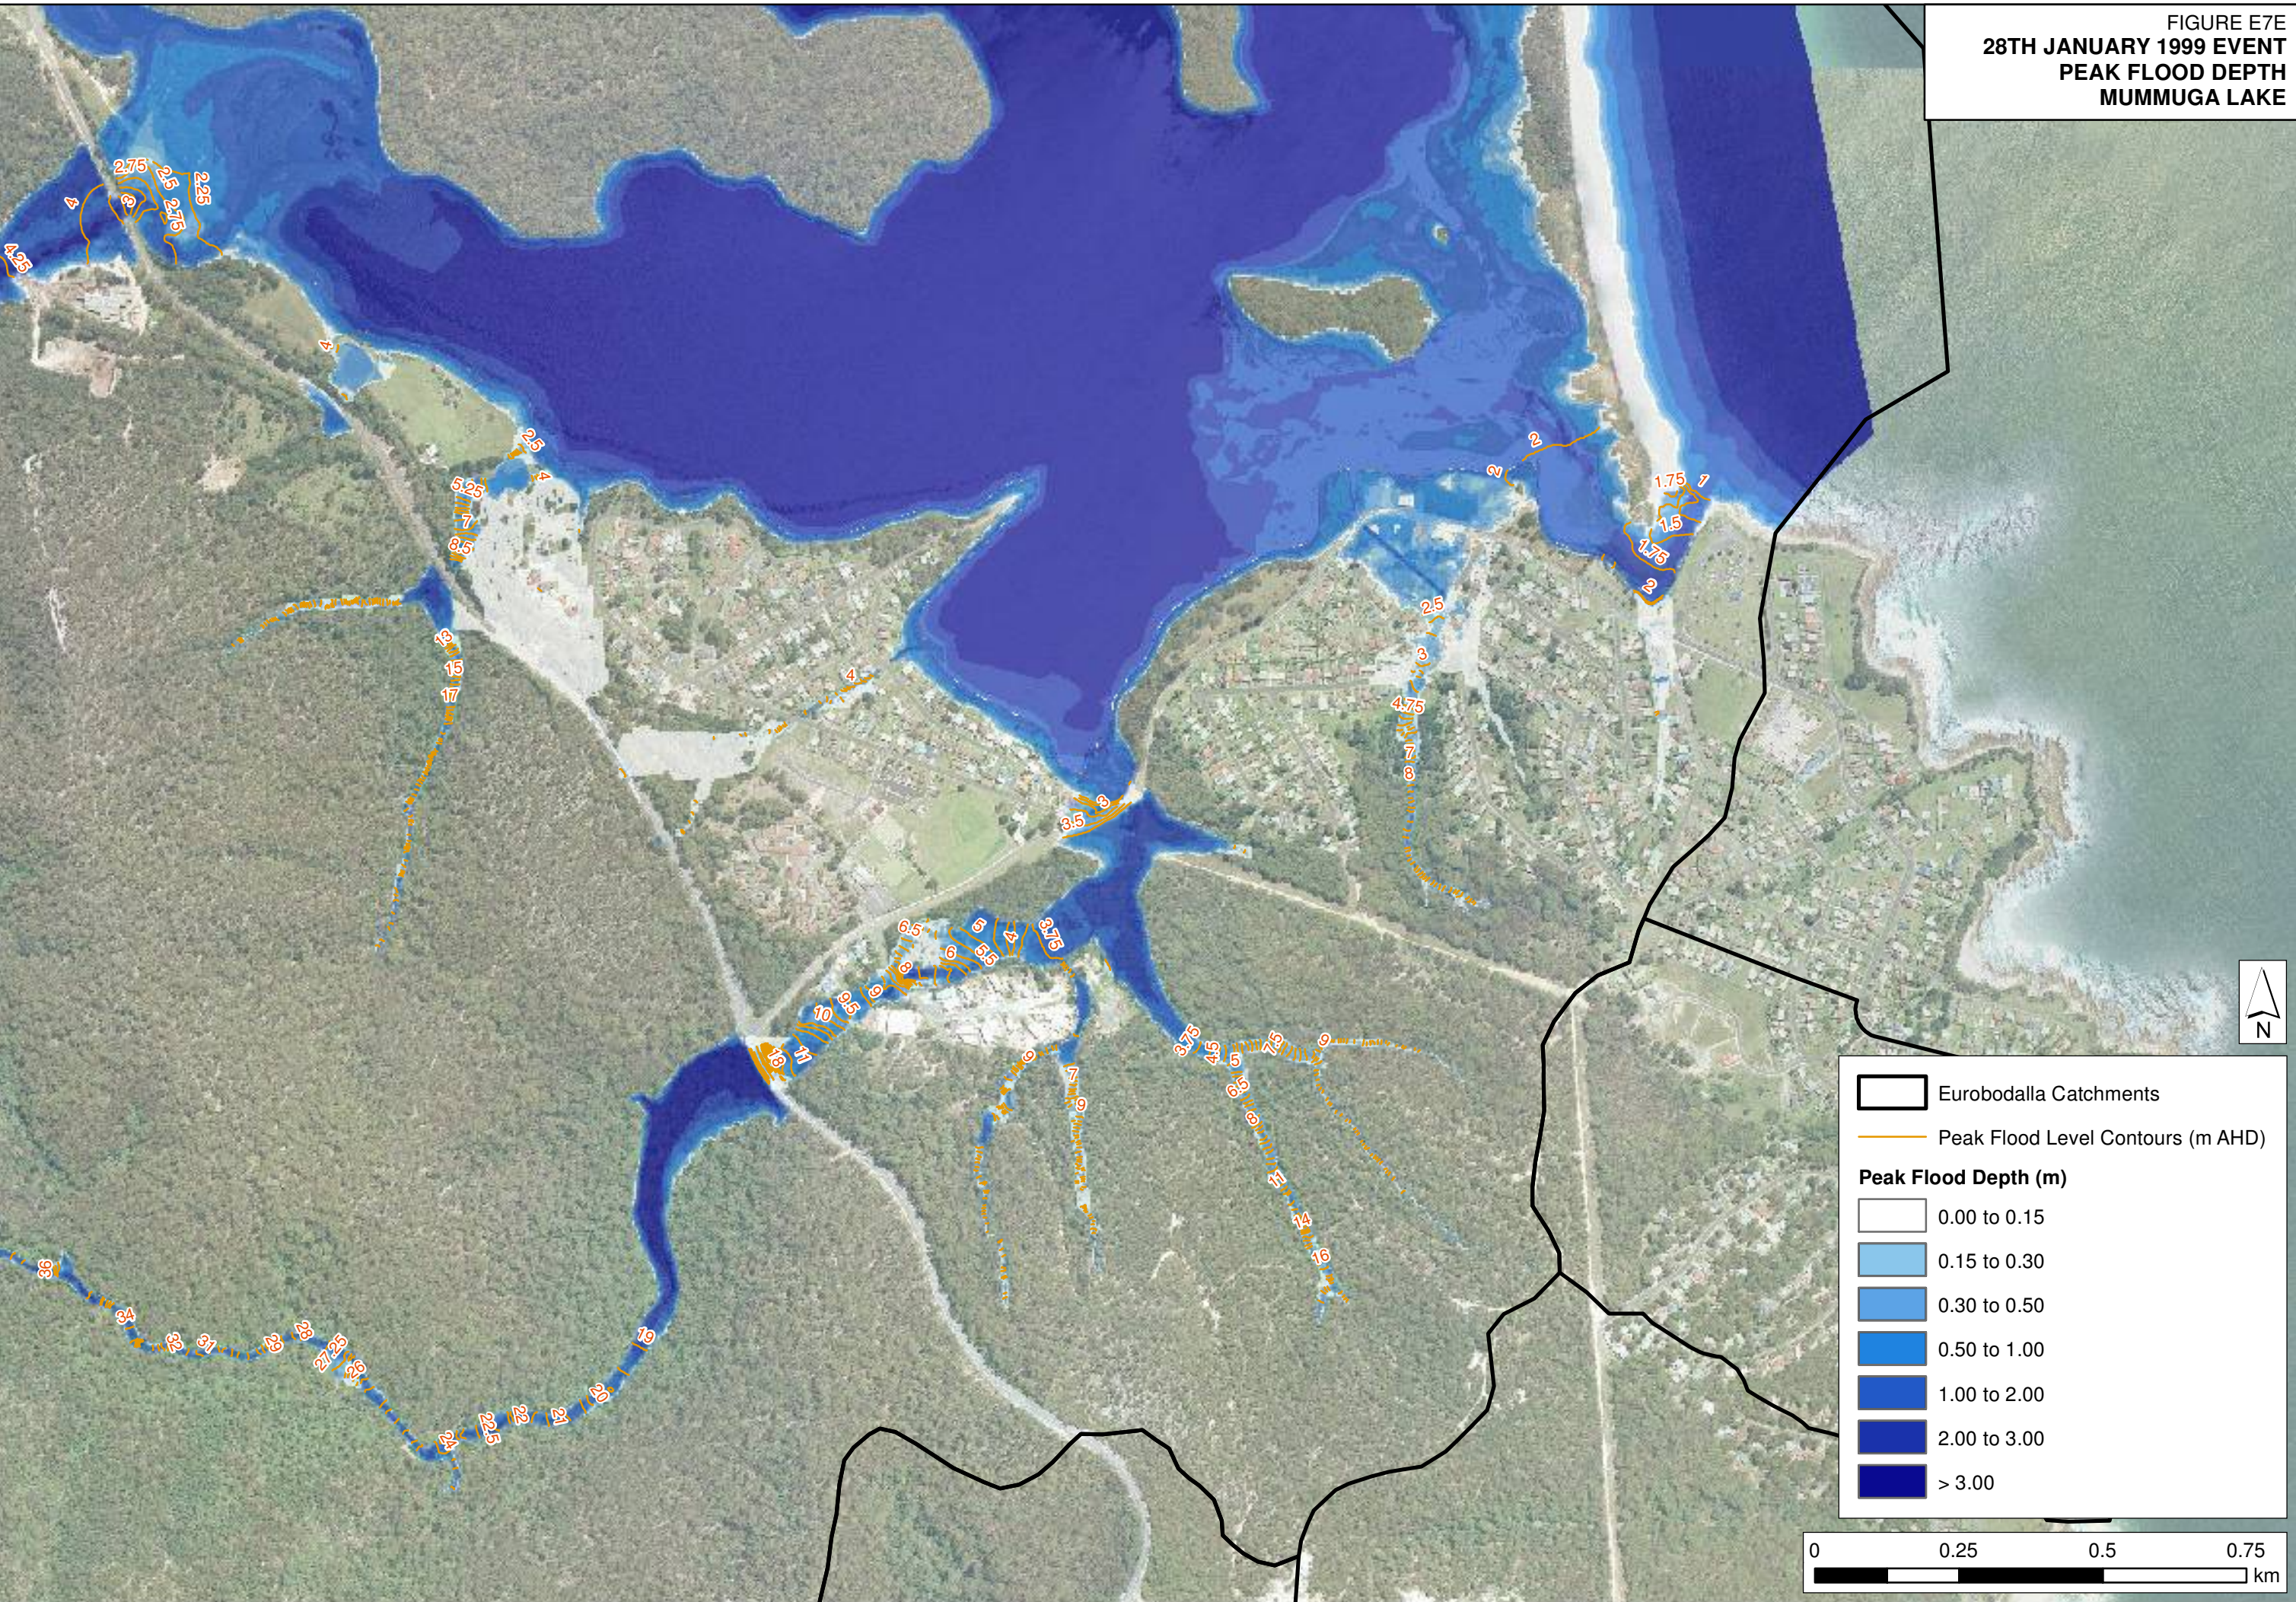
FIGURE E7E  
28TH JANUARY 1999 EVENT  
PEAK FLOOD DEPTH  
MUMMUGA LAKE

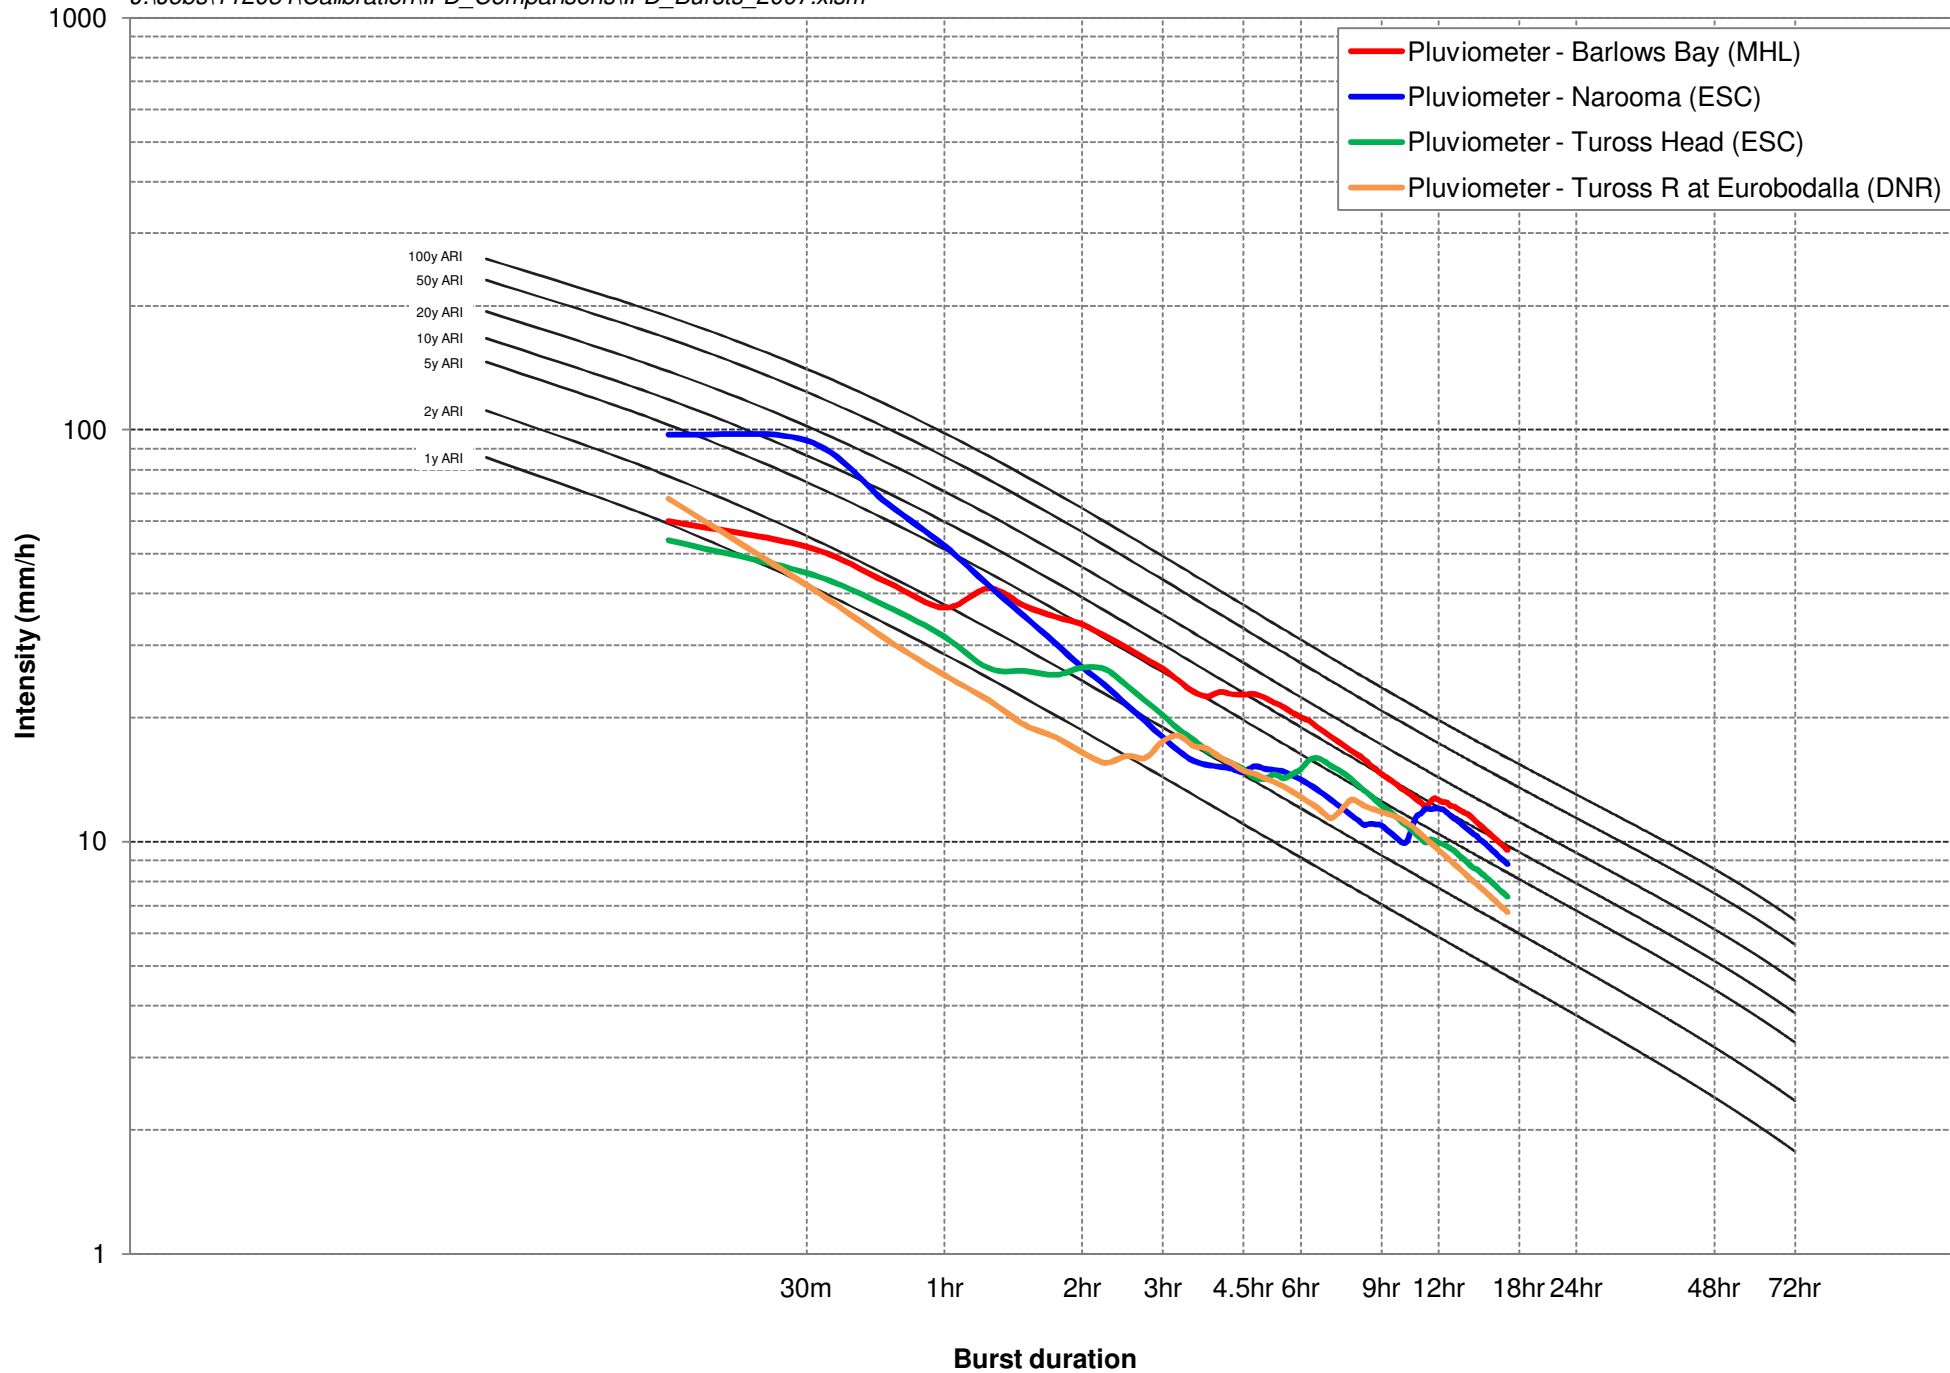
FIGURE E8  
11TH FEBRUARY 2007 EVENT  
IFD DATA
