**Eurobodalla Catchments**

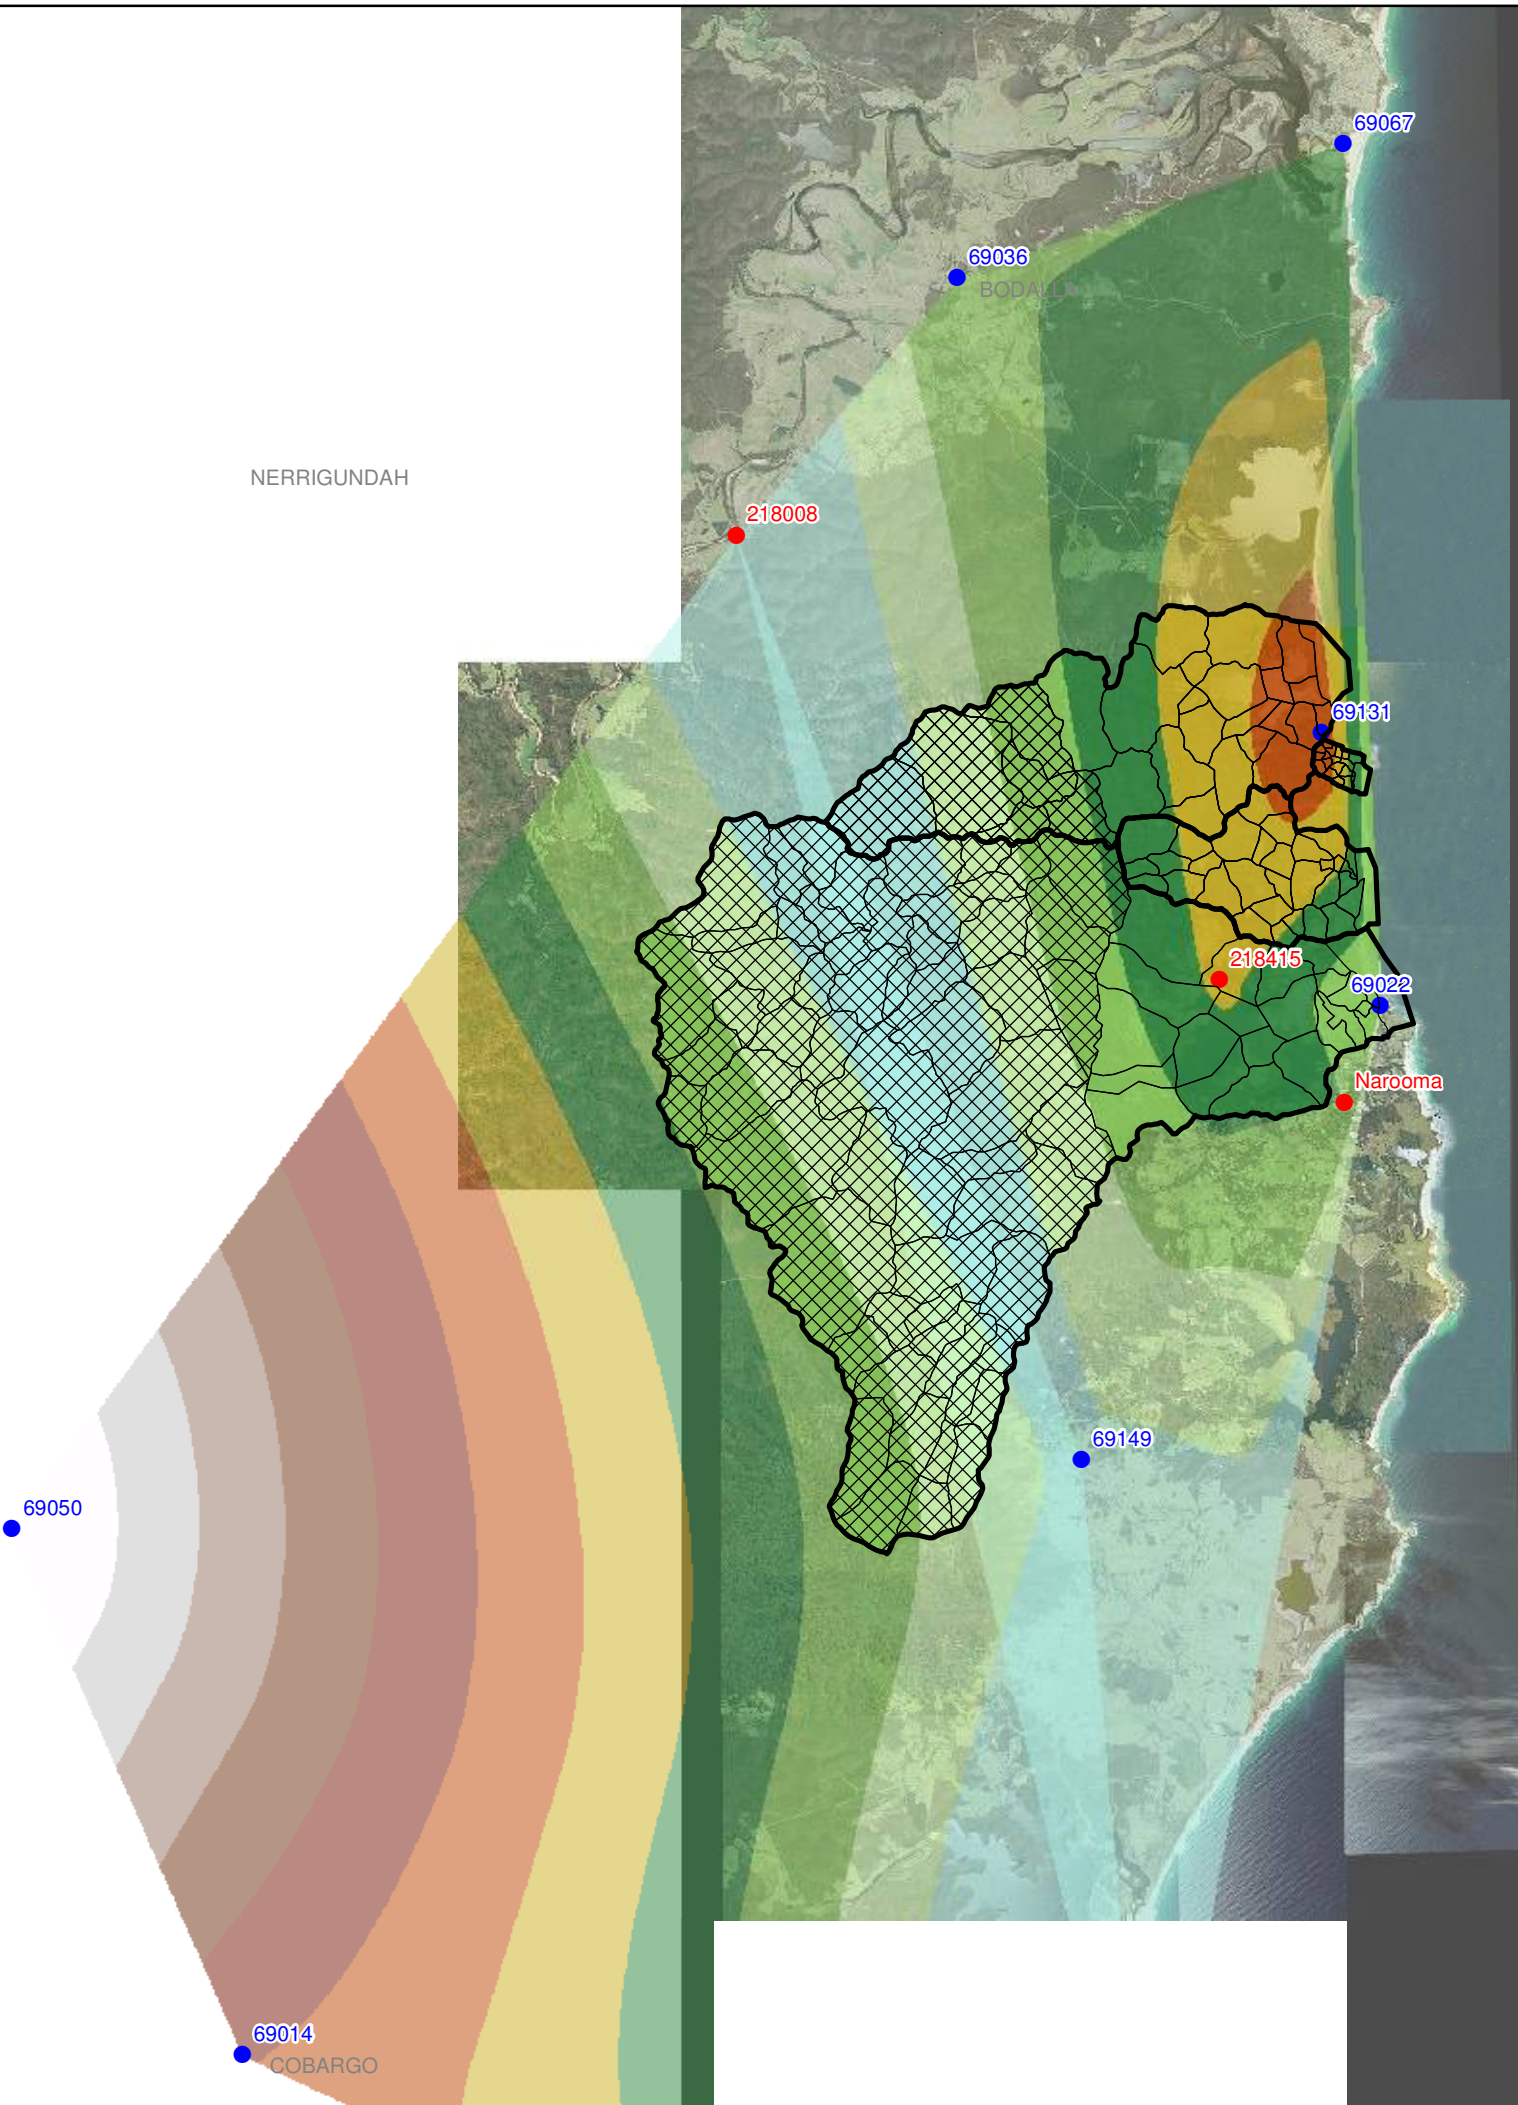
FIGURE E9  
11TH FEBRUARY 2007 EVENT  
RAINFALL DISTRIBUTION

**Temporal Pattern Applied to Subcatchments**

**Rainfall Depth in mm (48 hours to 9am)**

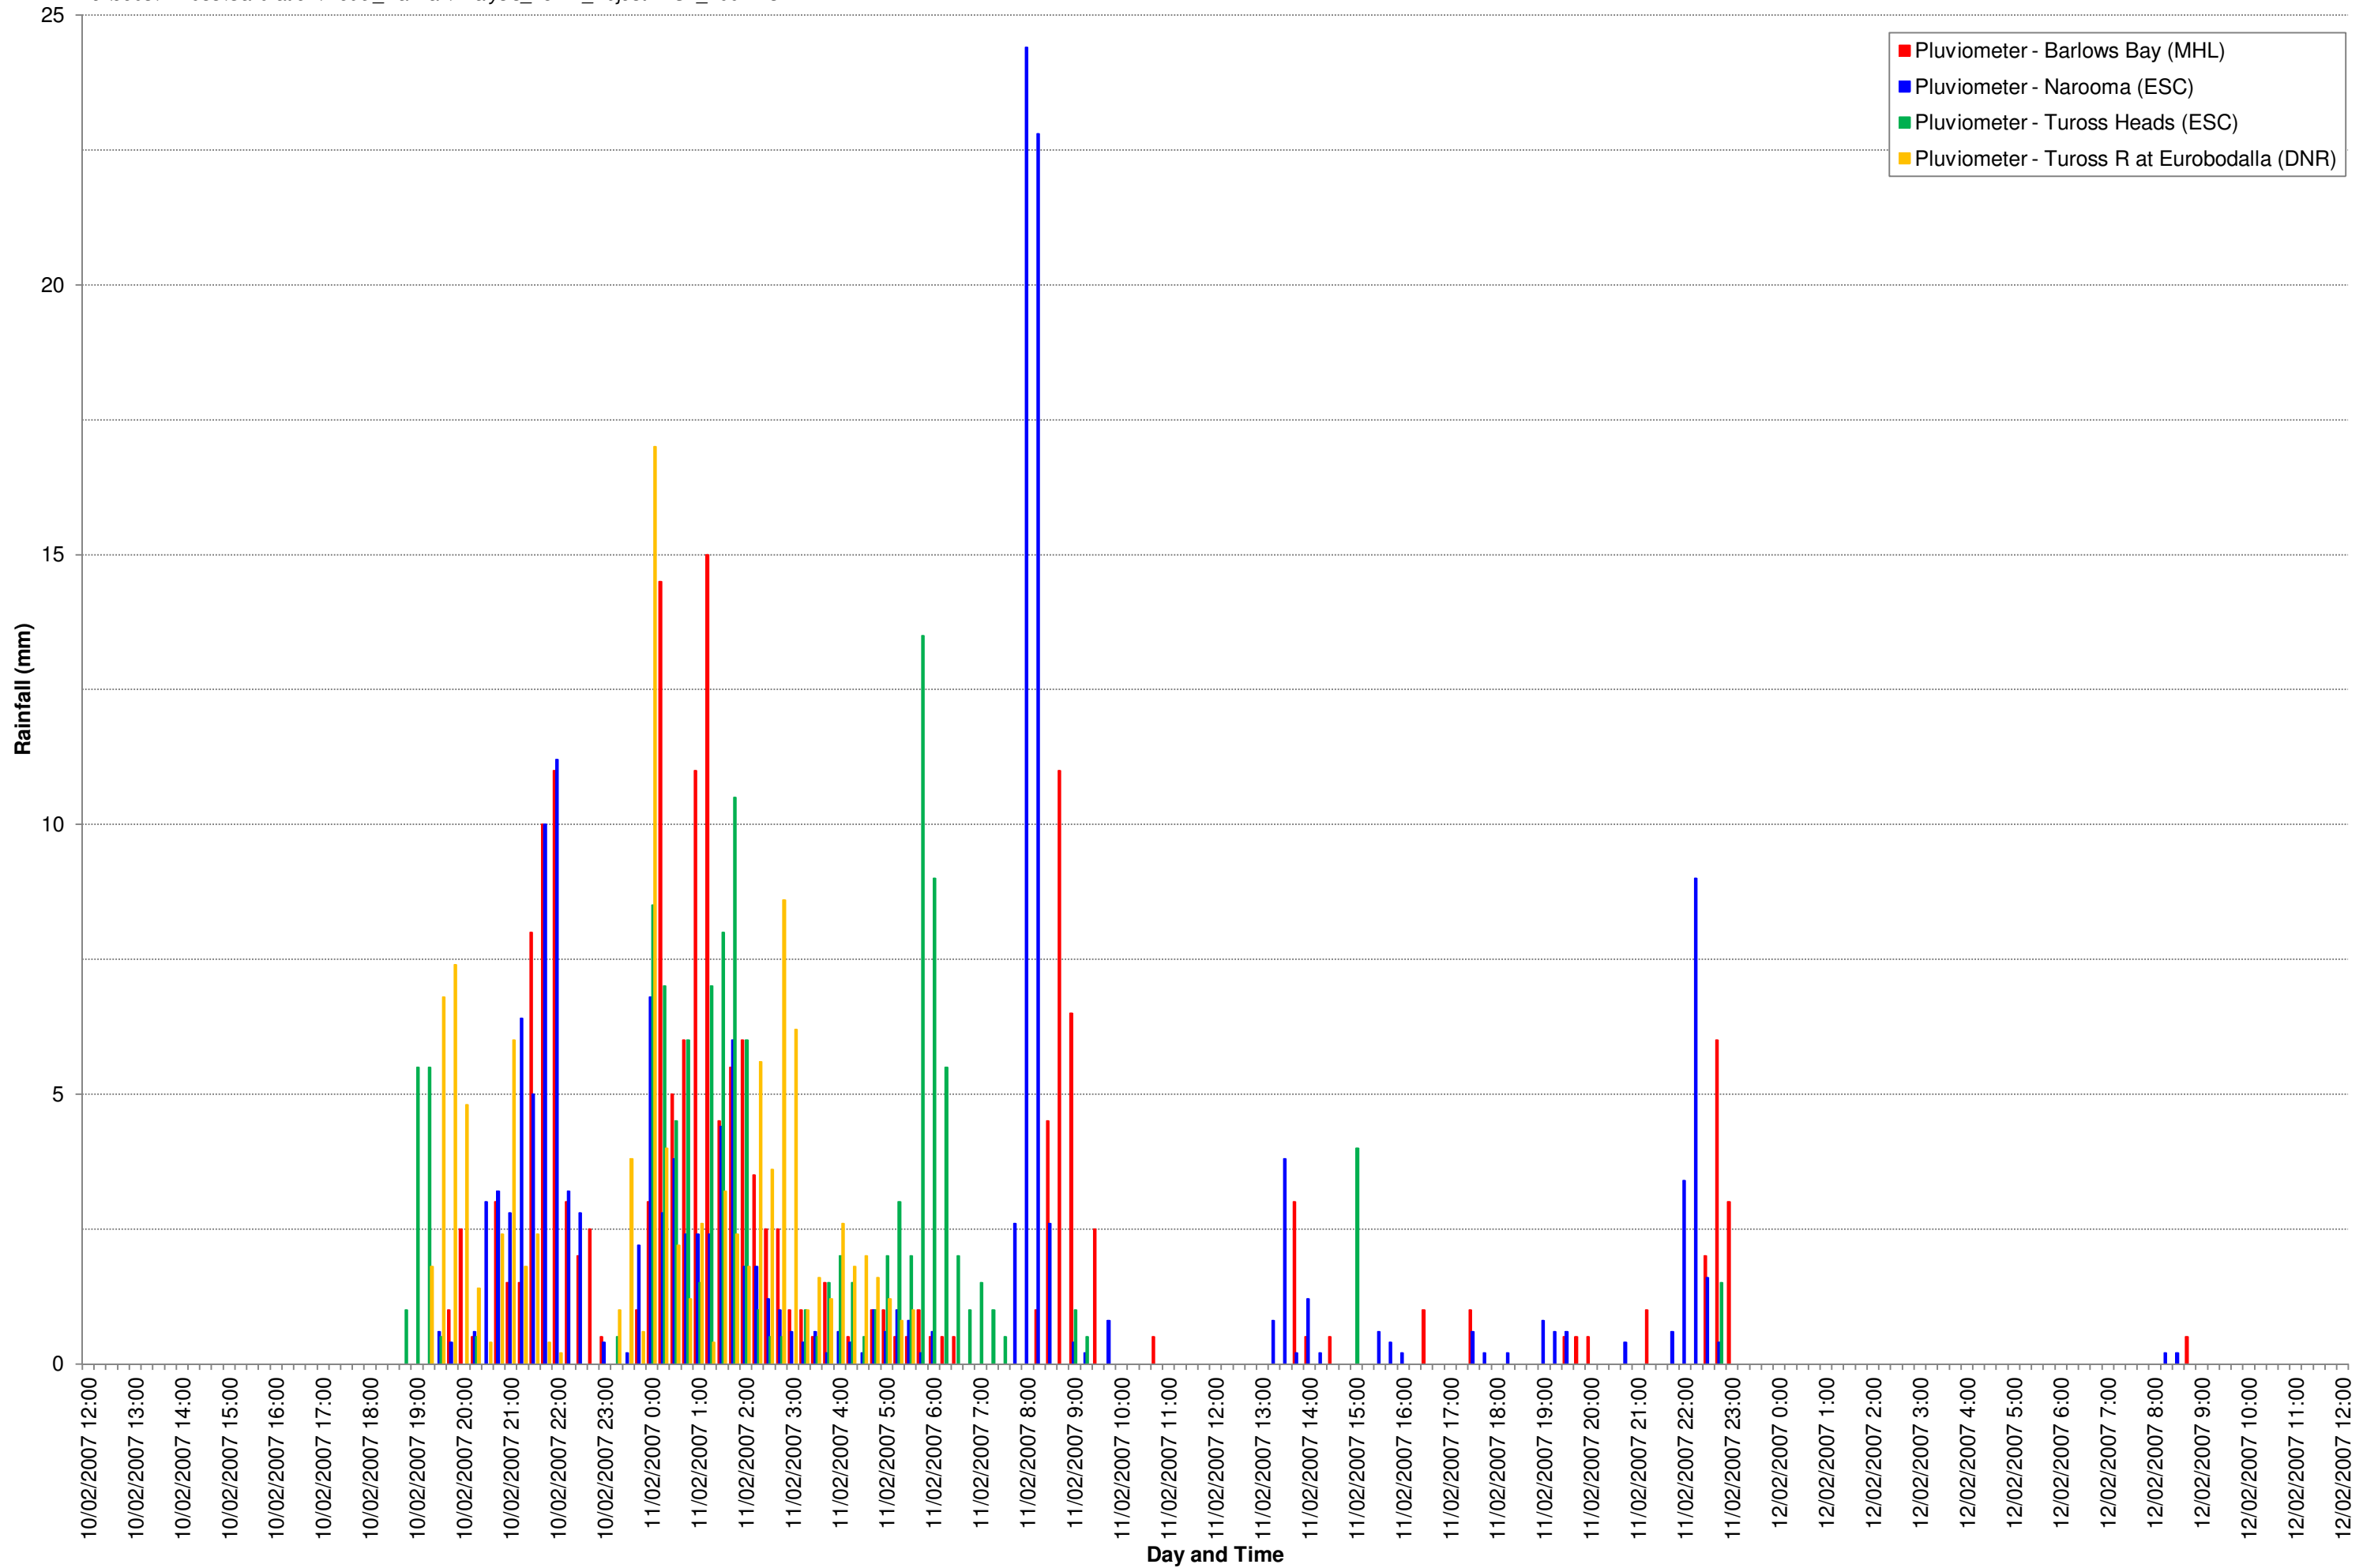
FIGURE E10  
11TH FEBRUARY 2007 EVENT  
RAINFALL HYETOGRAPH COMPARISON

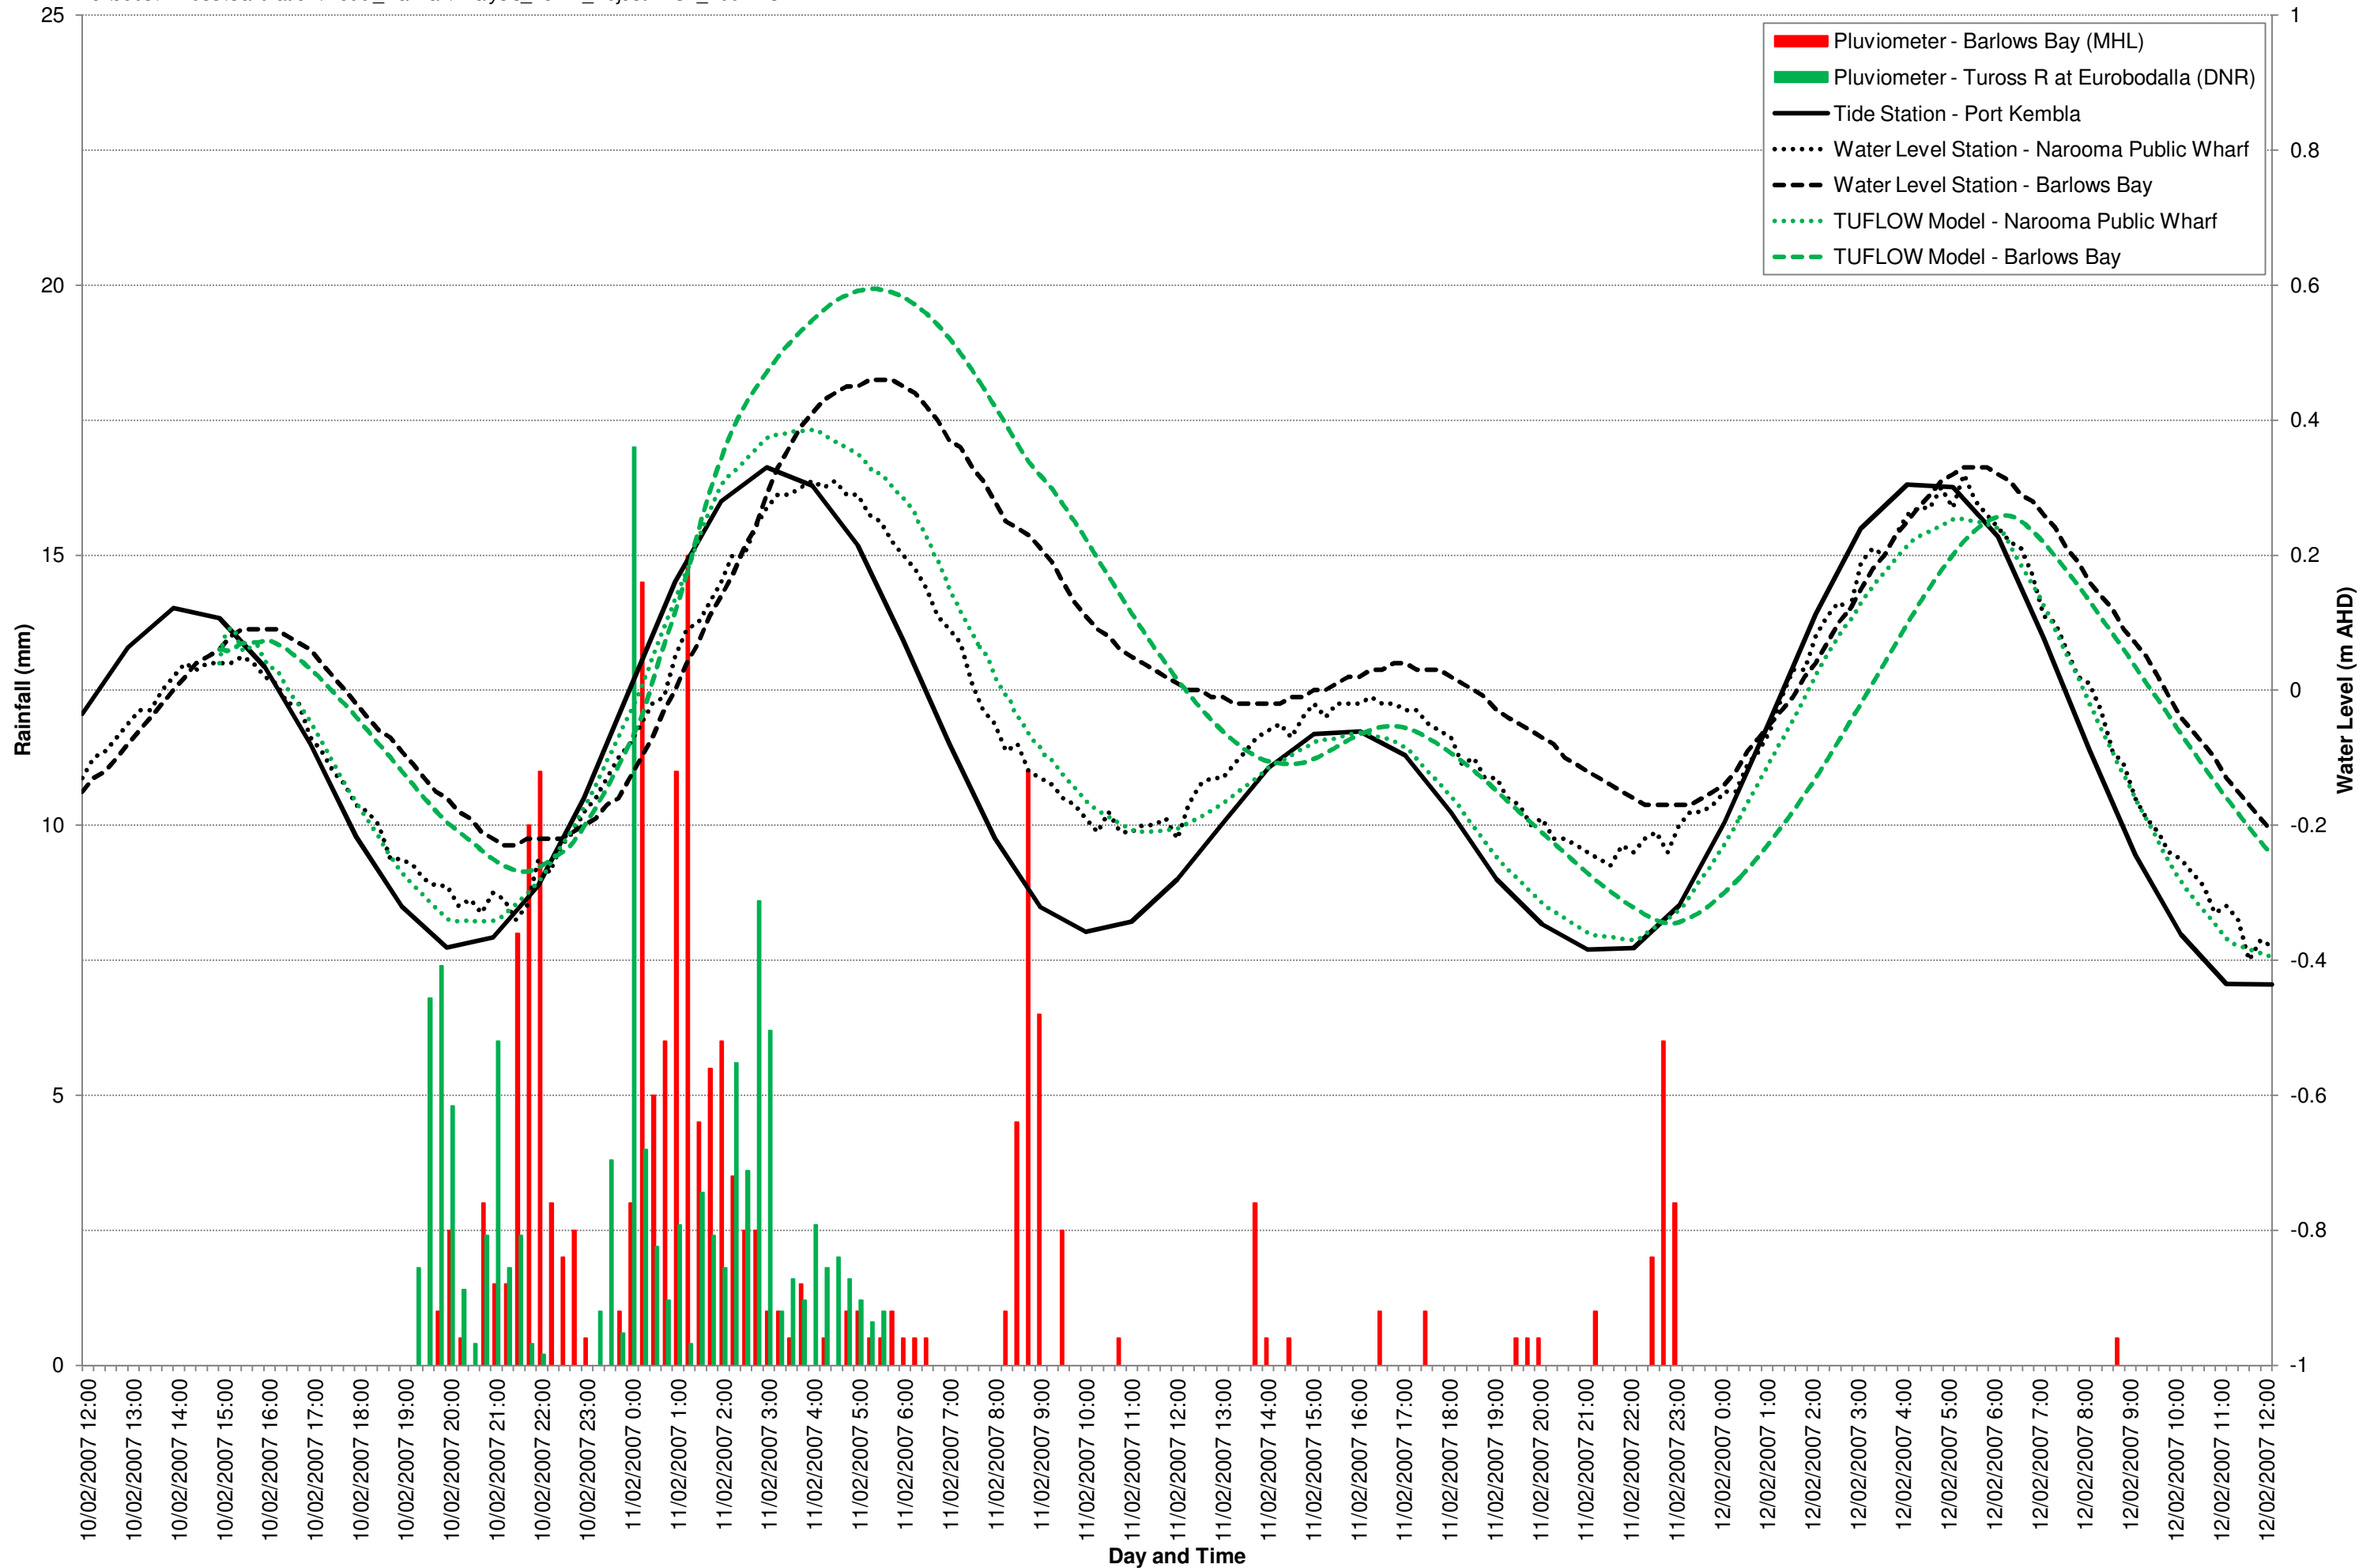
FIGURE E11  
11TH FEBRUARY 2007 EVENT  
STAGE HYDROGRAPHS

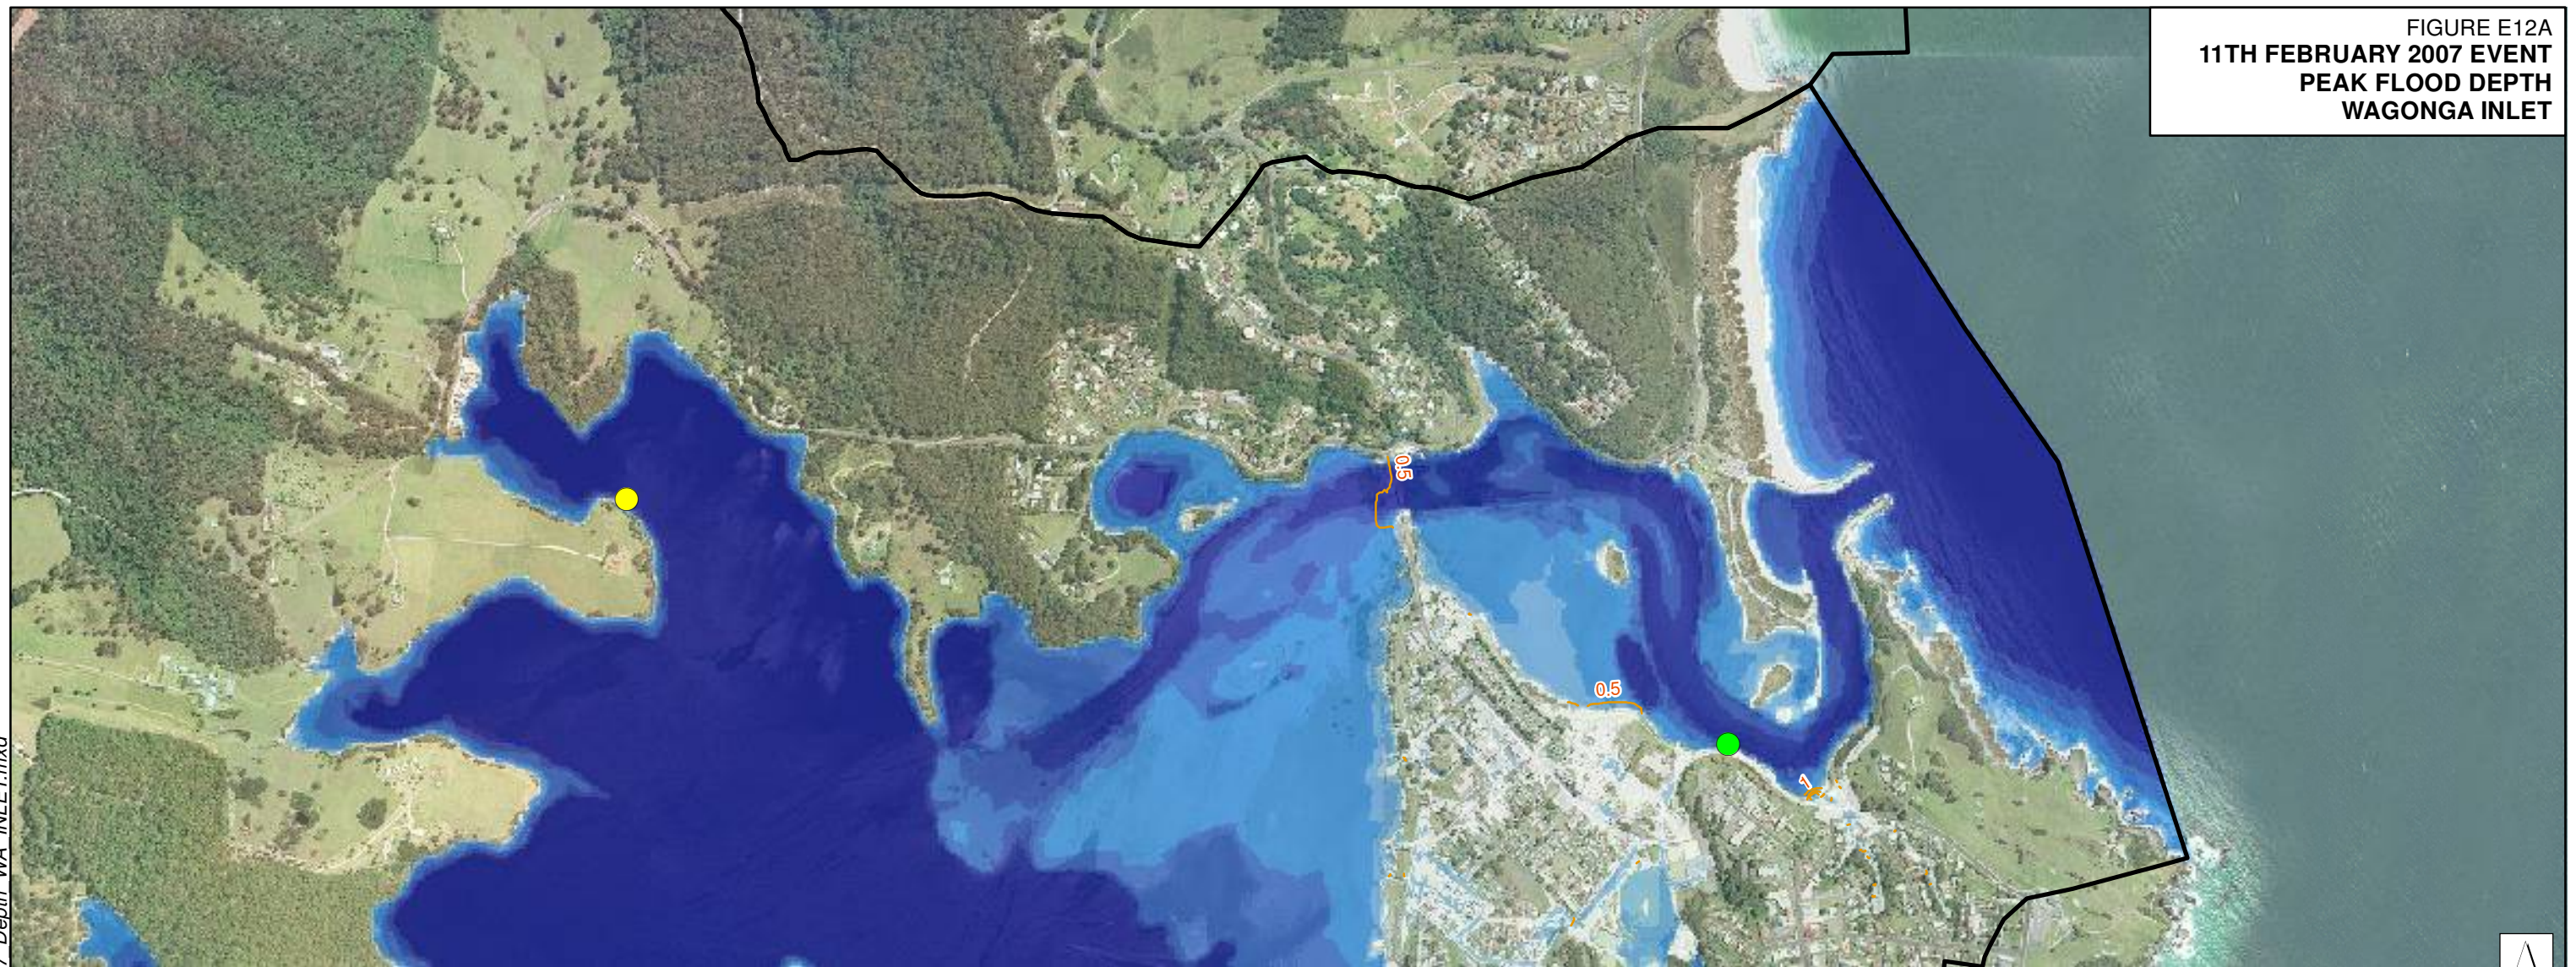
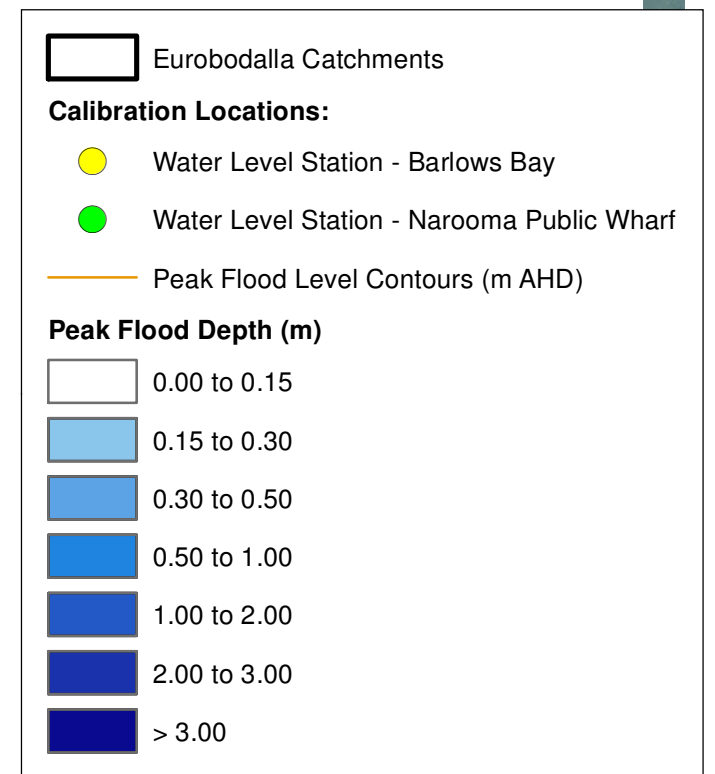
FIGURE E12A  
11TH FEBRUARY 2007 EVENT  
PEAK FLOOD DEPTH  
WAGONGA INLET

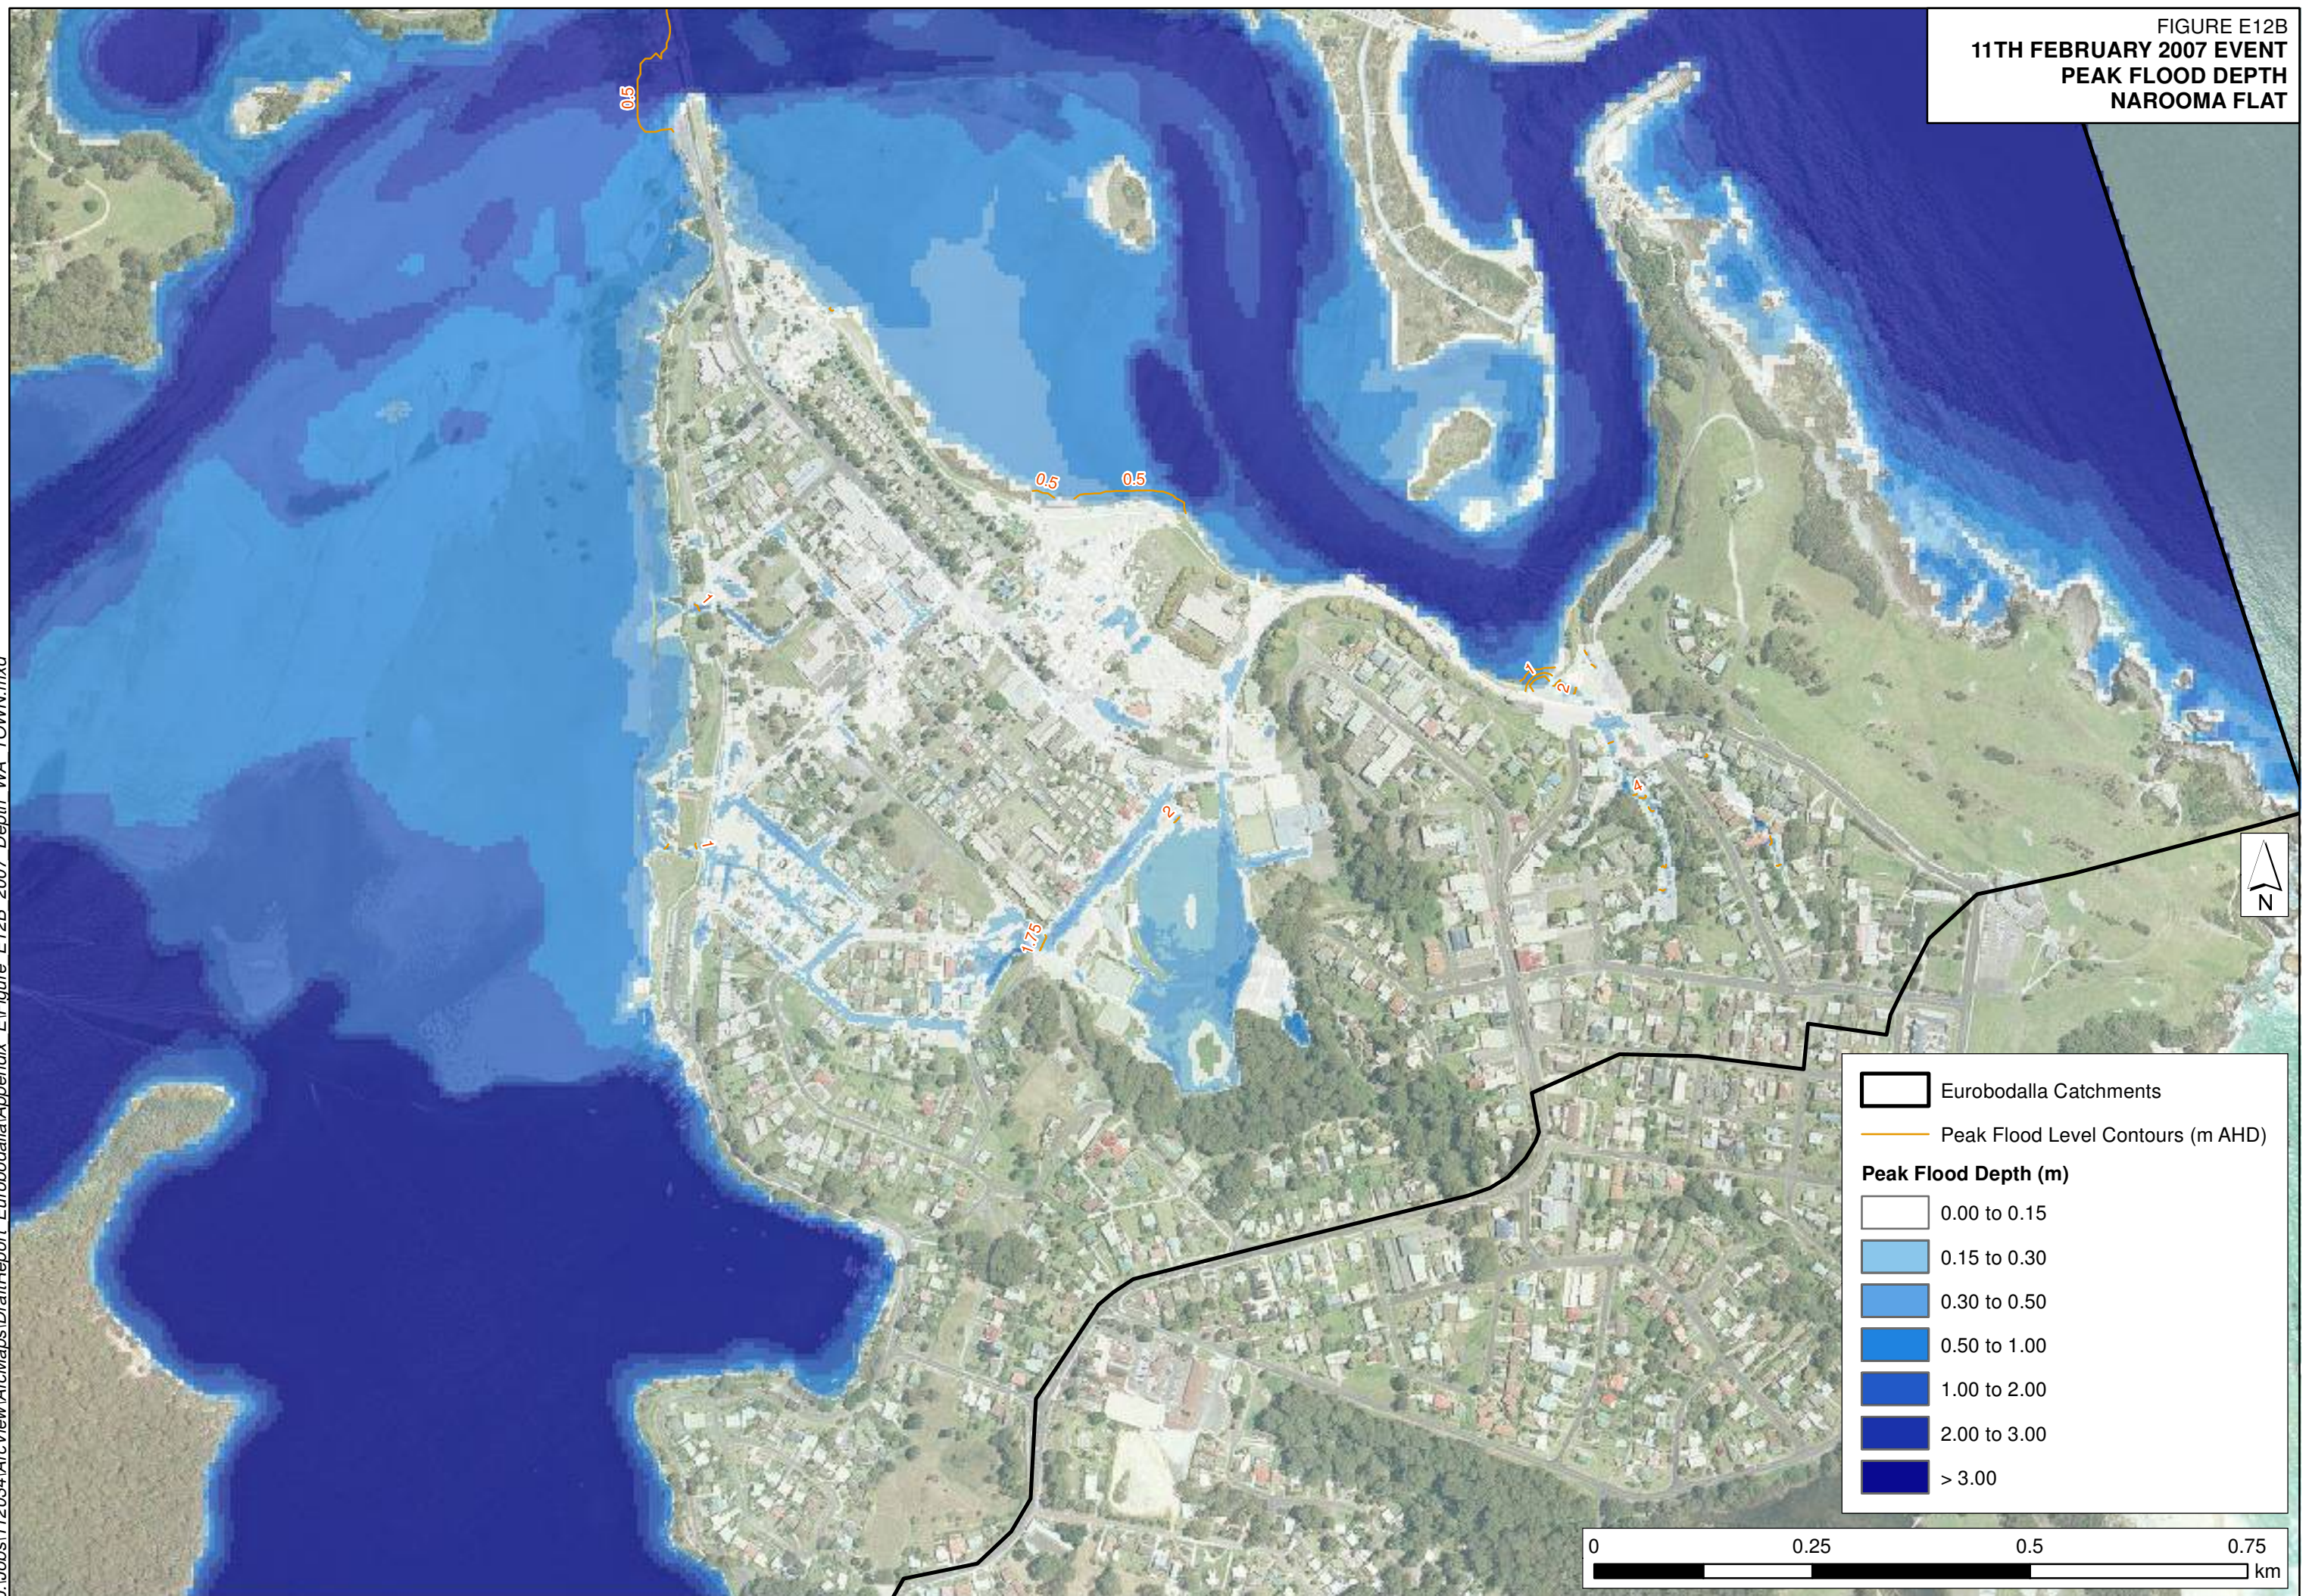
FIGURE E12B  
11TH FEBRUARY 2007 EVENT  
PEAK FLOOD DEPTH  
NAROOMA FLAT

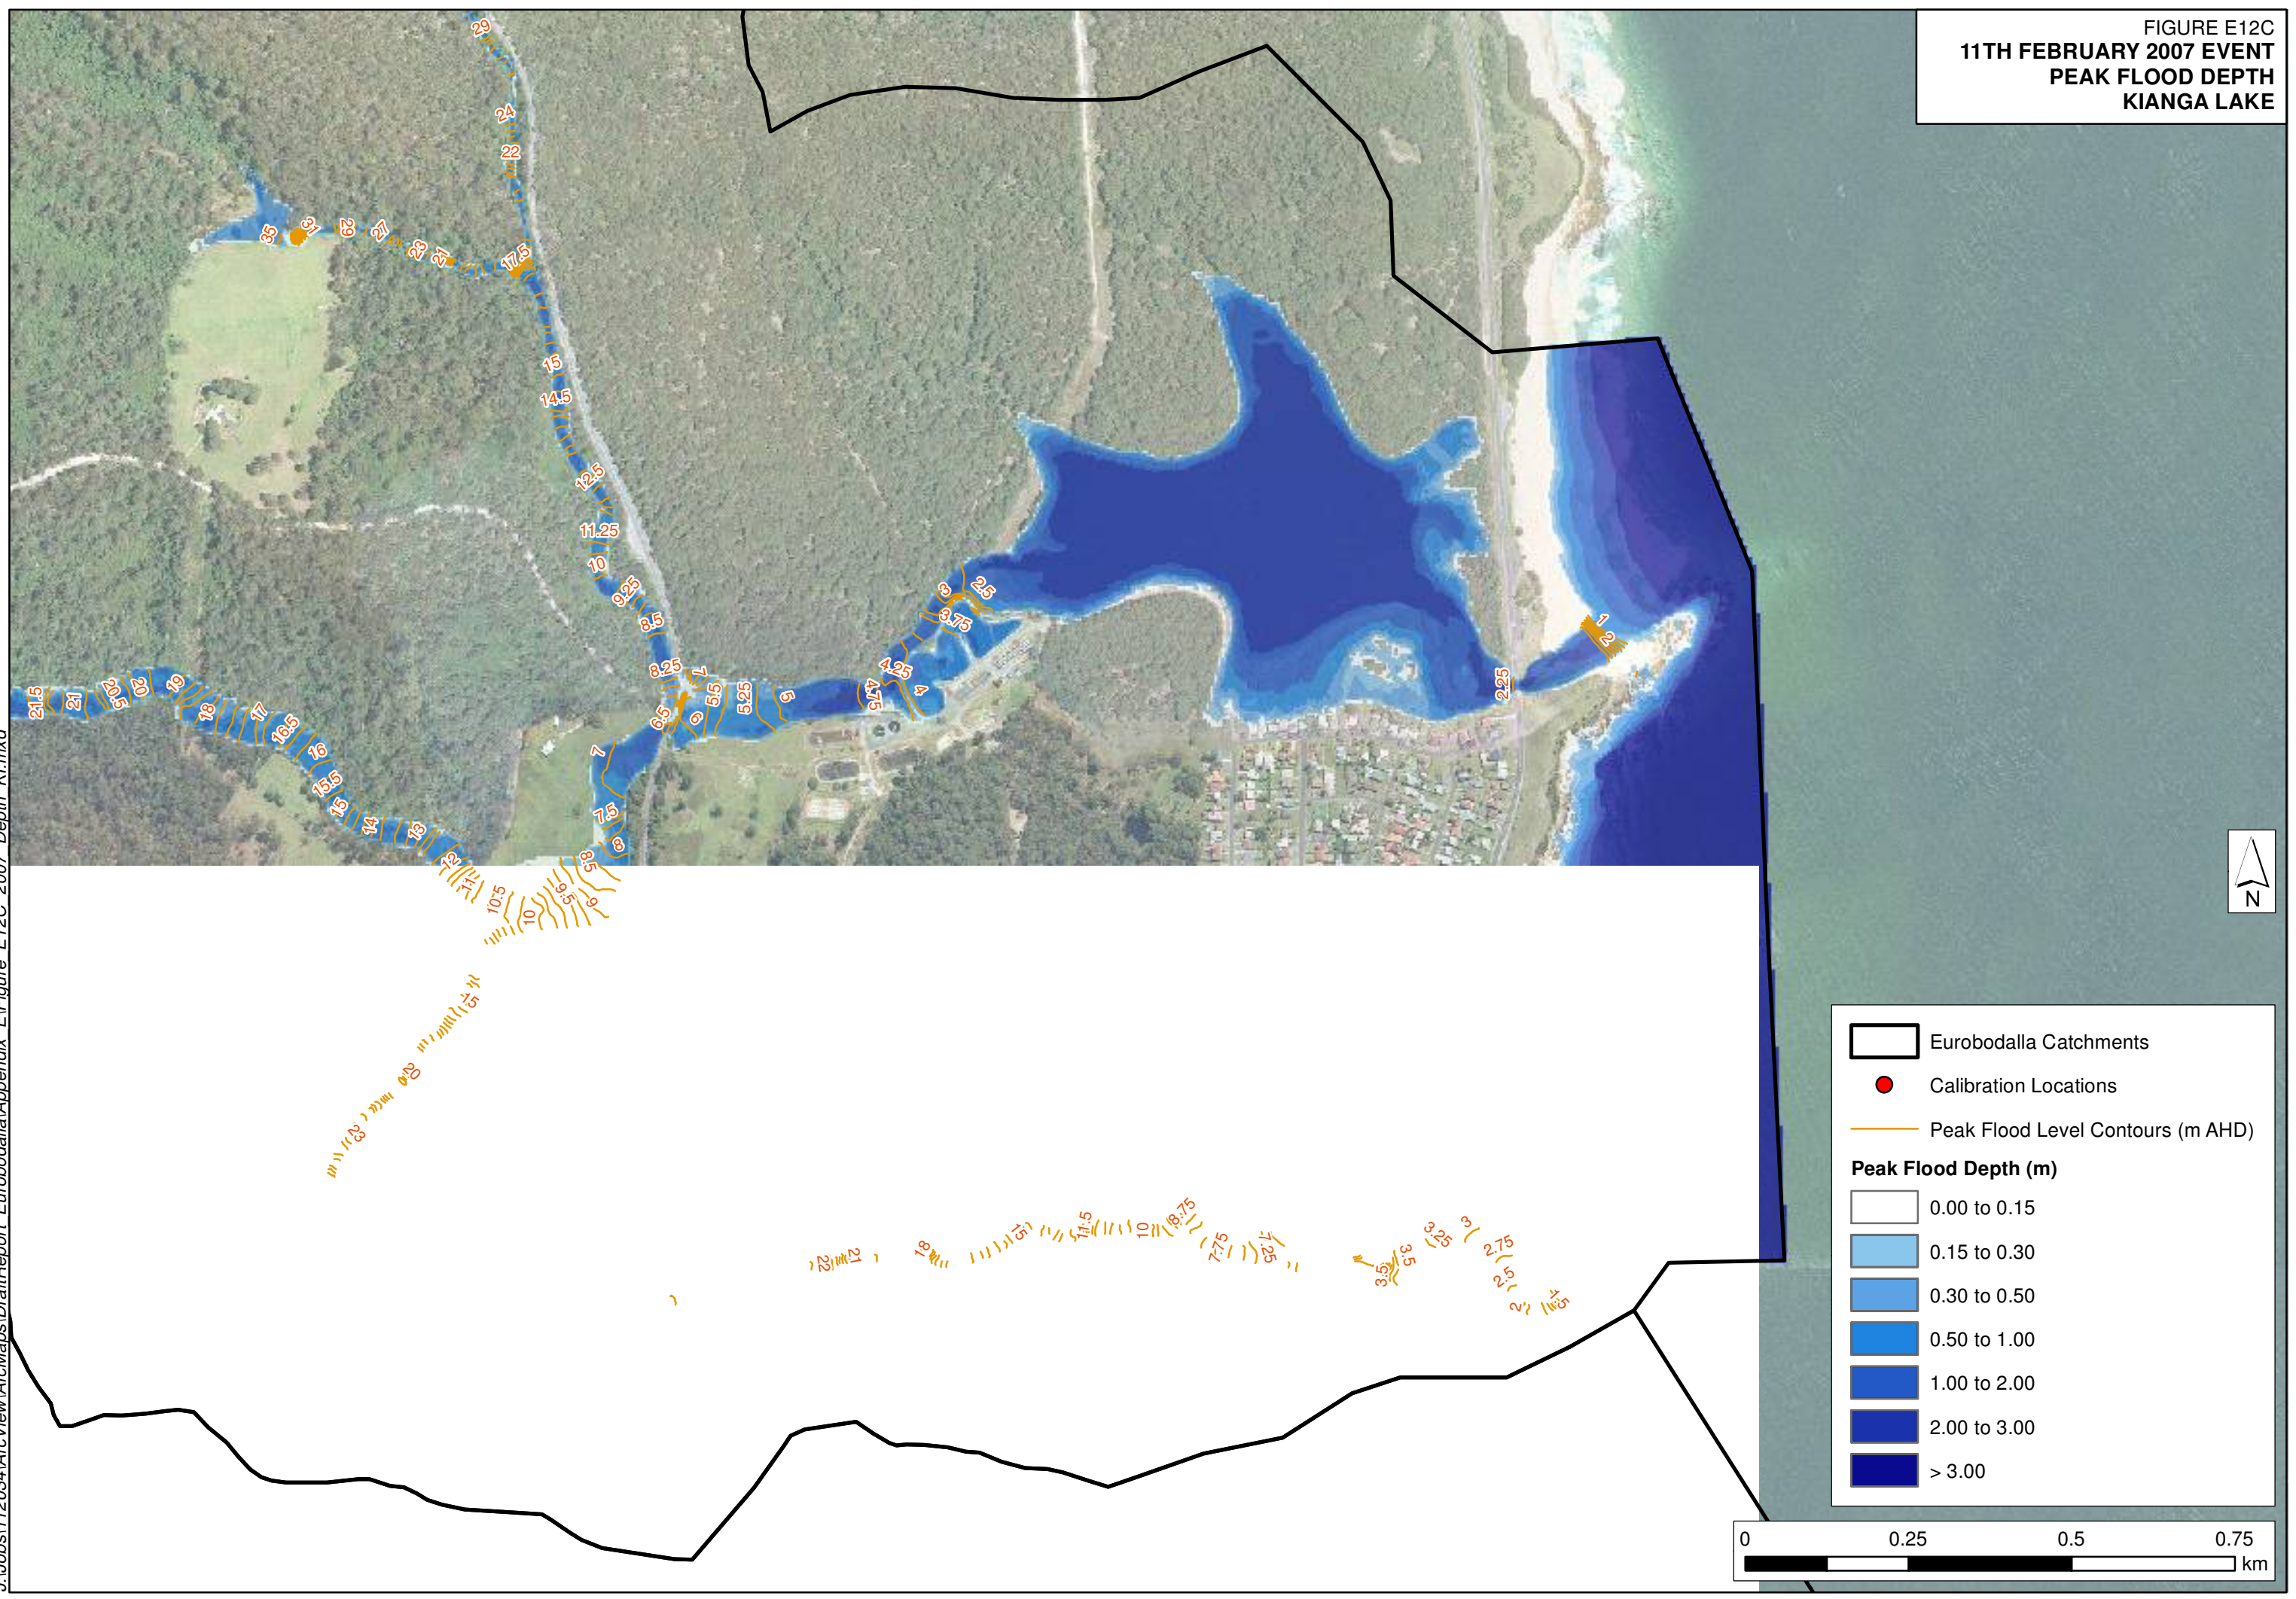
FIGURE E12C  
11TH FEBRUARY 2007 EVENT  
PEAK FLOOD DEPTH  
KIANGA LAKE
