**Eurobodalla Catchments**

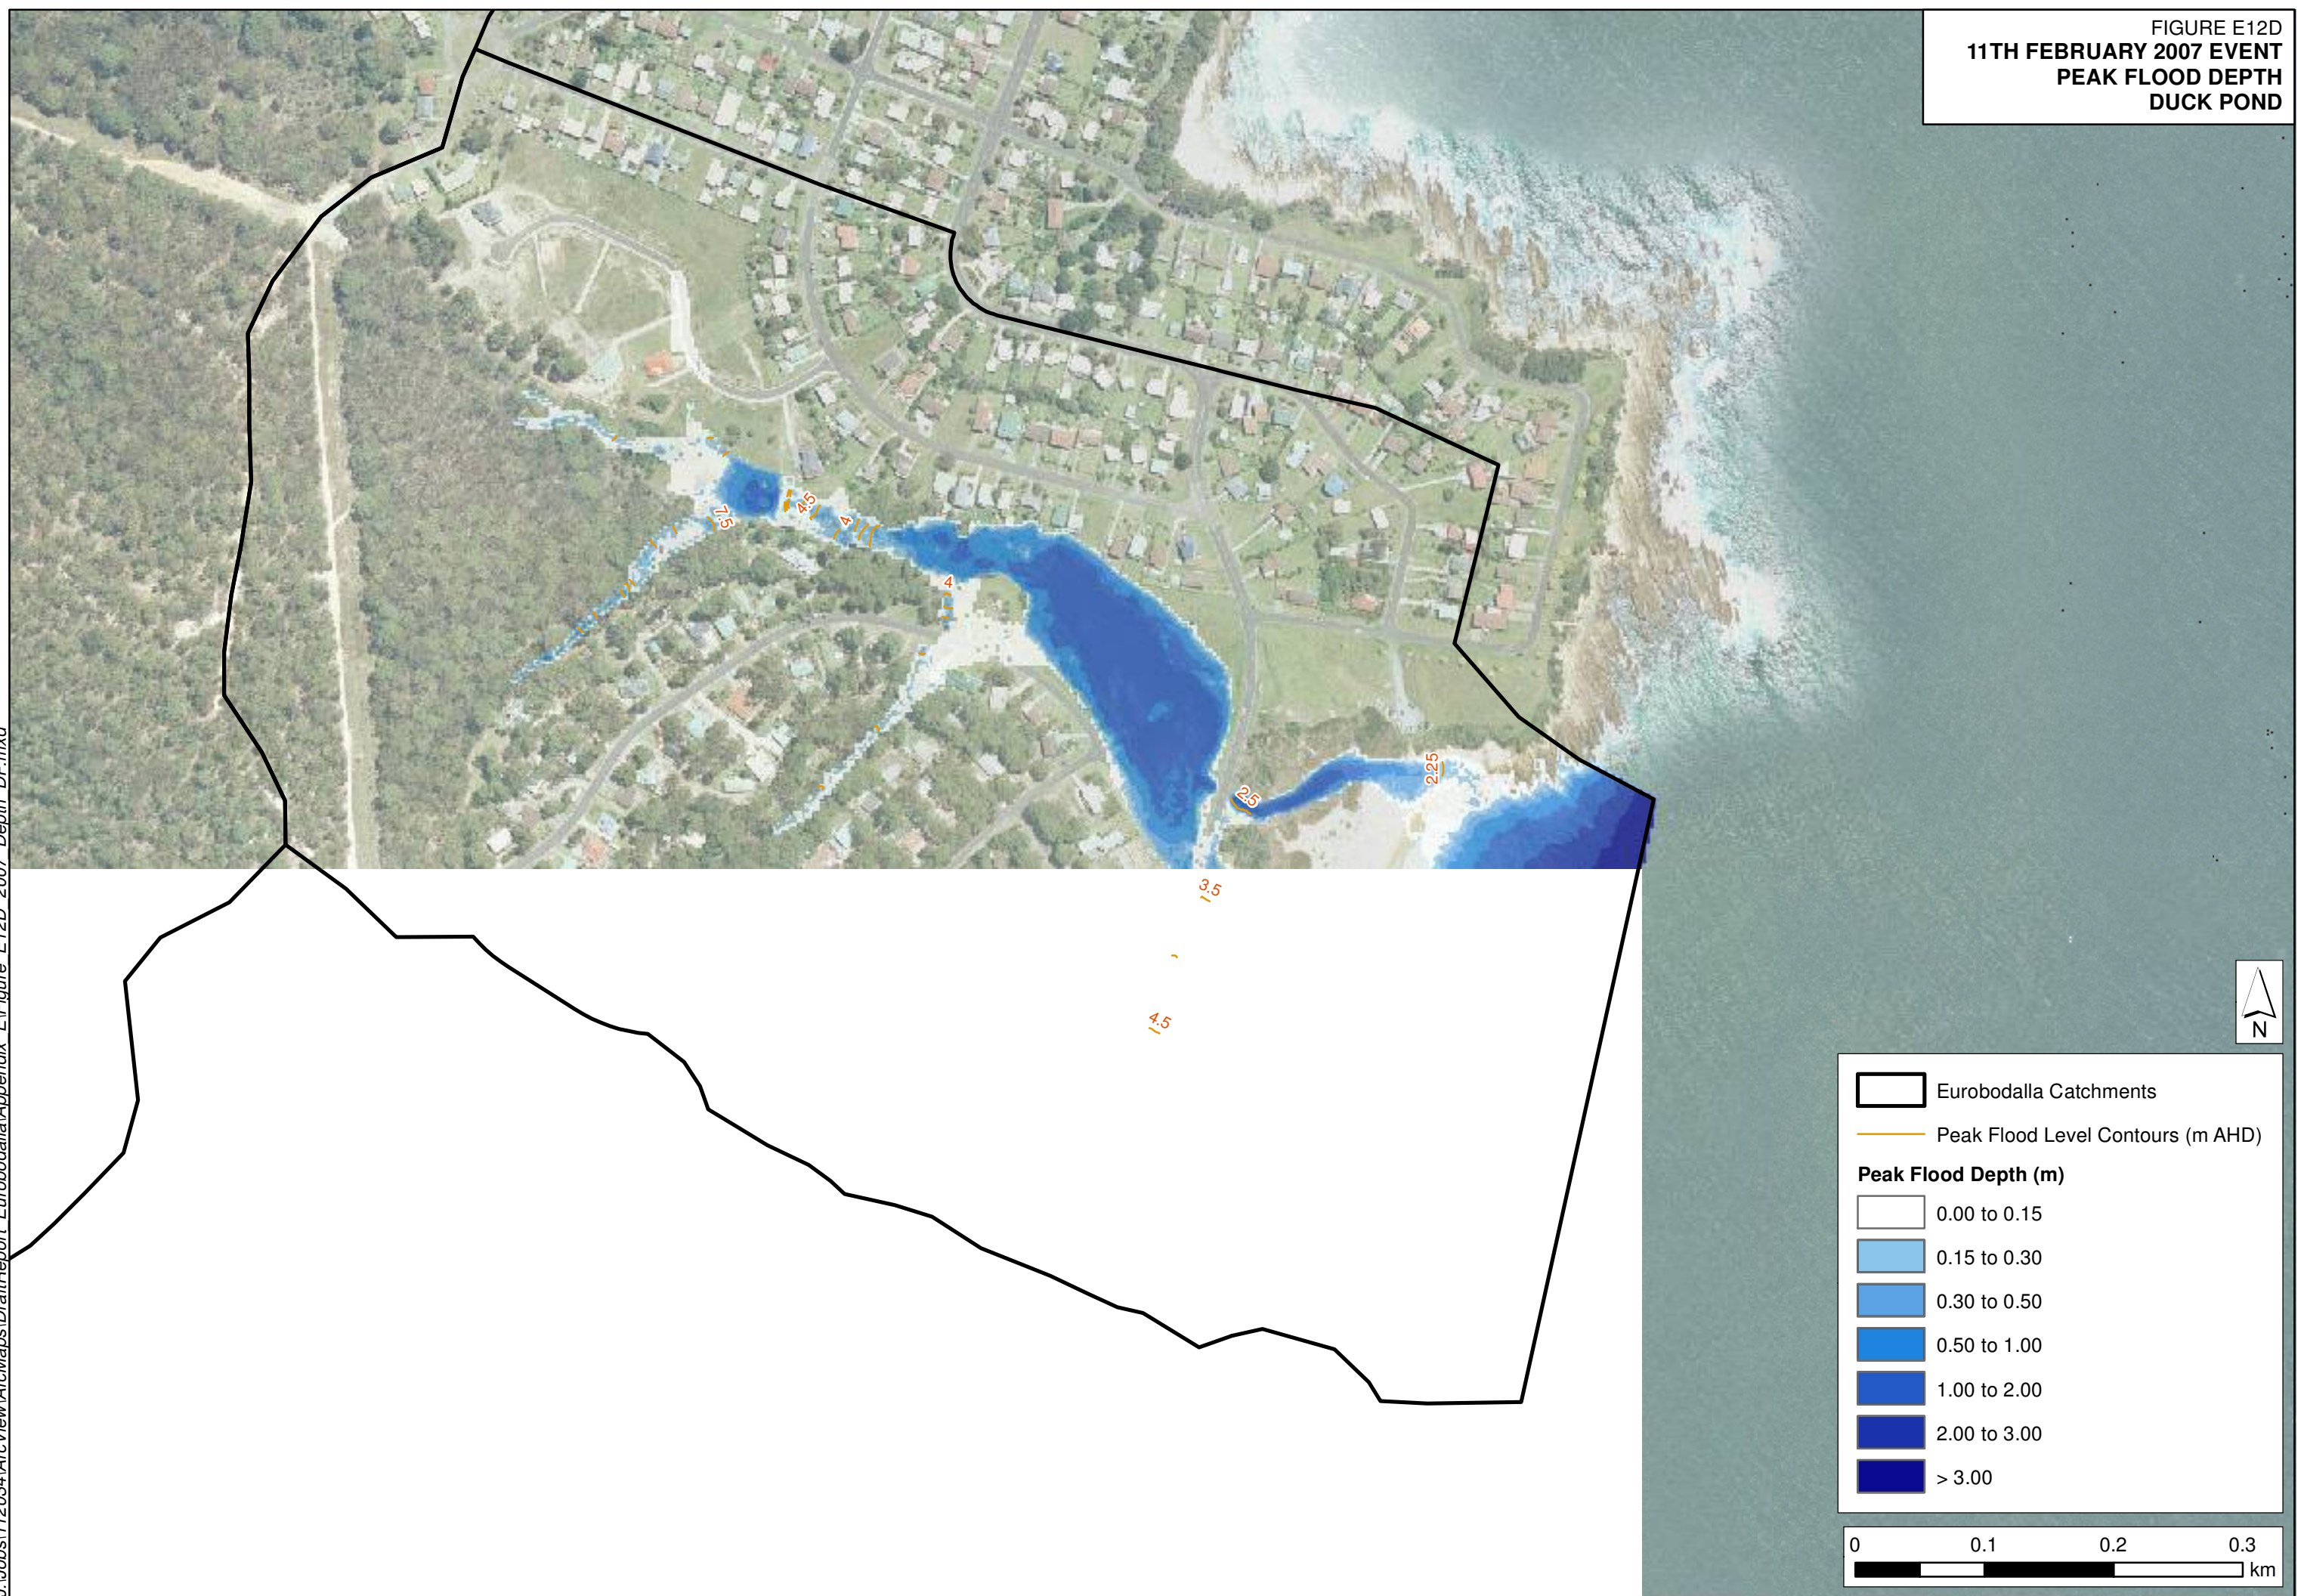
FIGURE E12D  
11TH FEBRUARY 2007 EVENT  
PEAK FLOOD DEPTH  
DUCK POND

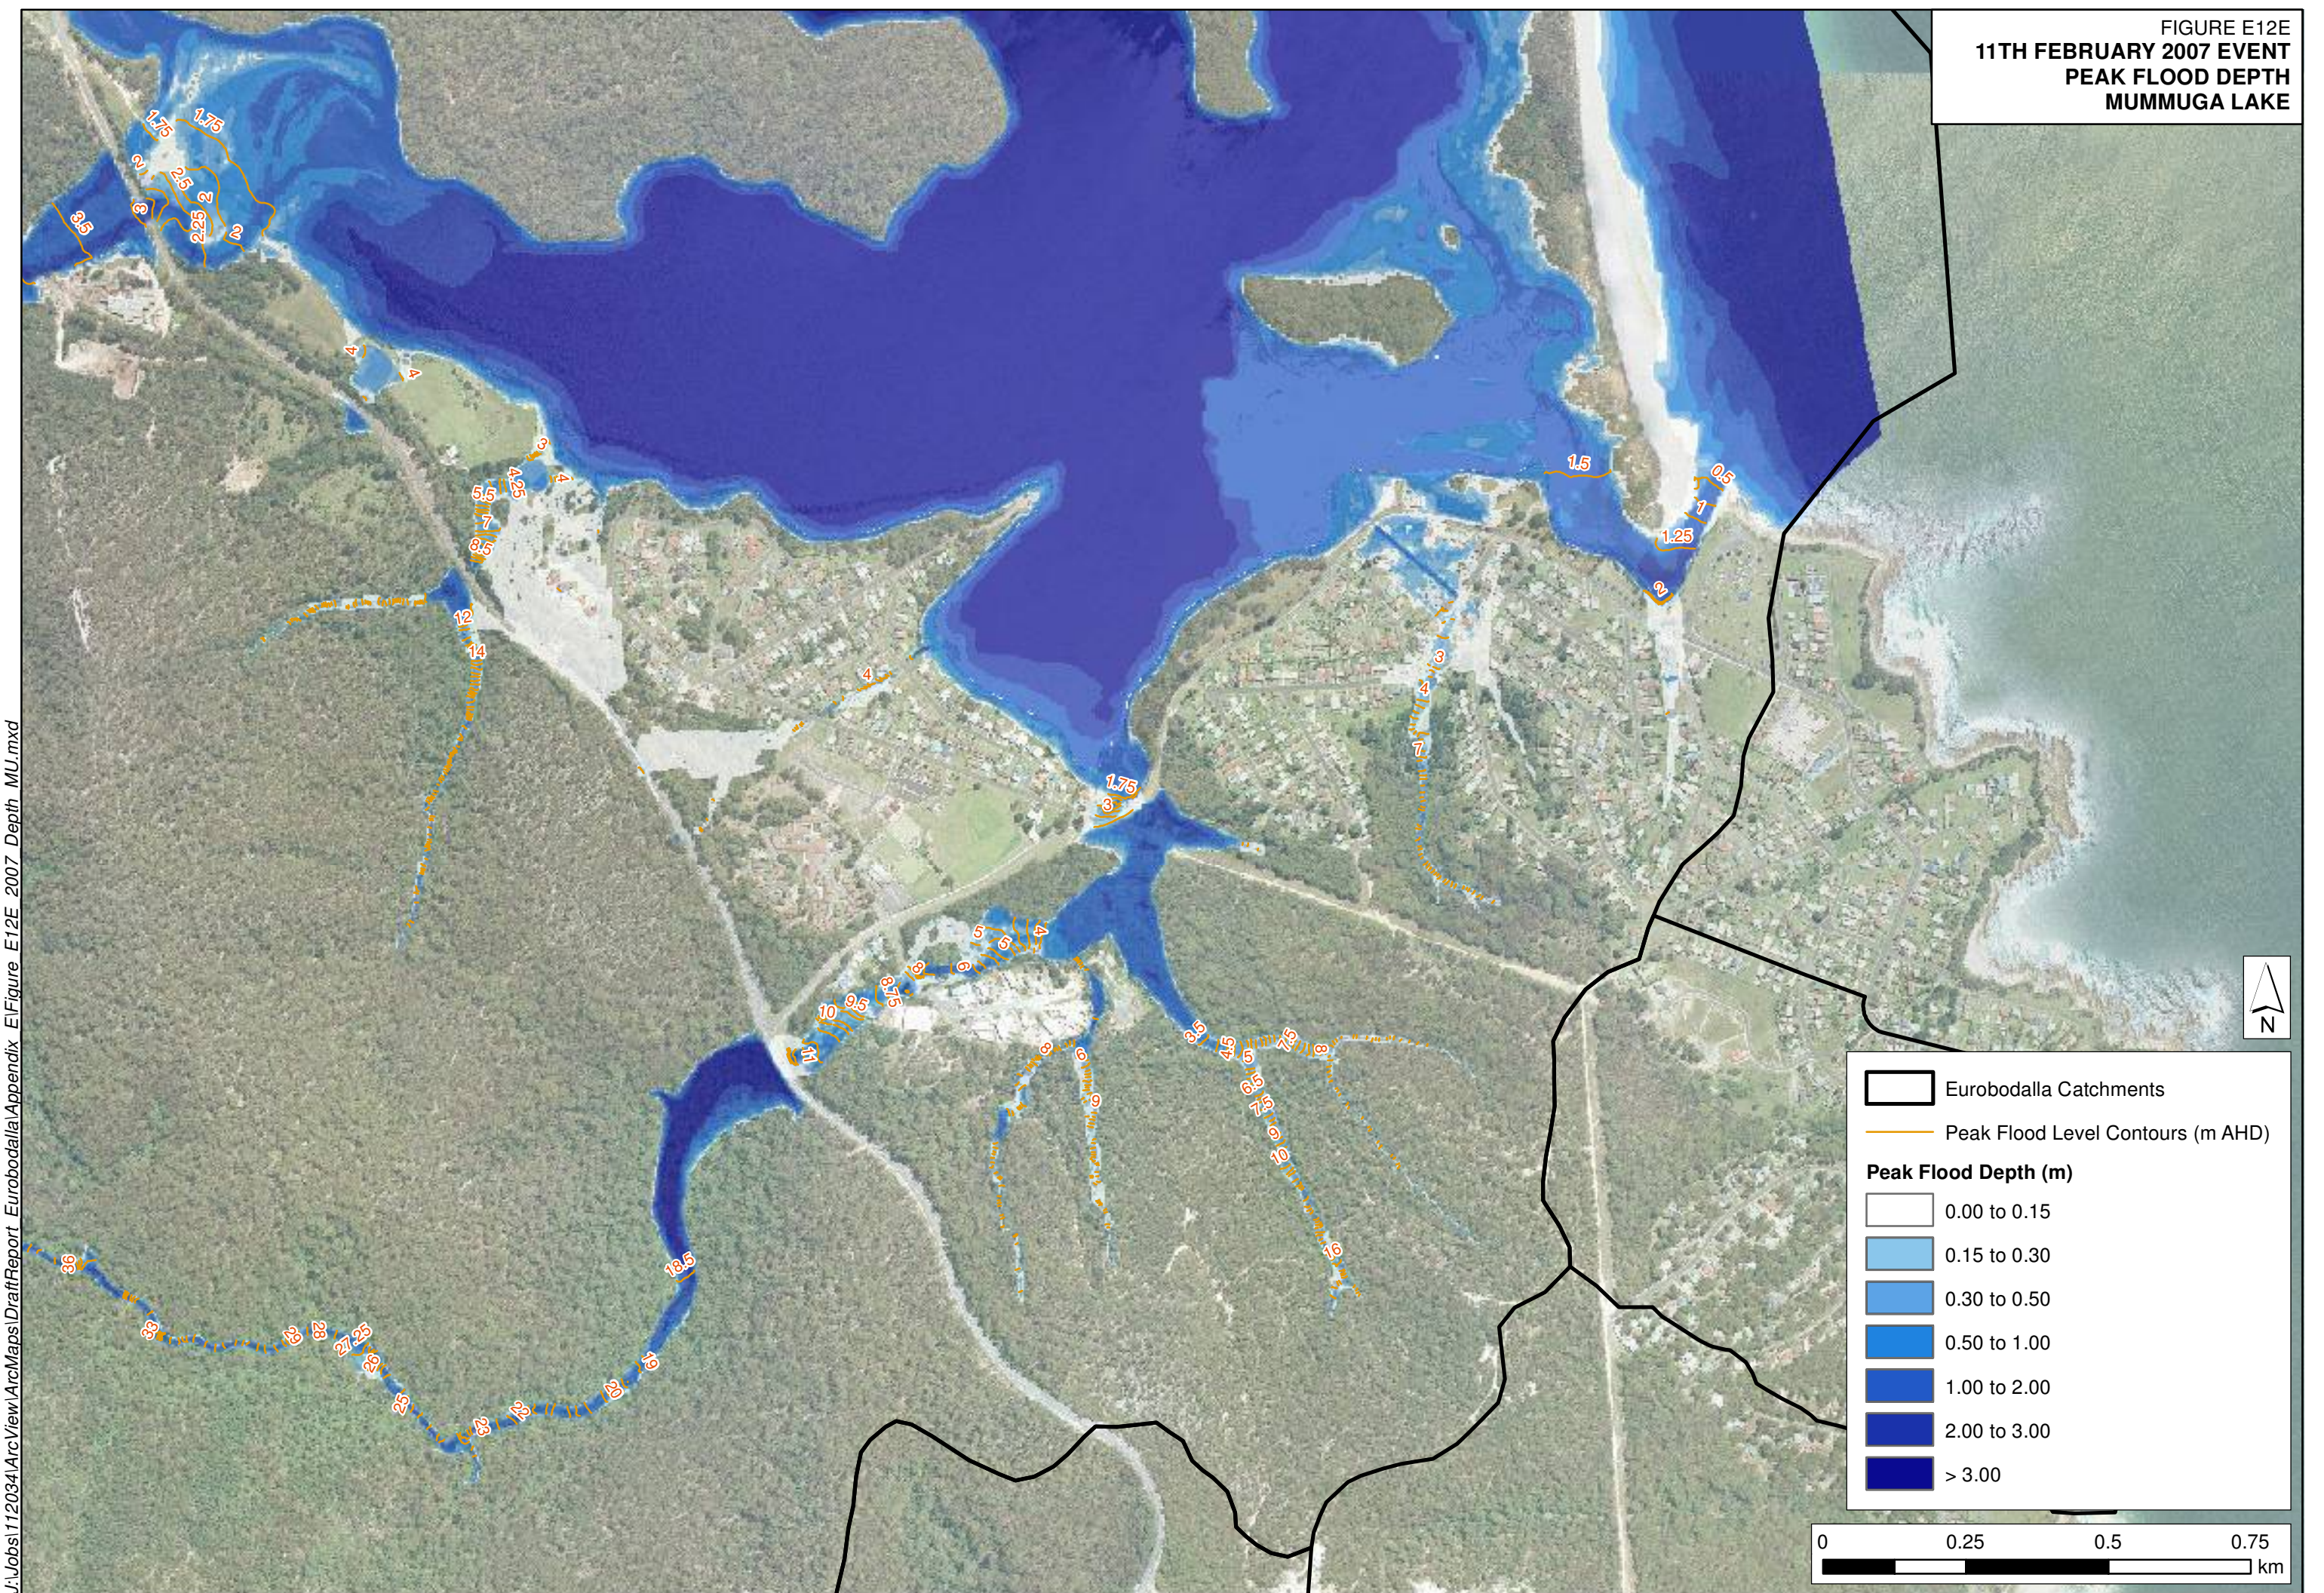
FIGURE E12E  
11TH FEBRUARY 2007 EVENT  
PEAK FLOOD DEPTH  
MUMMUGA LAKE

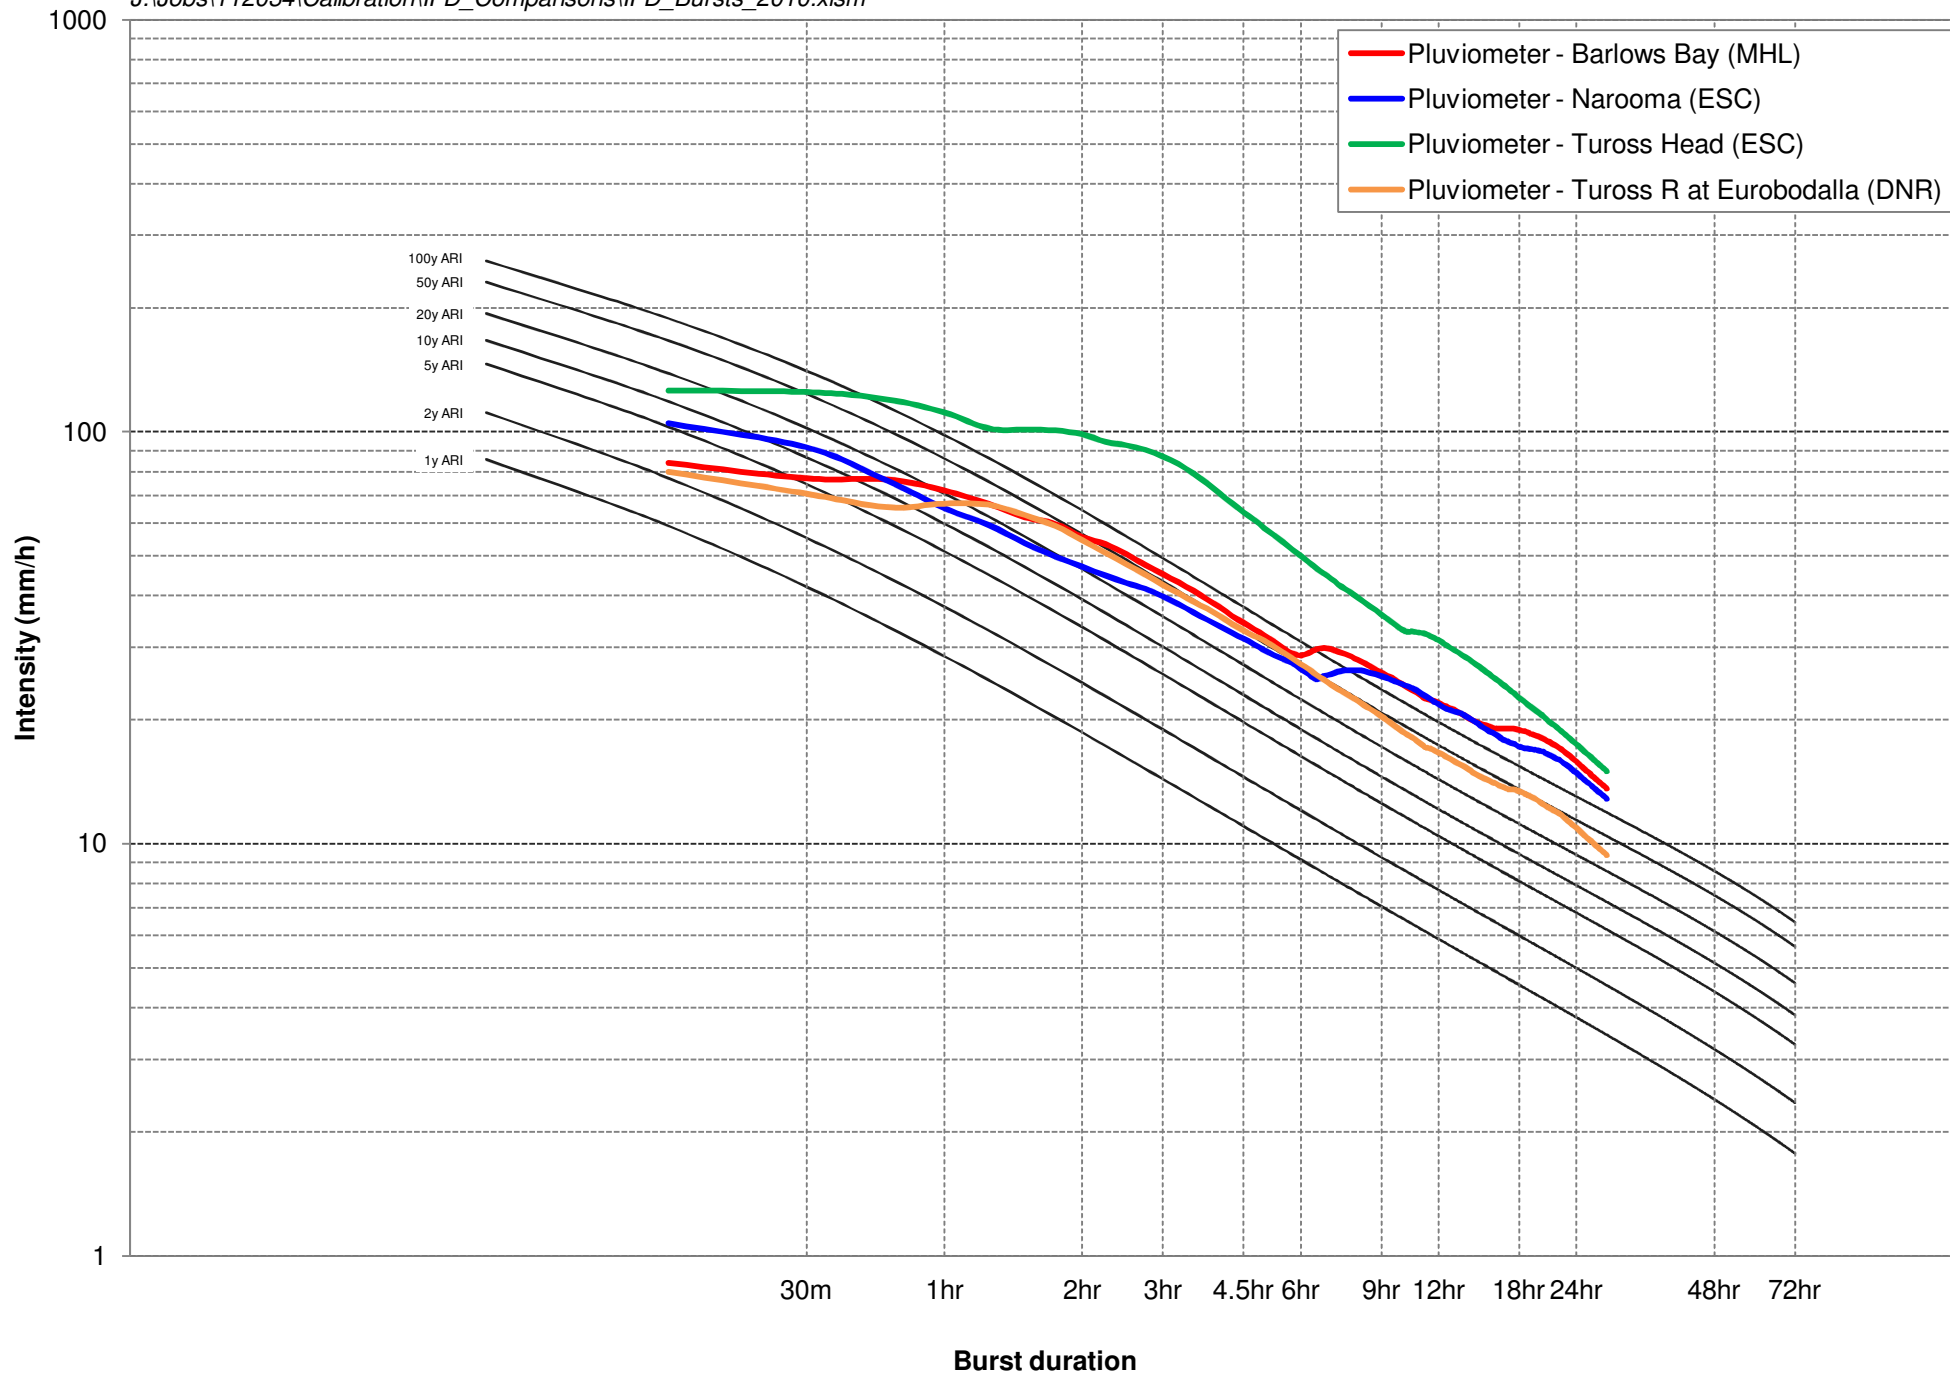
FIGURE E13  
15TH FEBRUARY 2010 EVENT  
IFD DATA

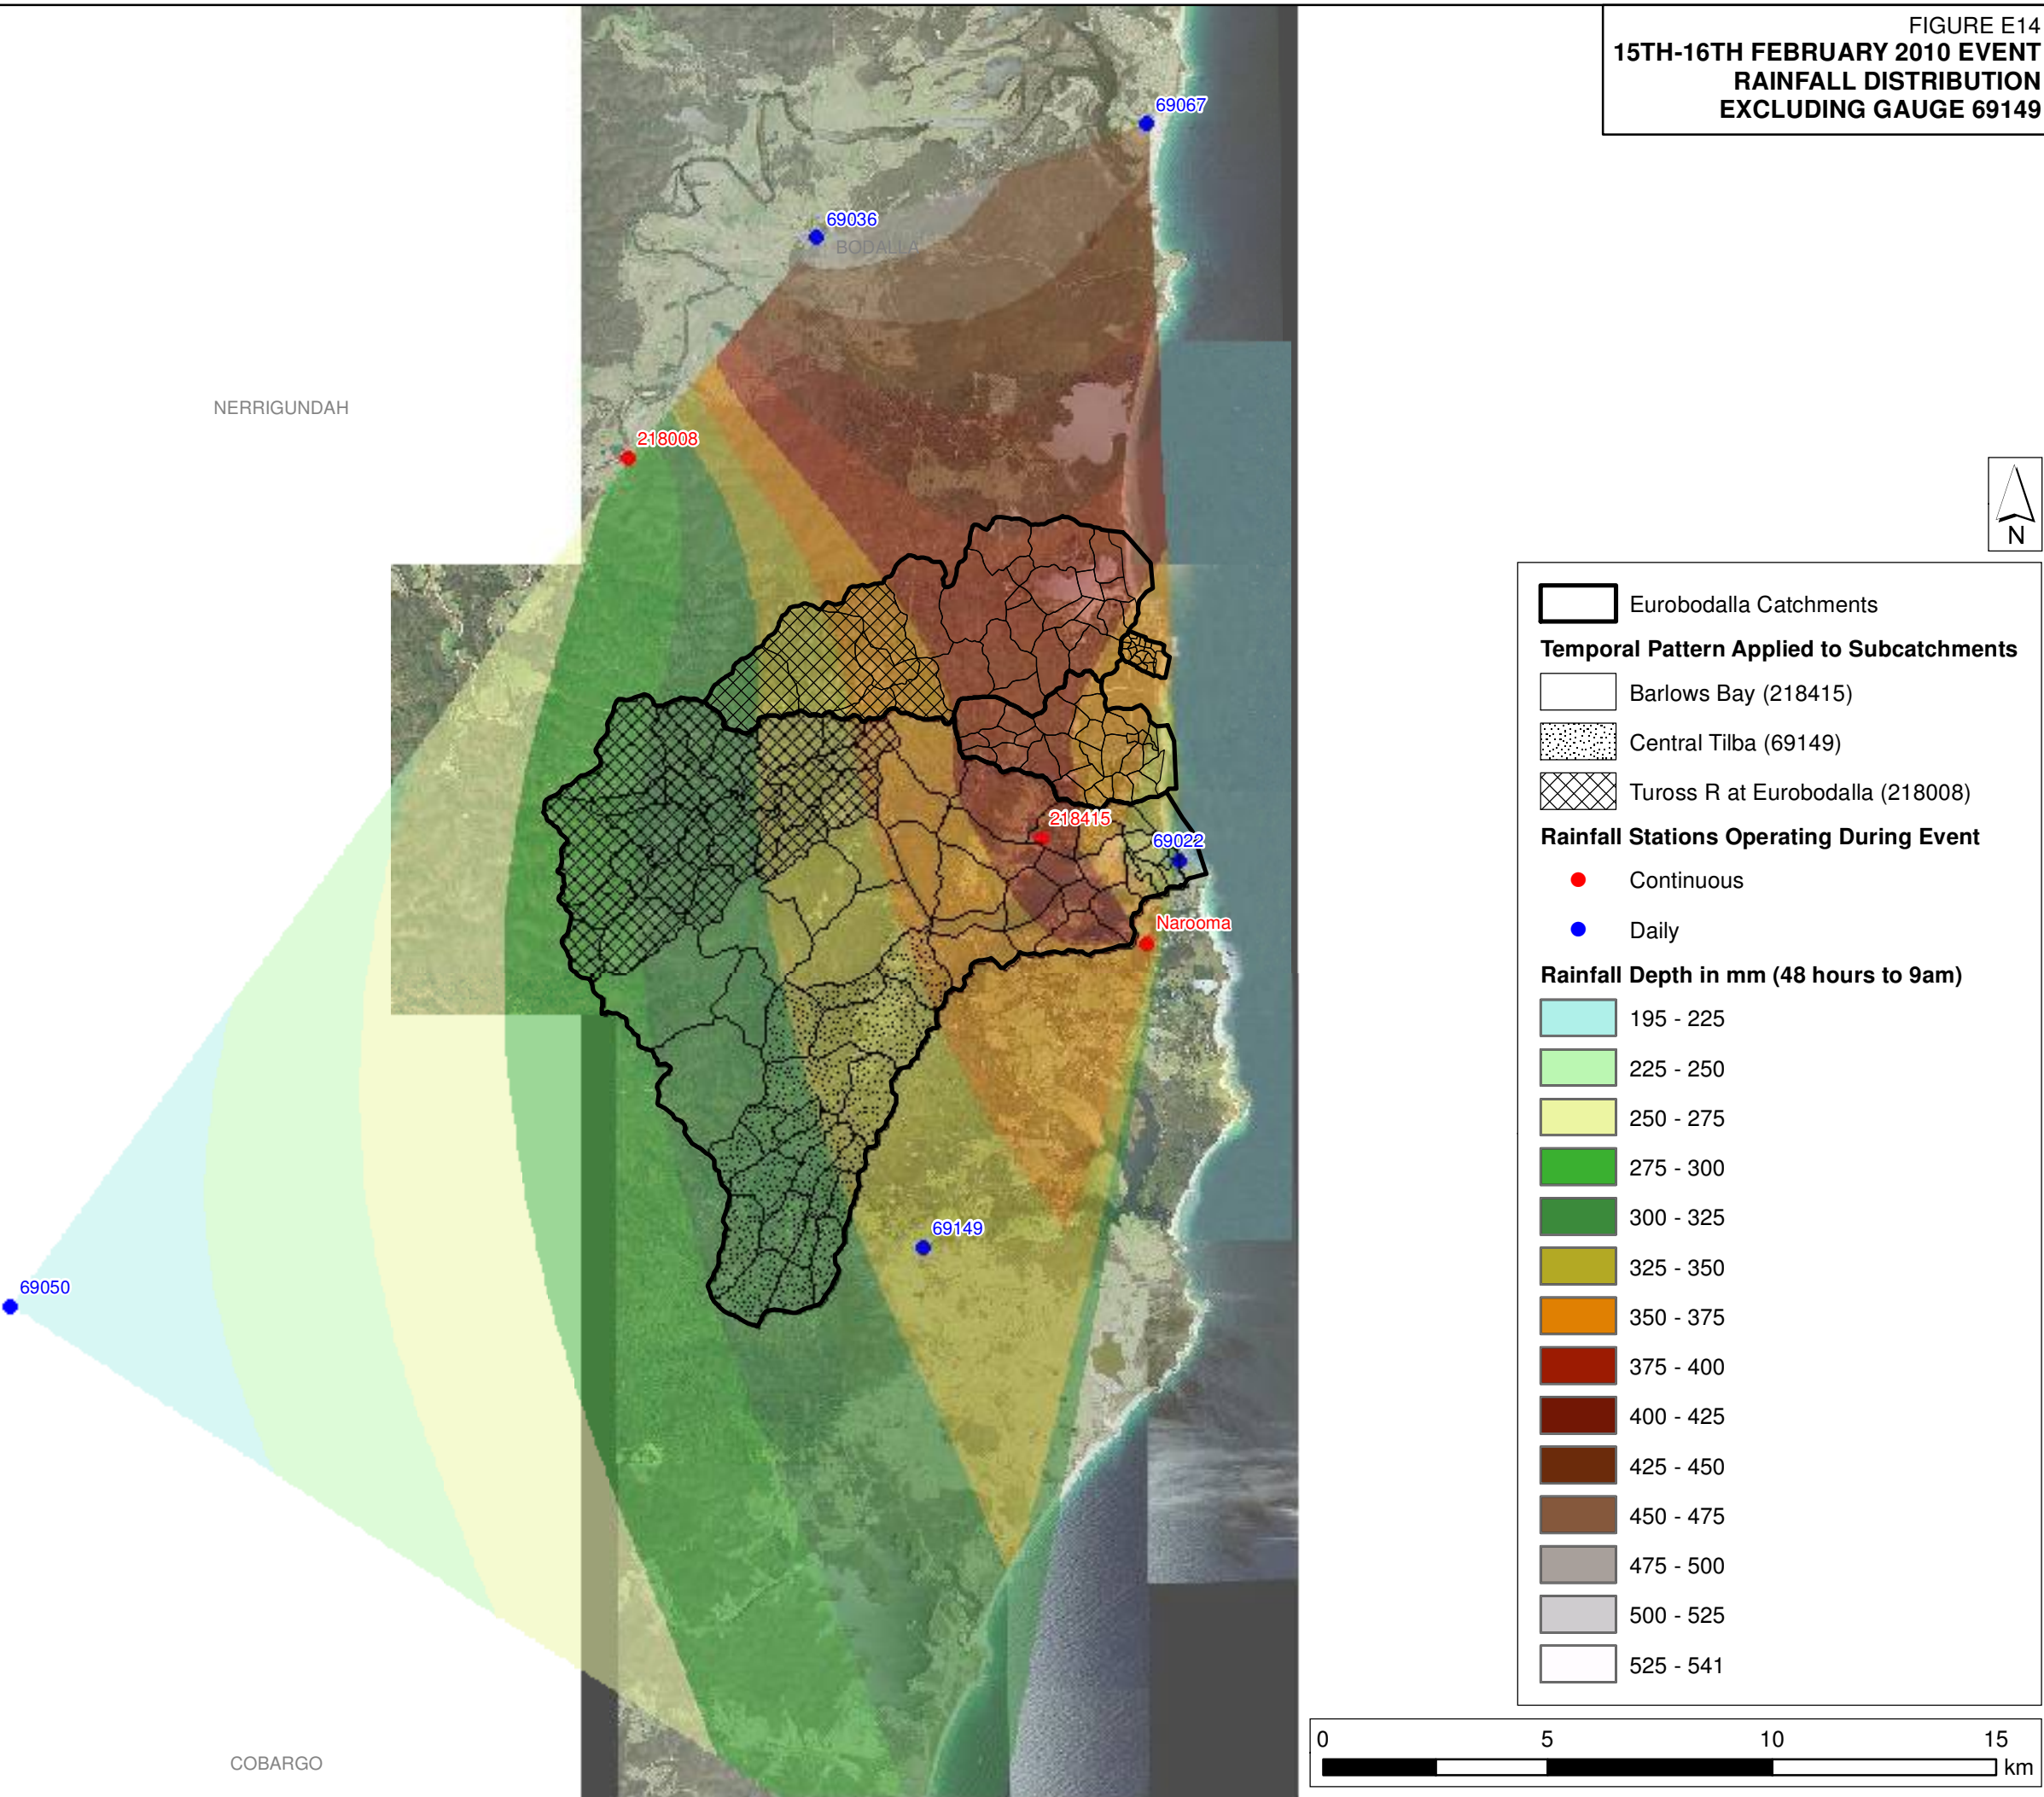
FIGURE E14  
15TH-16TH FEBRUARY 2010 EVENT  
RAINFALL DISTRIBUTION  
EXCLUDING GAUGE 69149

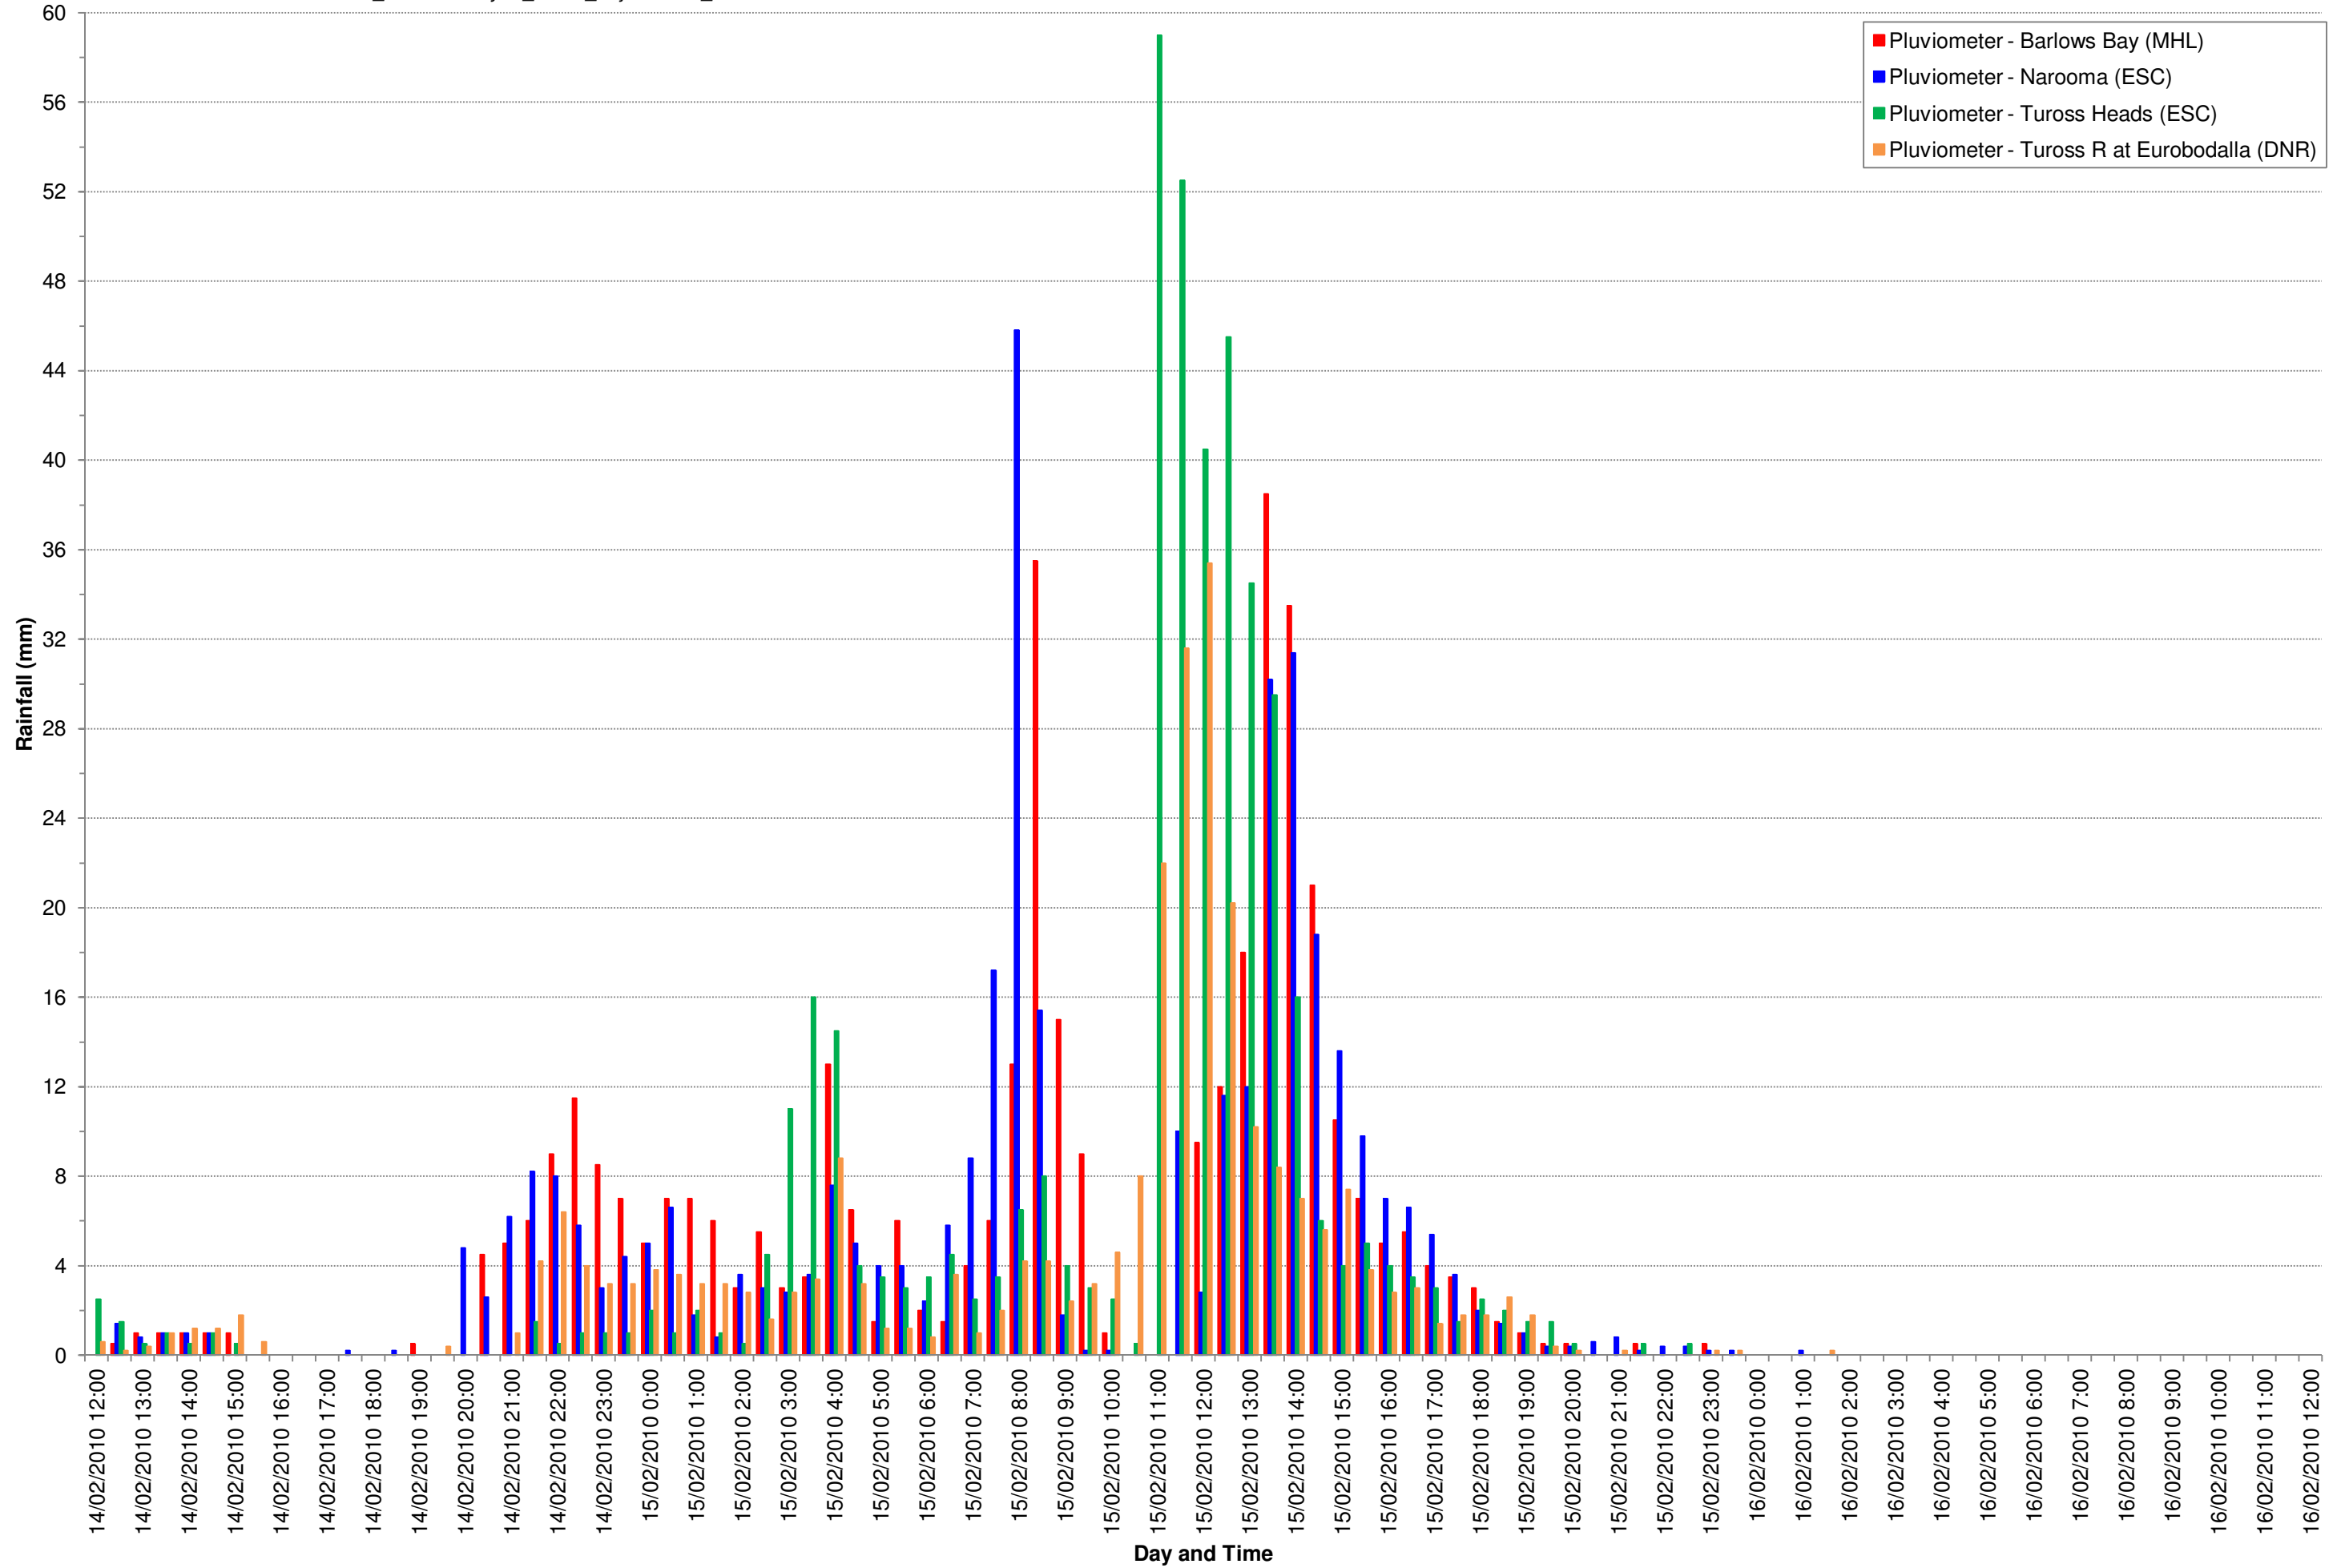
FIGURE E15  
15TH FEBRUARY 2010 EVENT  
RAINFALL HYETOGRAPH COMPARISON

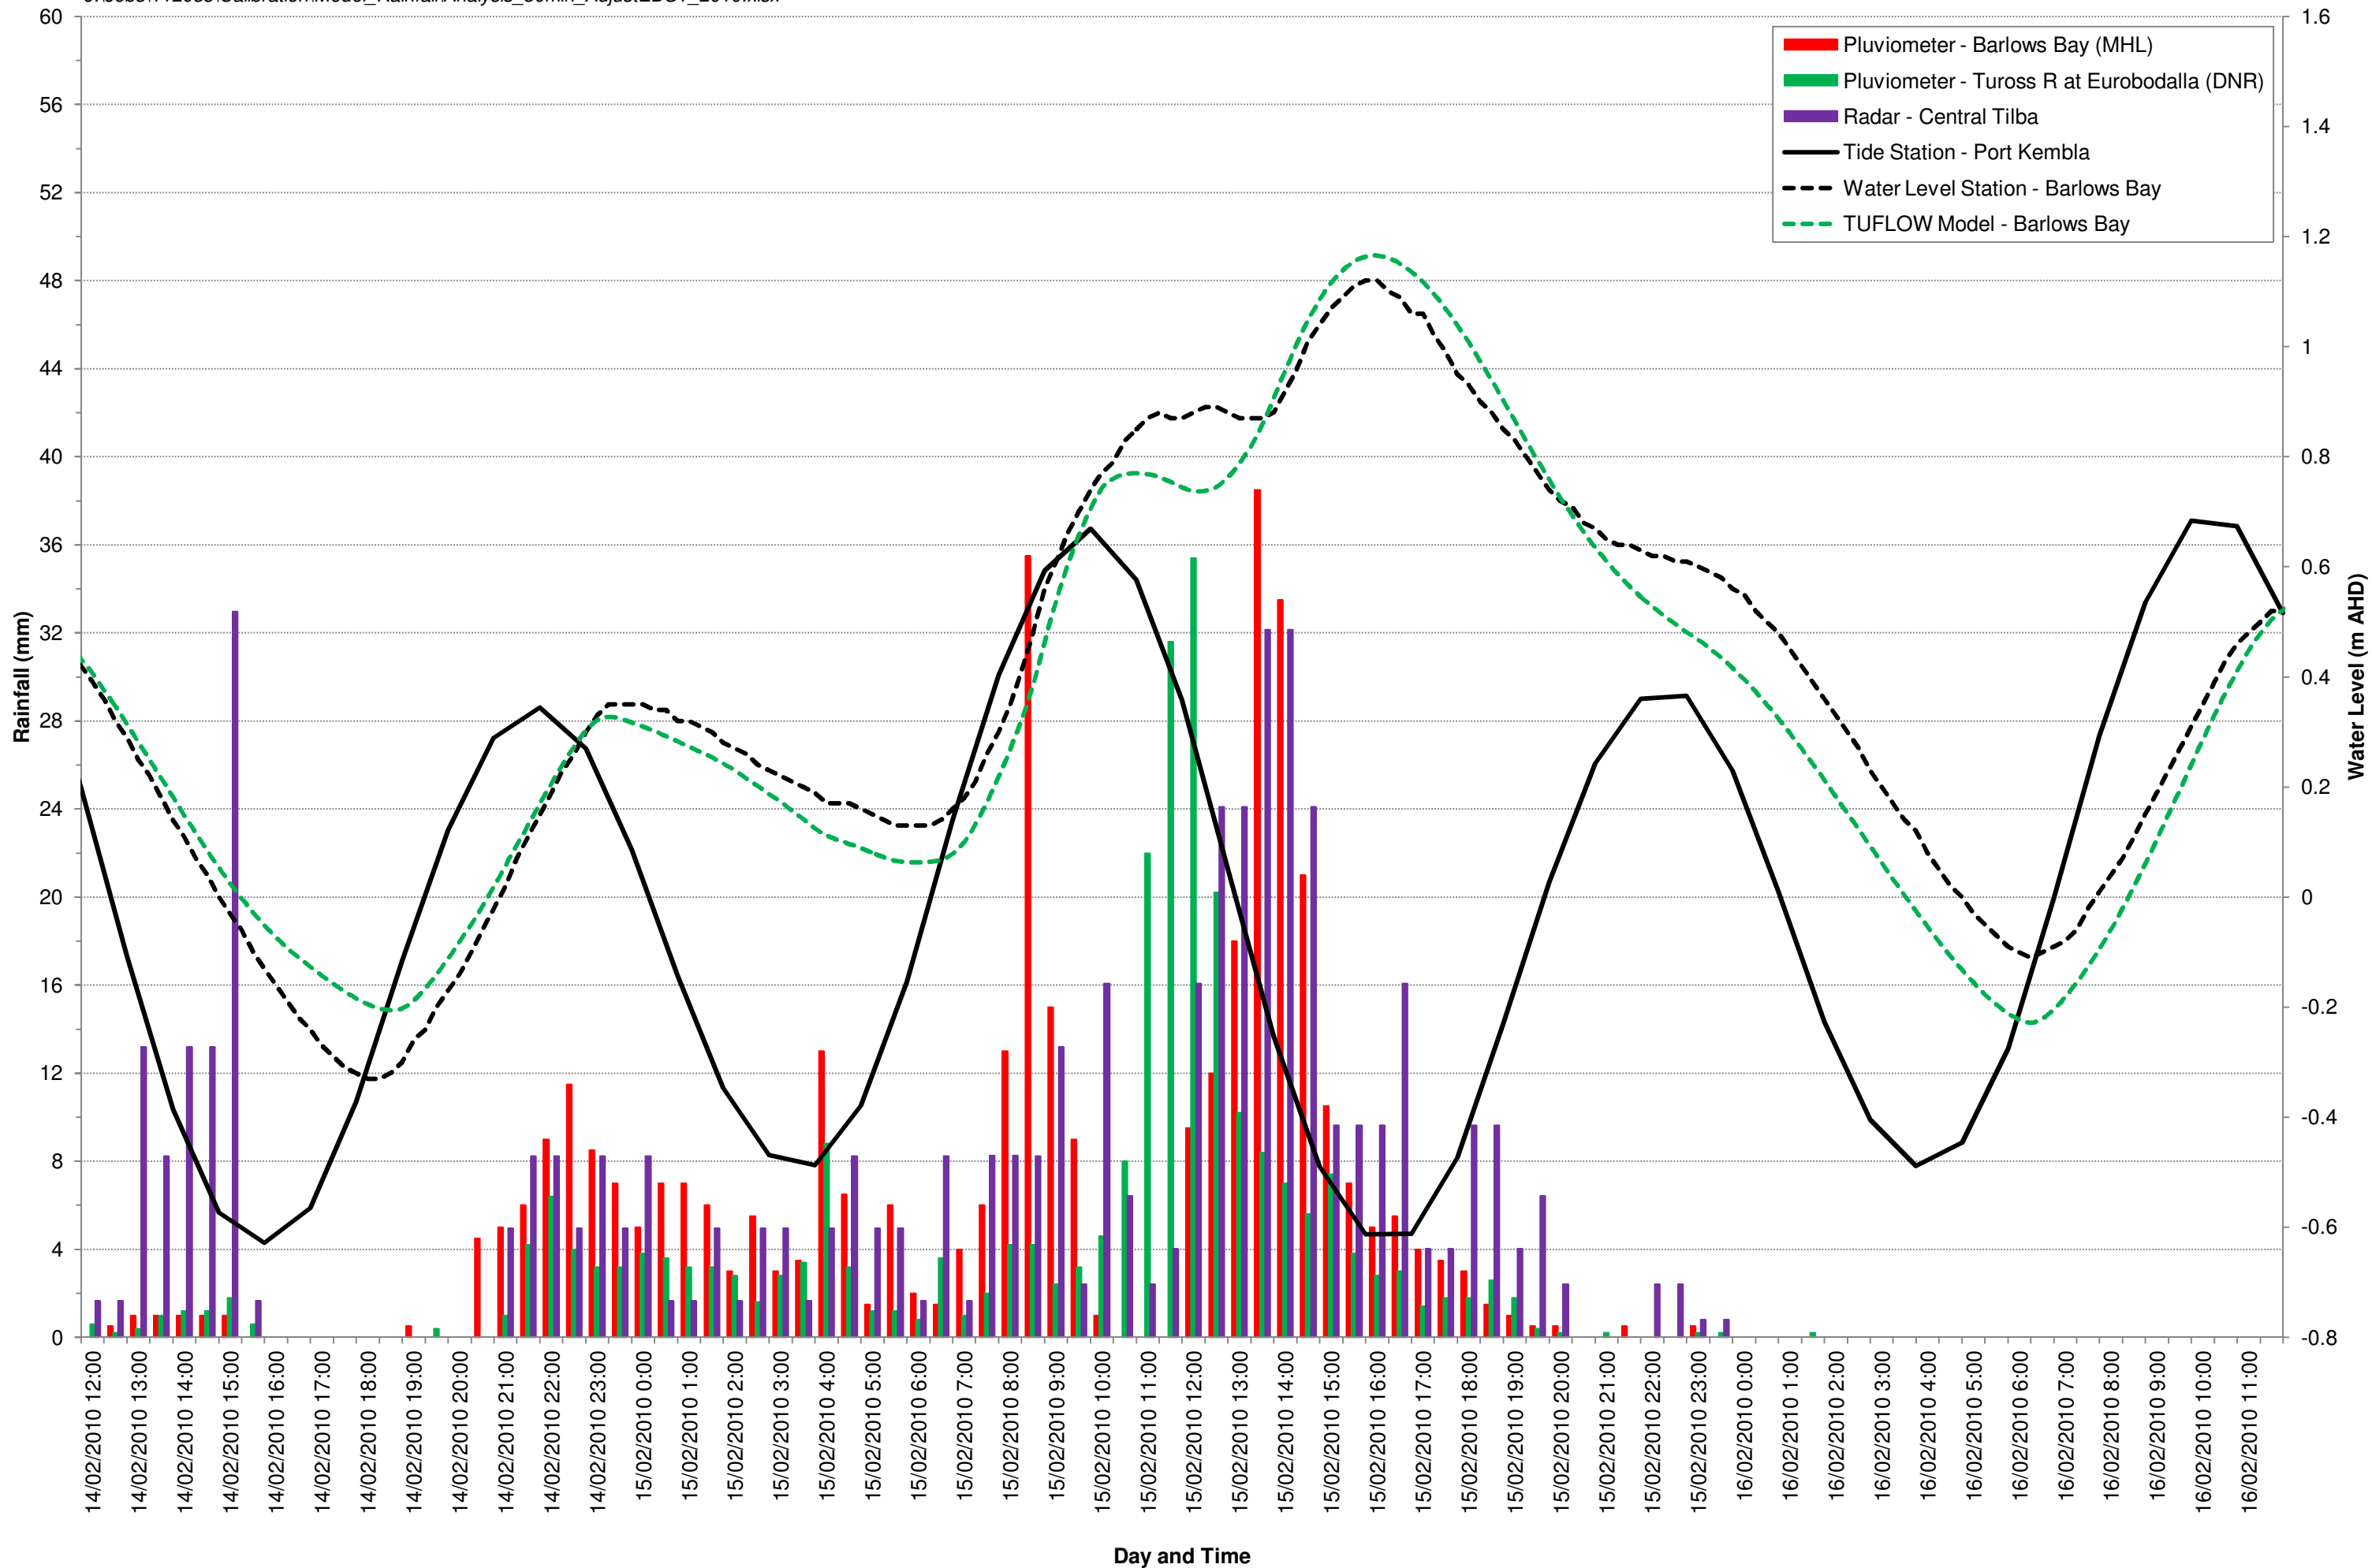
FIGURE E16  
15TH FEBRUARY 2010 EVENT  
STAGE HYDROGRAPHS
