**Eurobodalla Catchments**

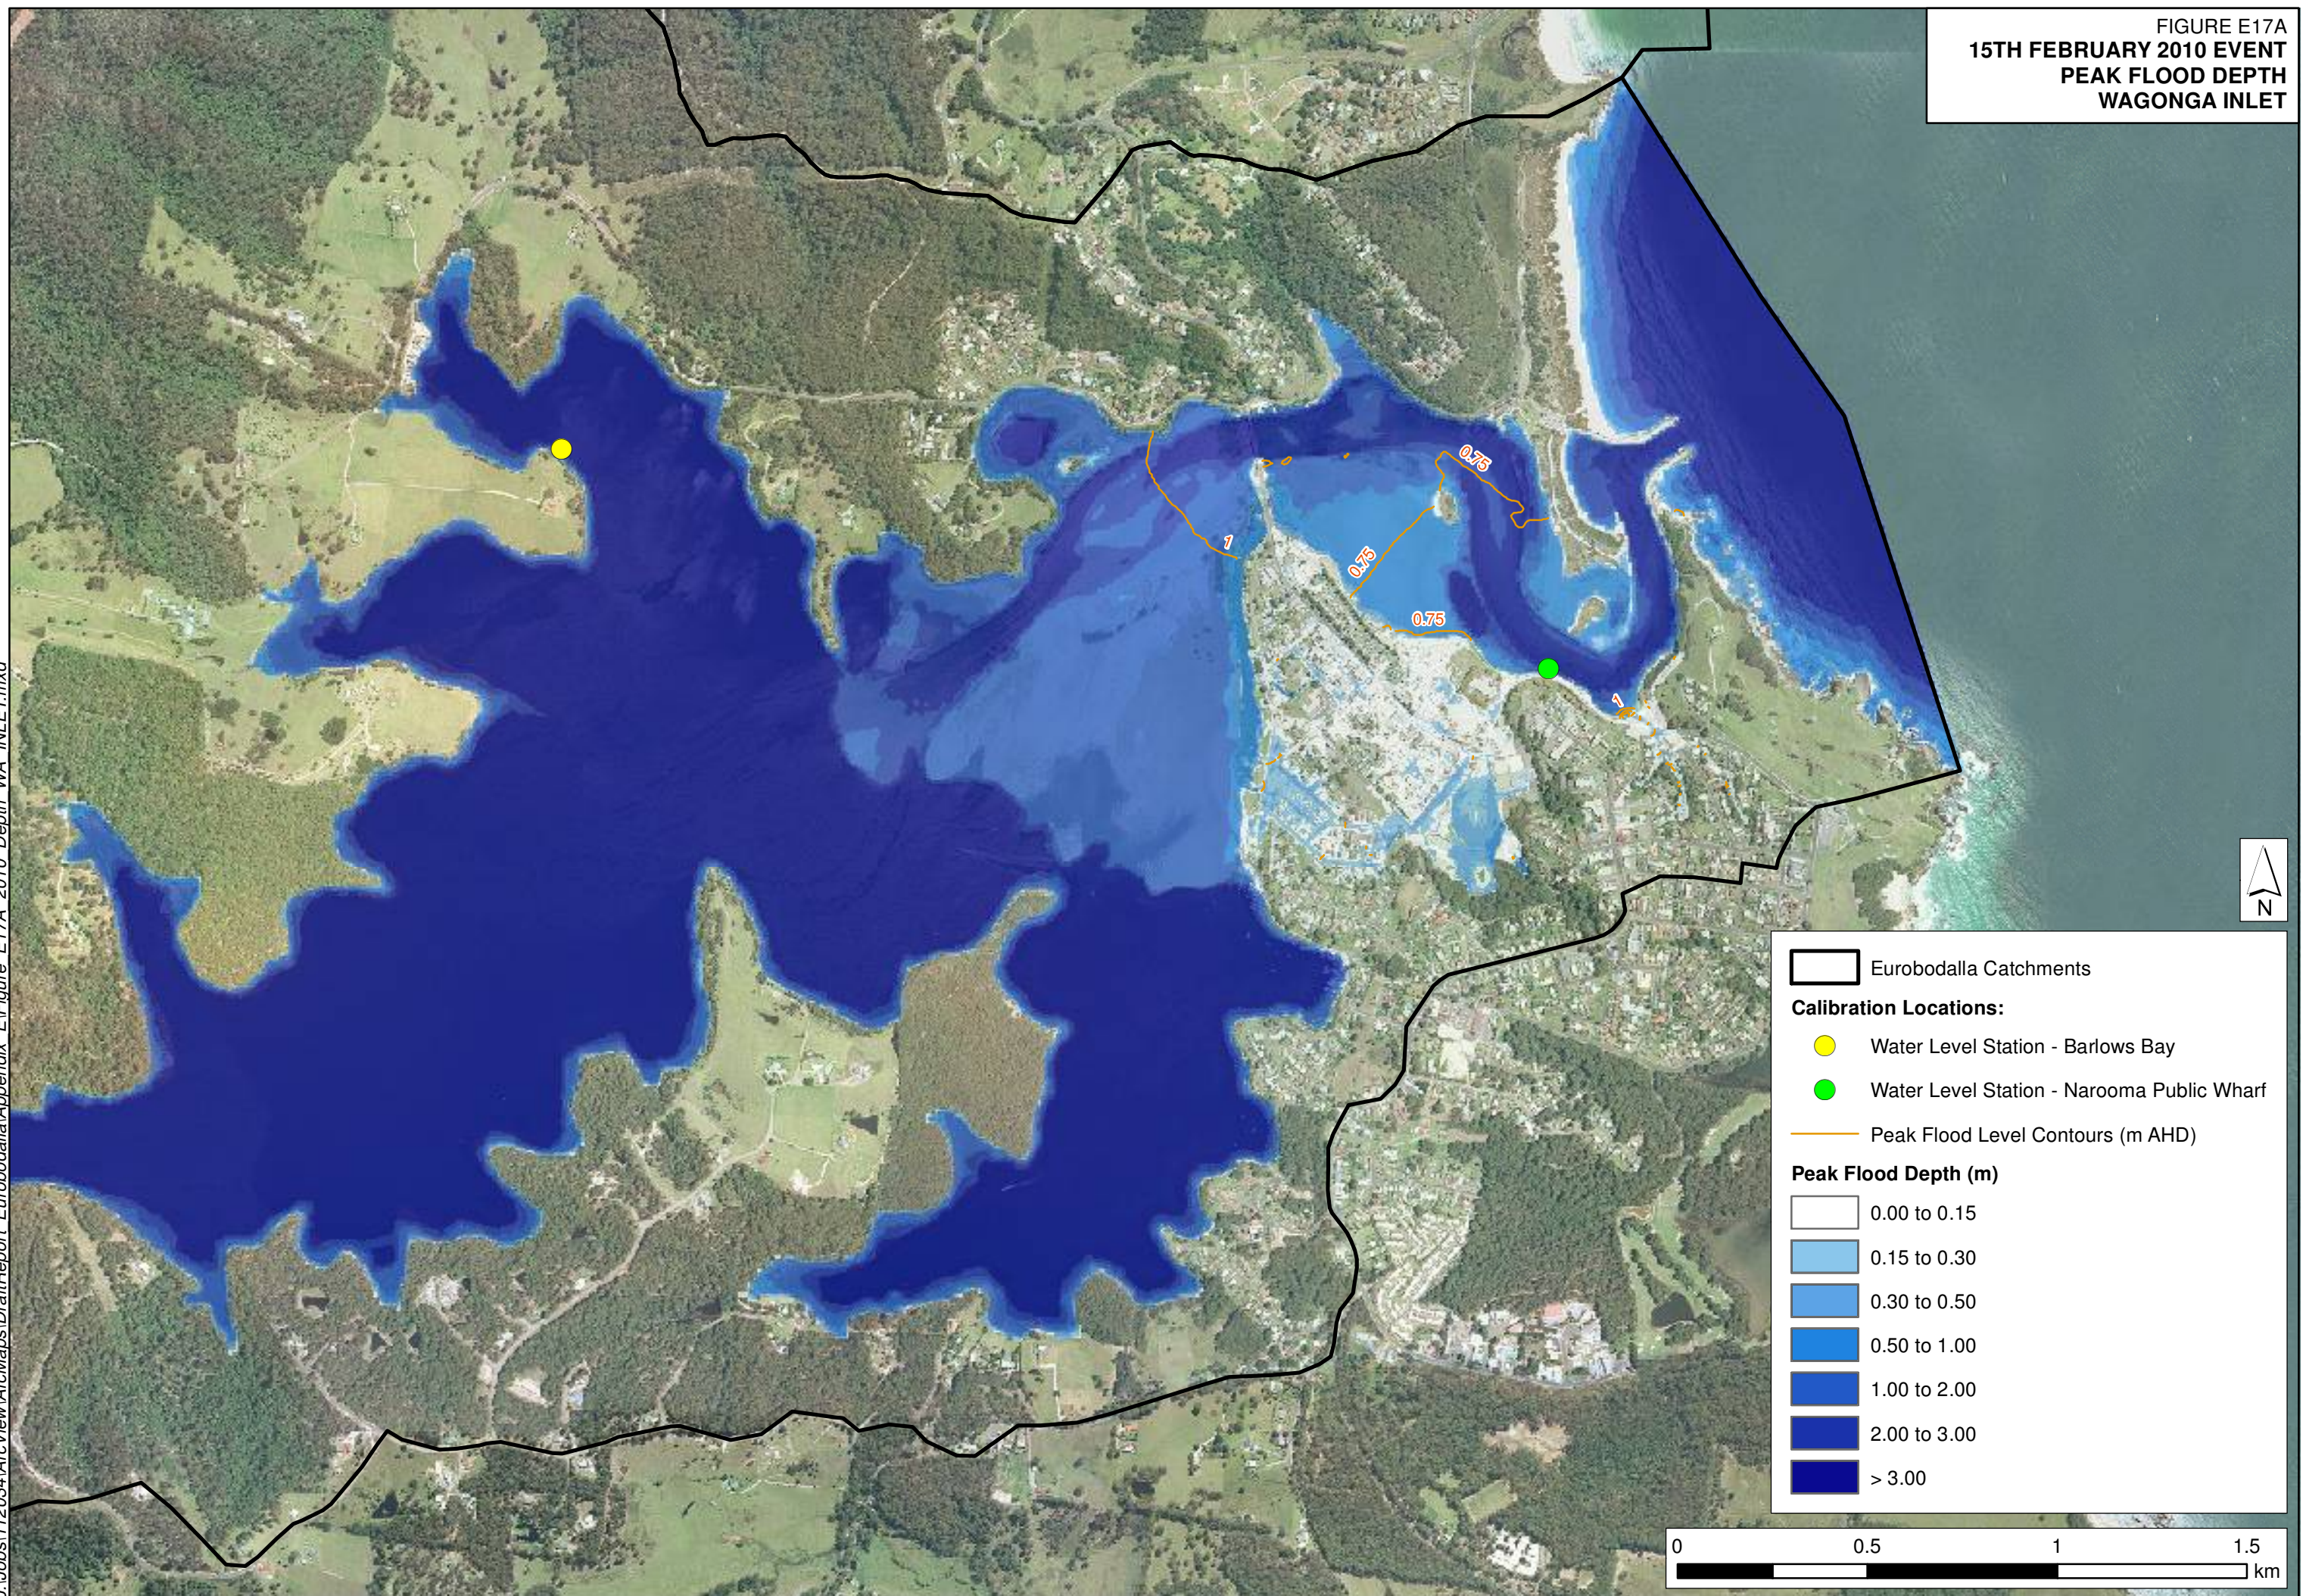
FIGURE E17A  
15TH FEBRUARY 2010 EVENT  
PEAK FLOOD DEPTH  
WAGONGA INLET

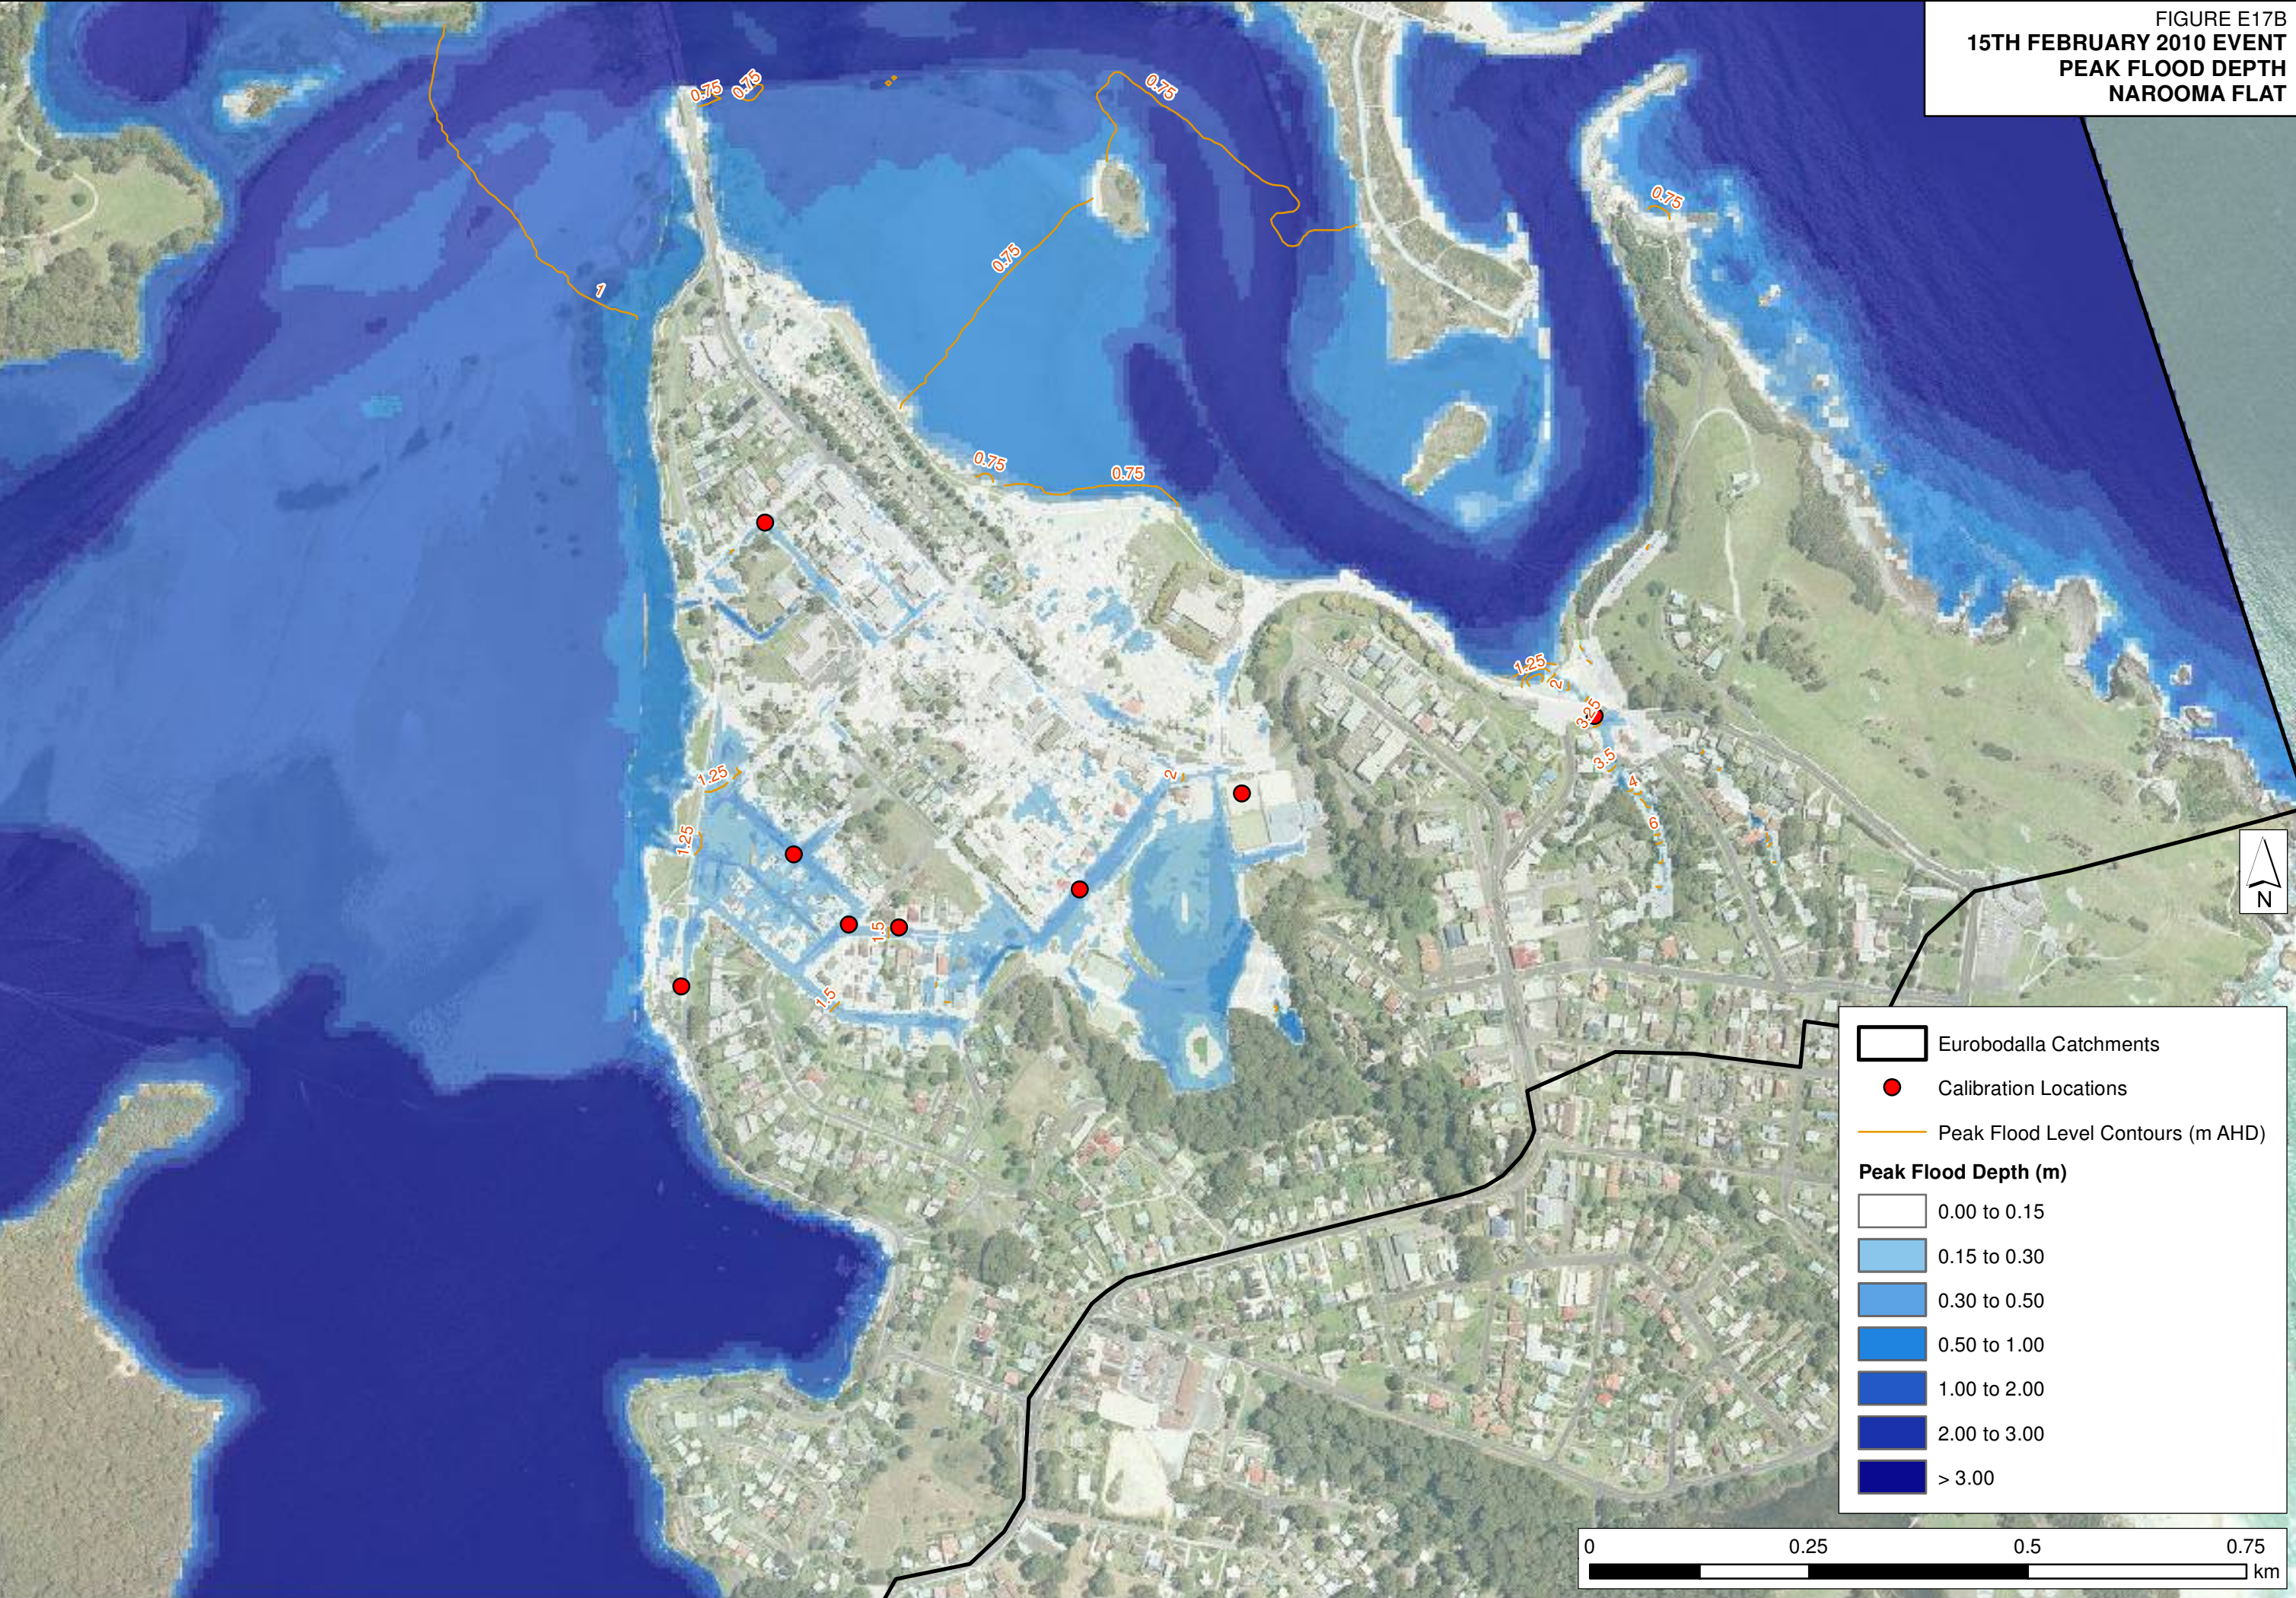
FIGURE E17B  
15TH FEBRUARY 2010 EVENT  
PEAK FLOOD DEPTH  
NAROOMA FLAT

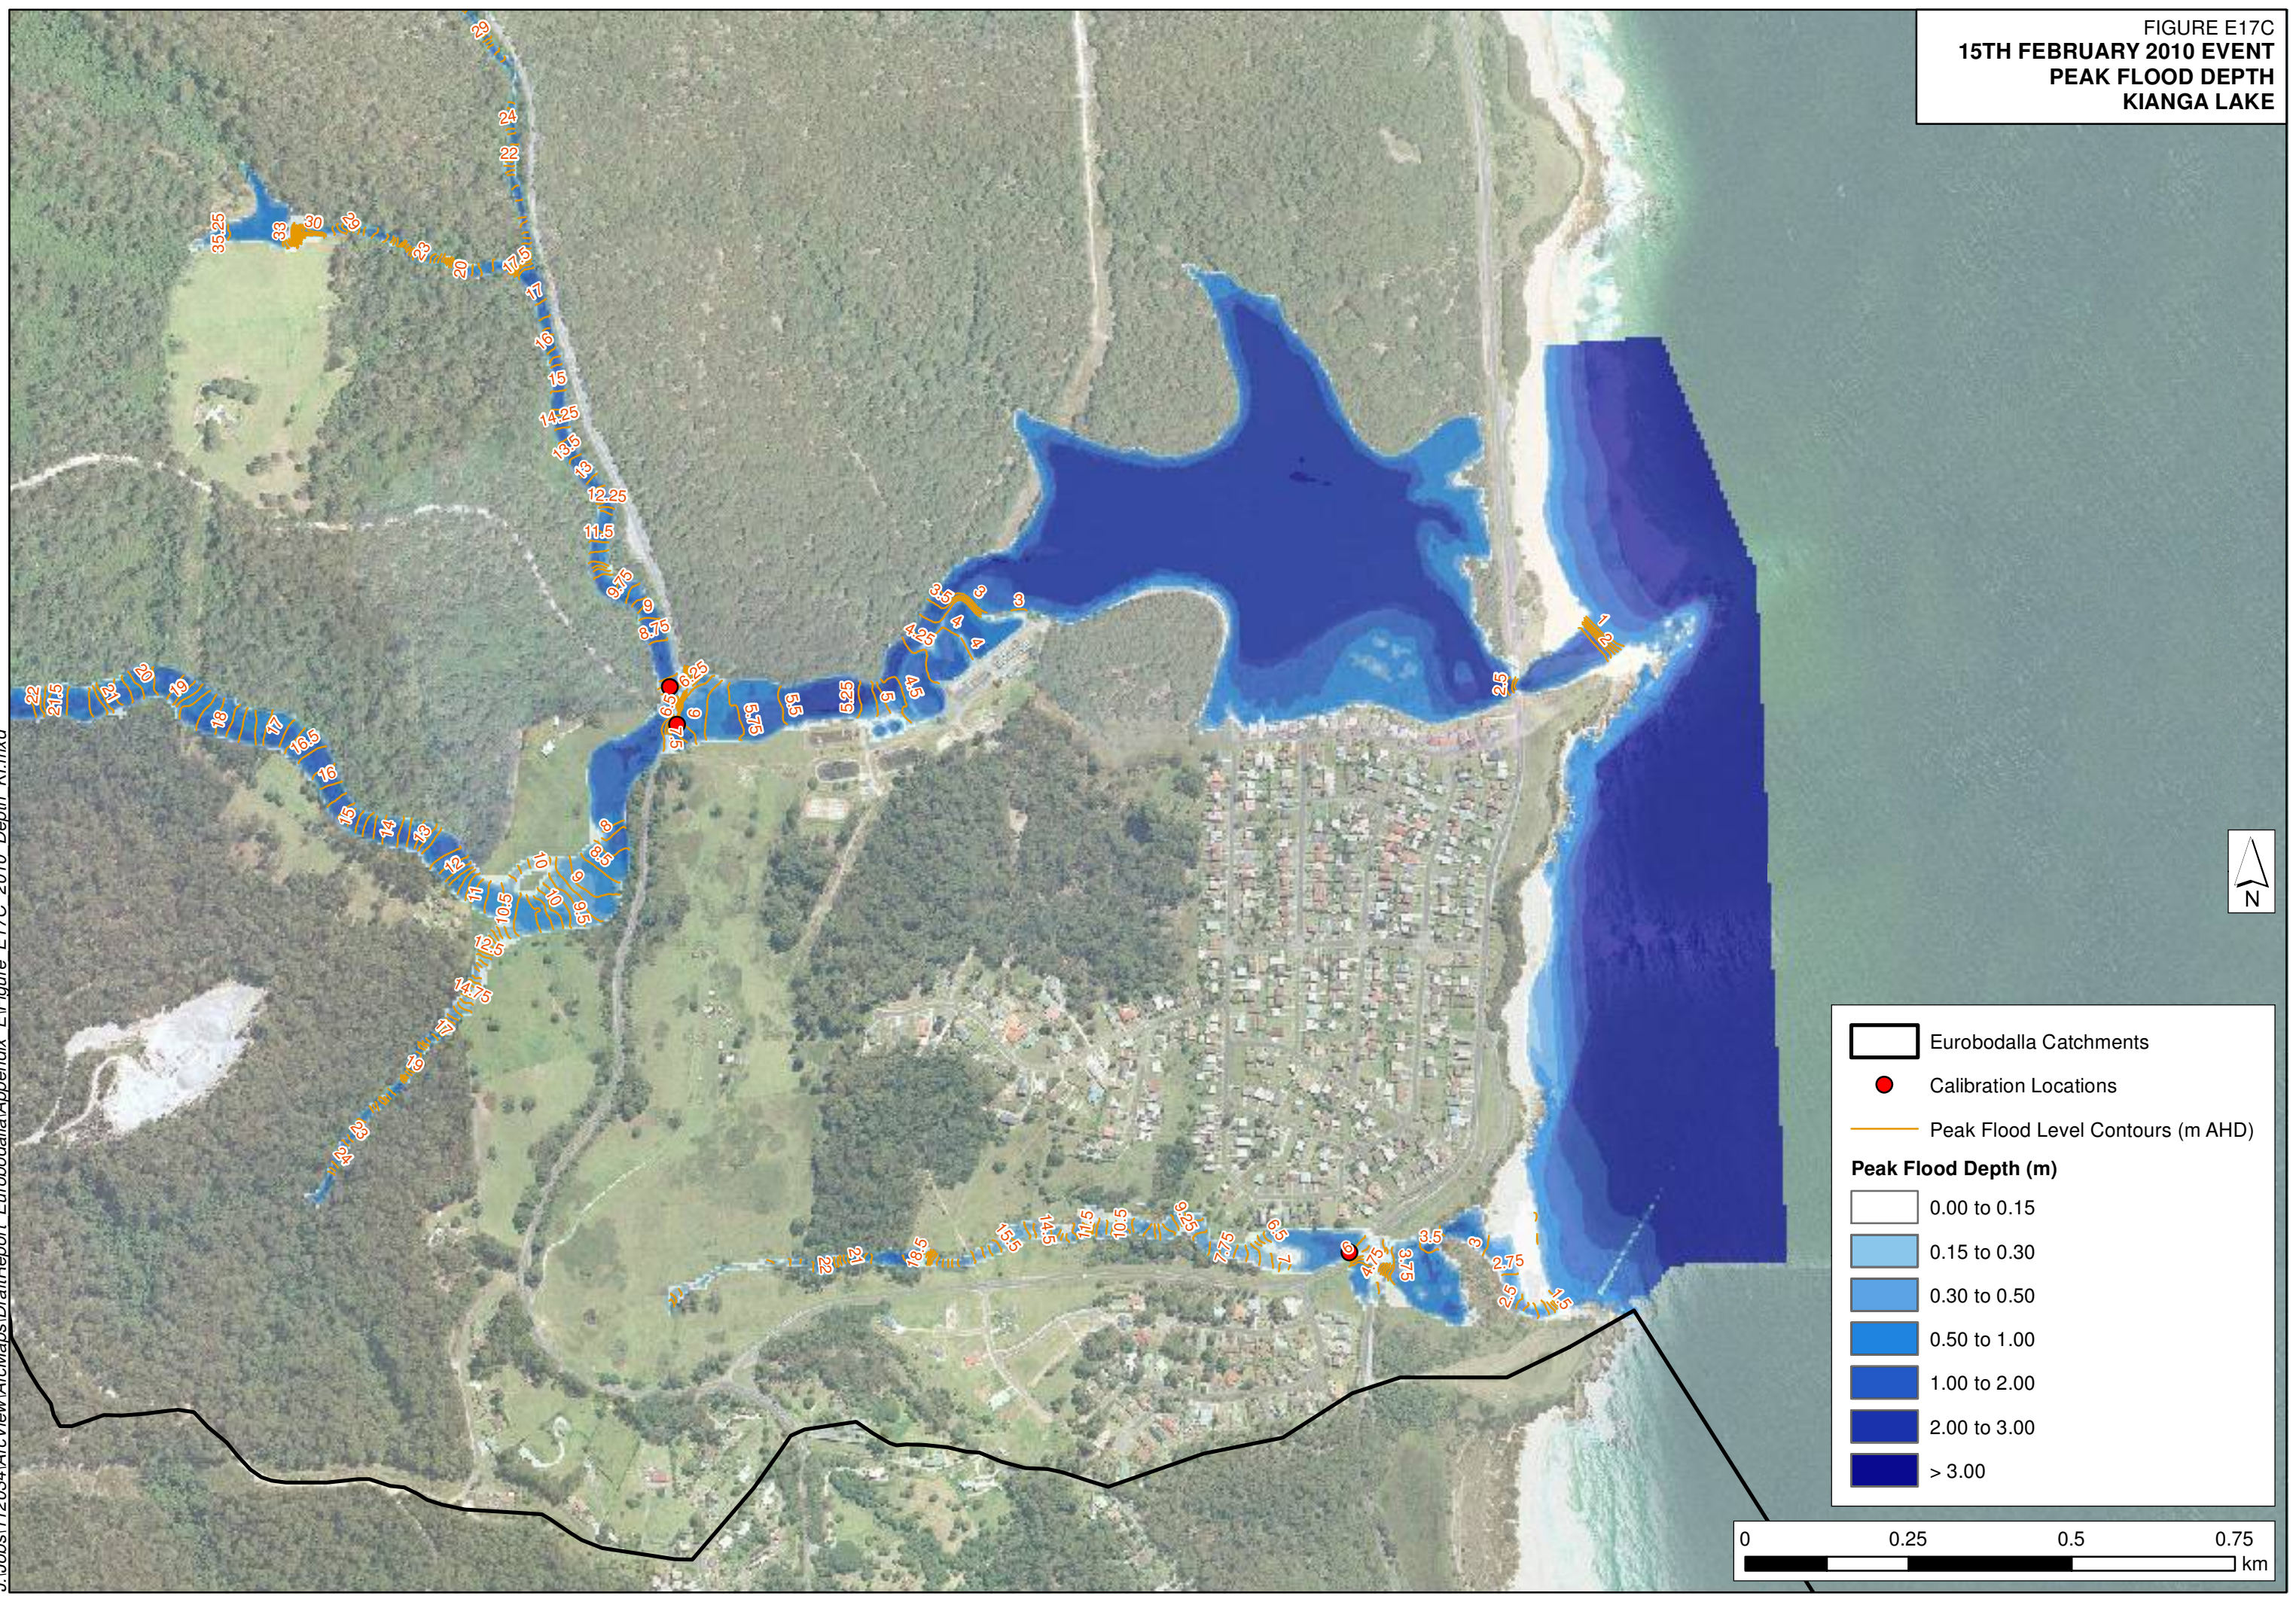
FIGURE E17C  
15TH FEBRUARY 2010 EVENT  
PEAK FLOOD DEPTH  
KIANGA LAKE

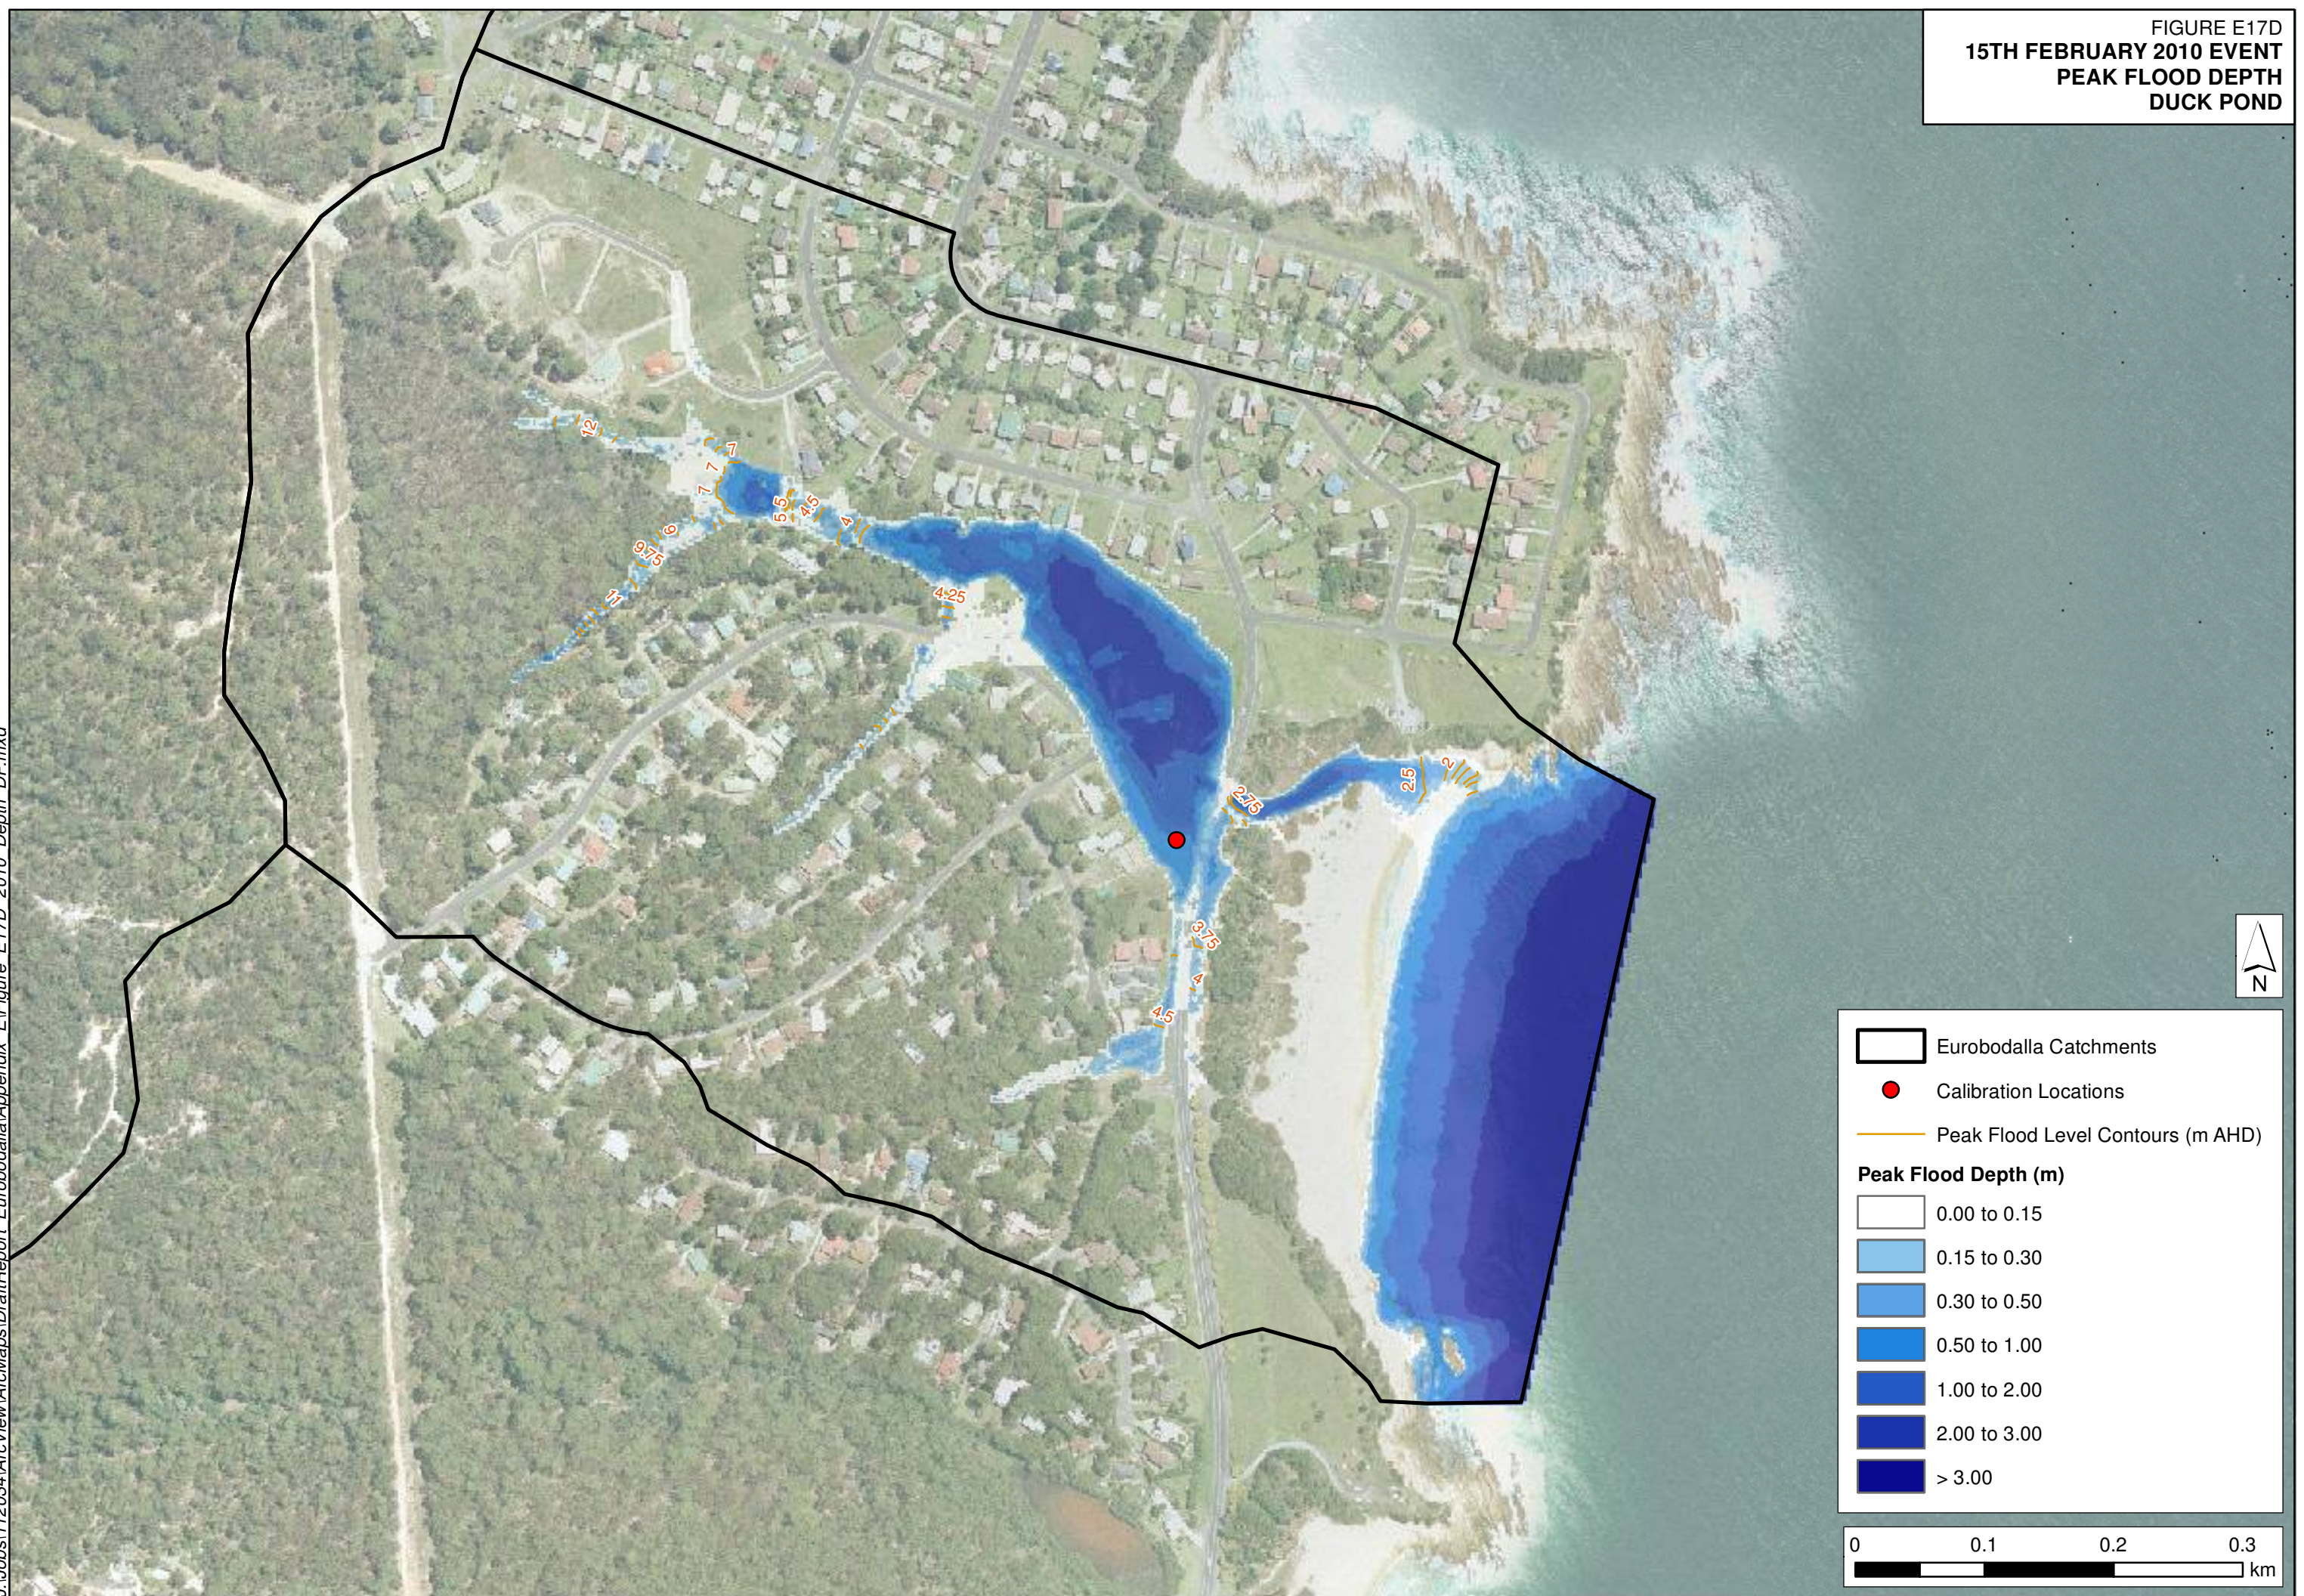
FIGURE E17D  
15TH FEBRUARY 2010 EVENT  
PEAK FLOOD DEPTH  
DUCK POND

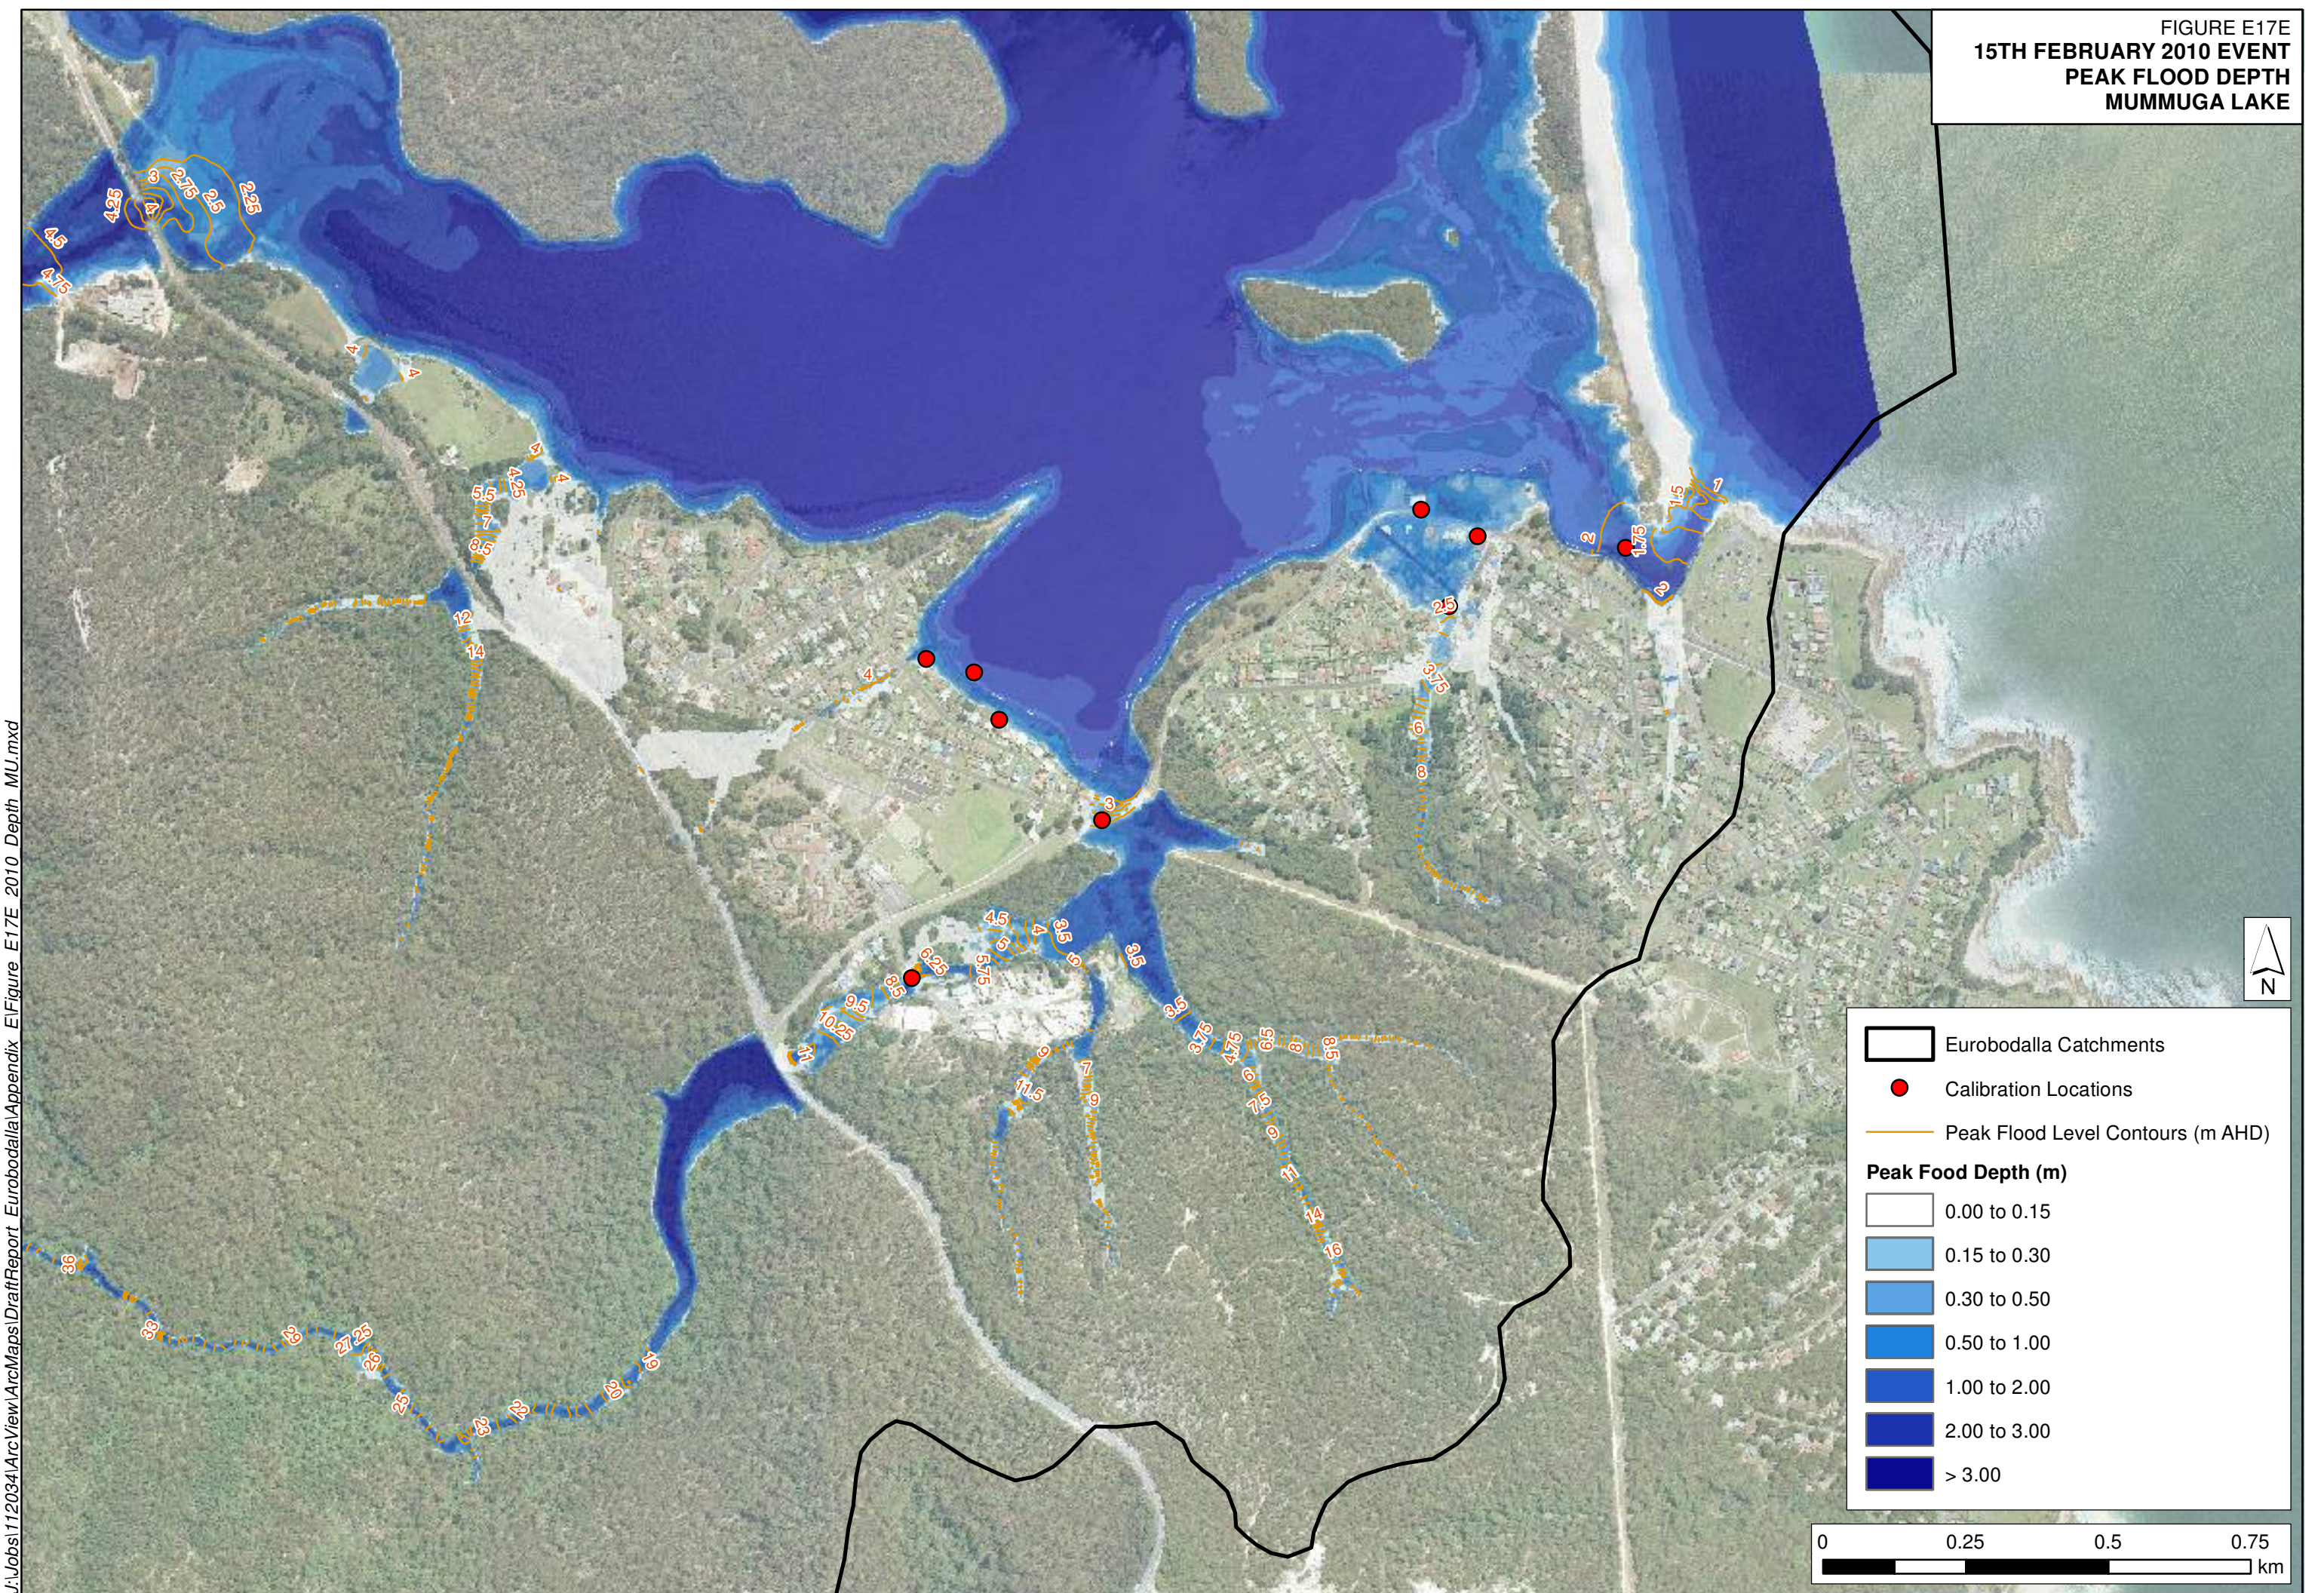
FIGURE E17E  
15TH FEBRUARY 2010 EVENT  
PEAK FLOOD DEPTH  
MUMMUGA LAKE

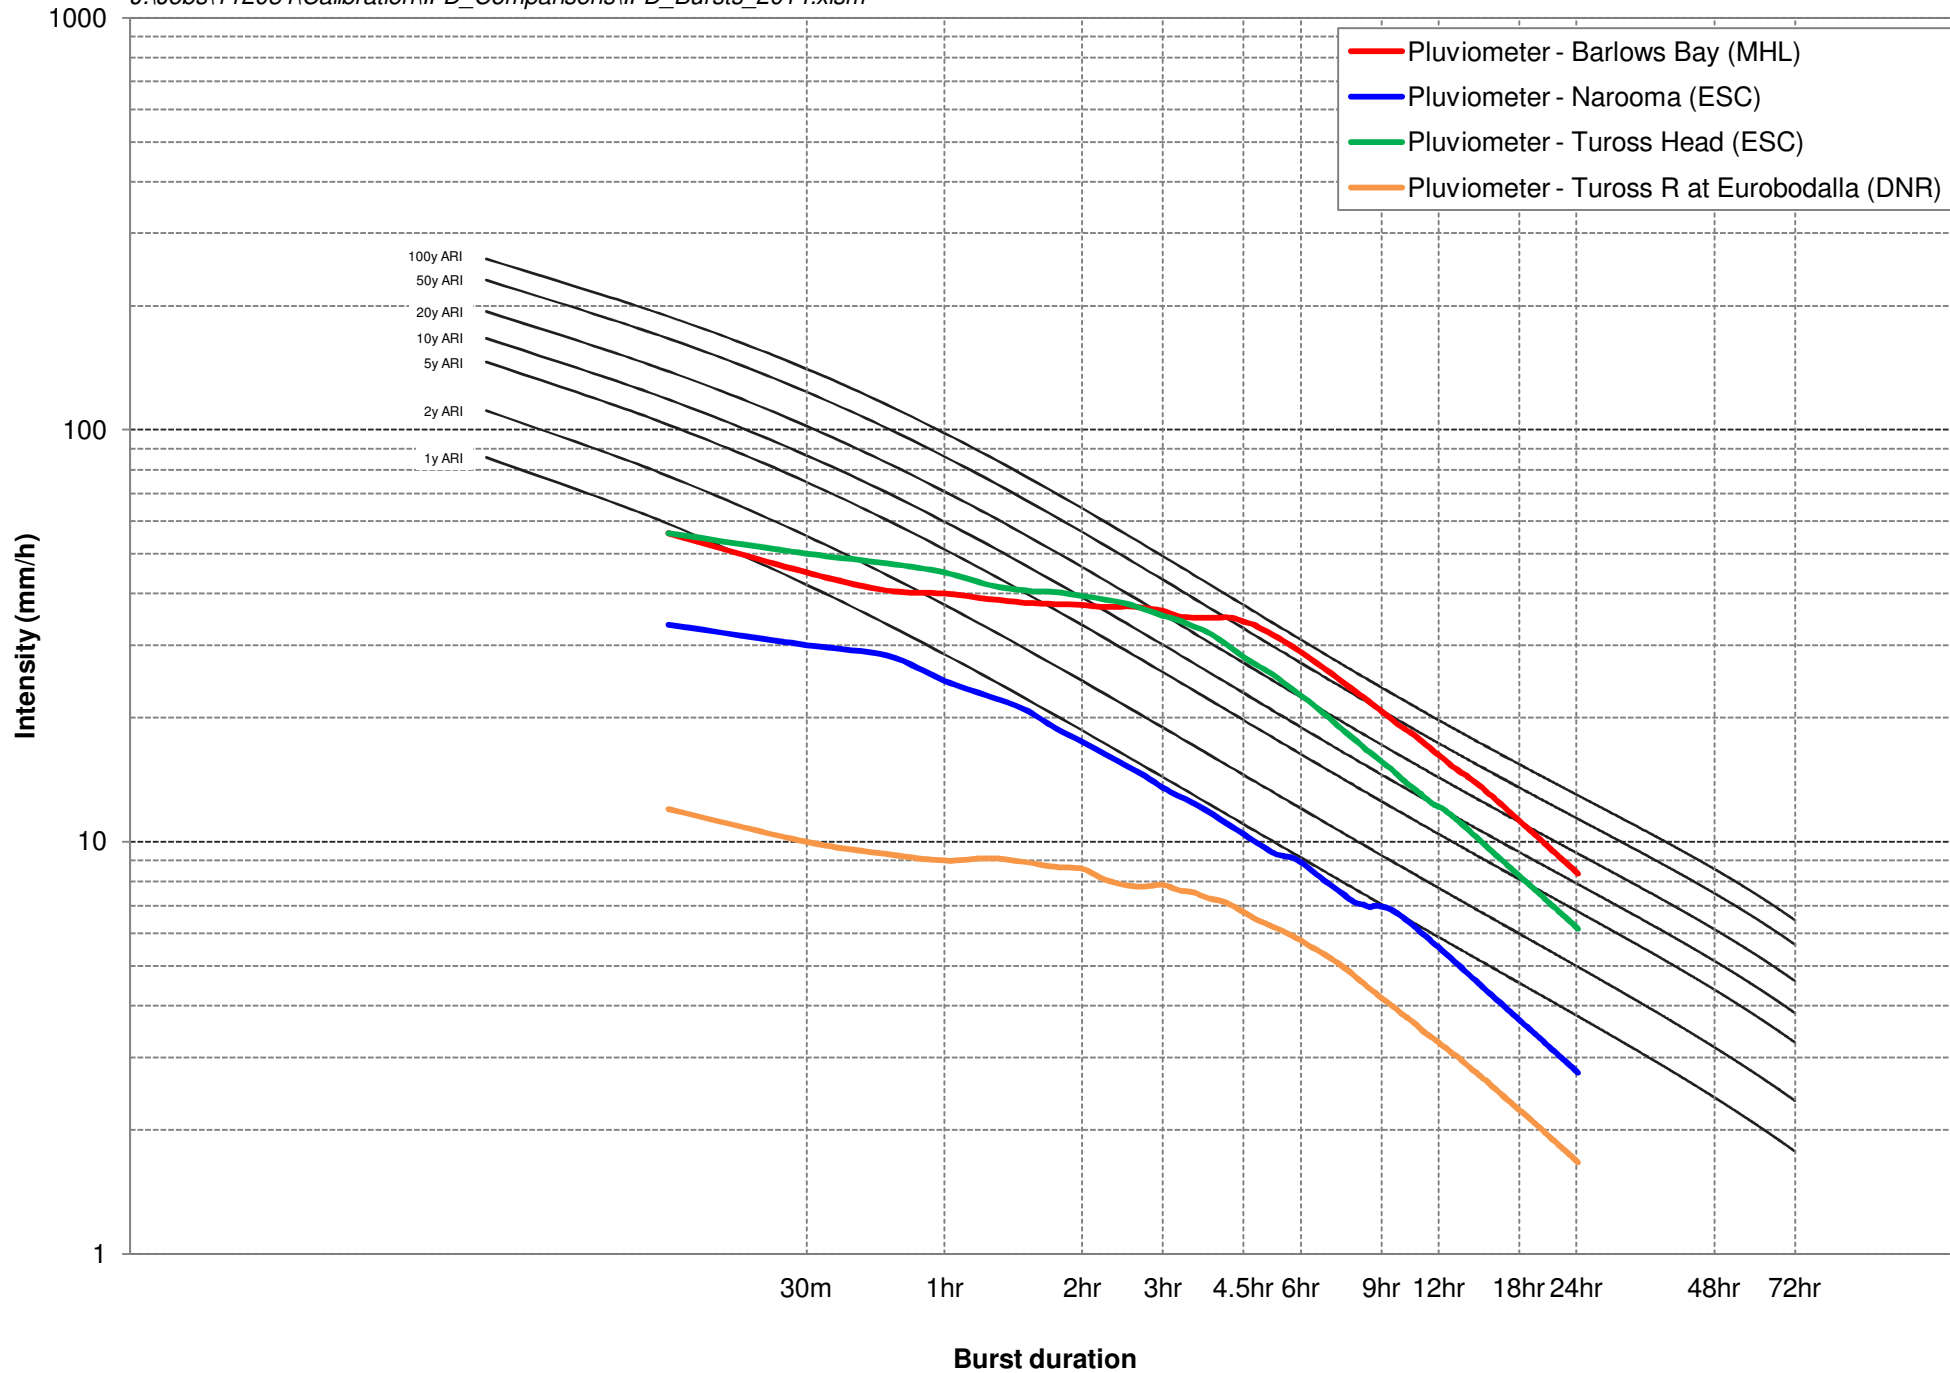
FIGURE E18  
14TH OCTOBER 2014 EVENT  
IFD DATA
