**Eurobodalla Catchments**

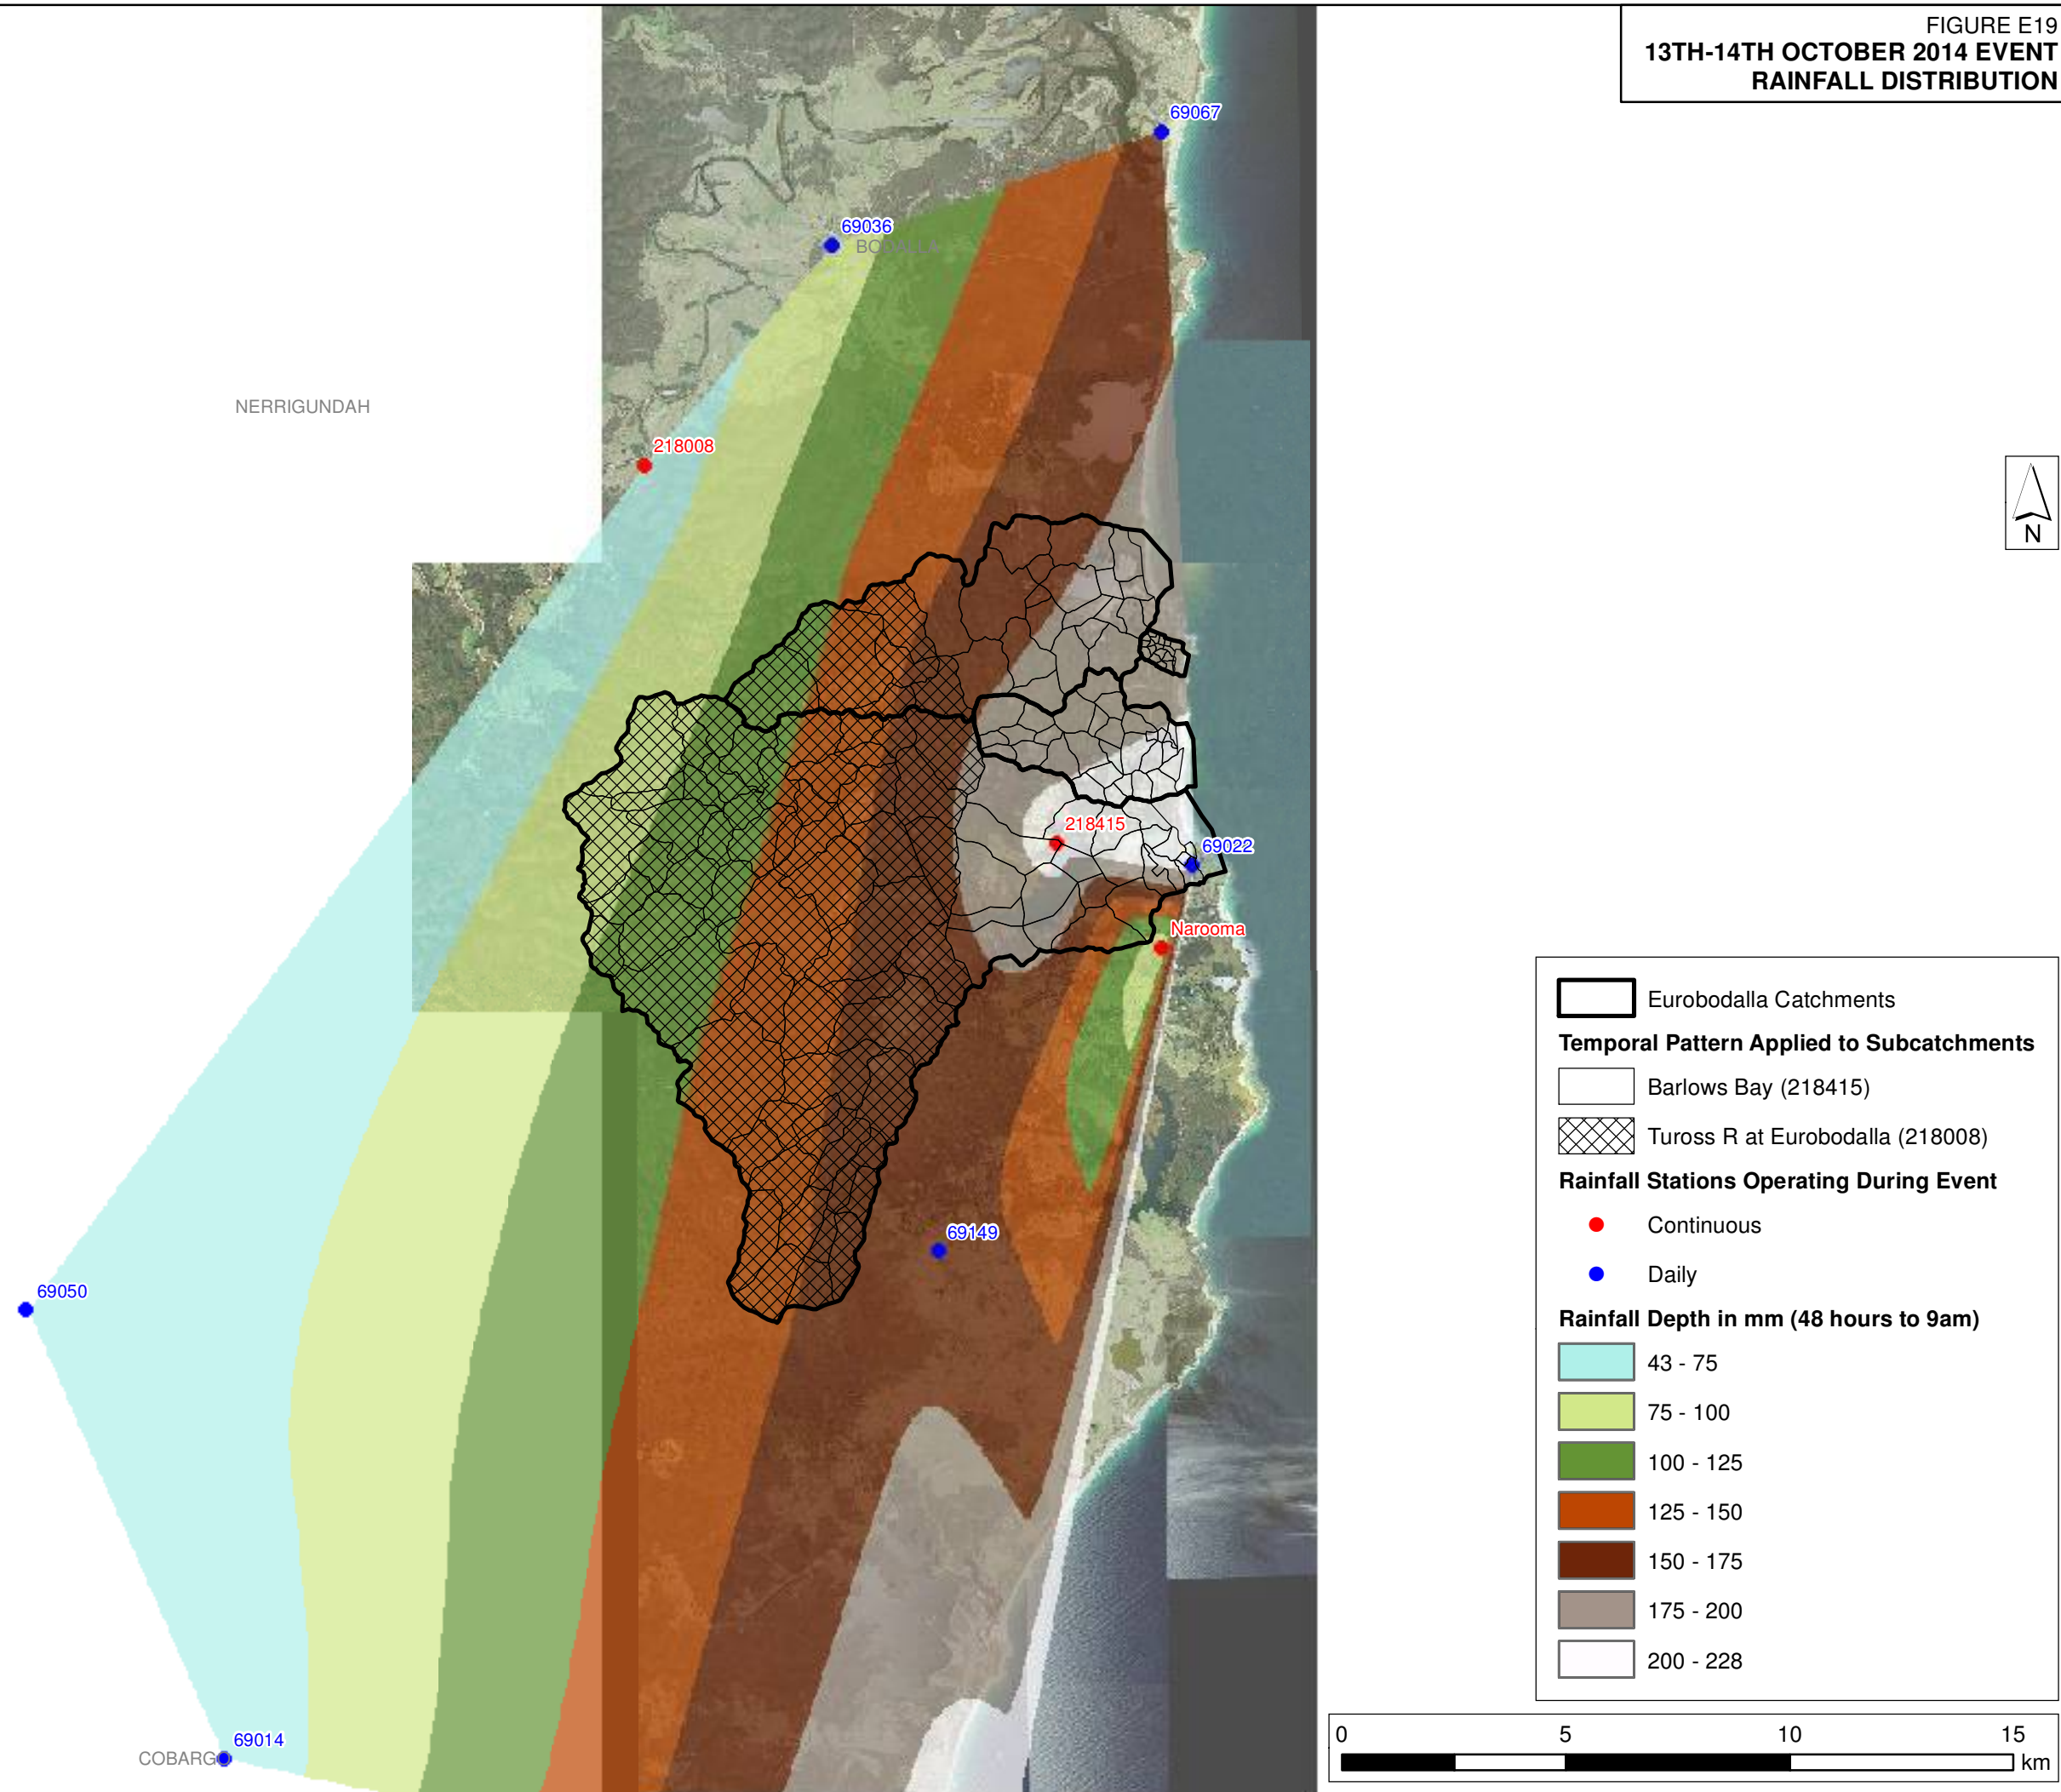
FIGURE E19  
13TH-14TH OCTOBER 2014 EVENT  
RAINFALL DISTRIBUTION

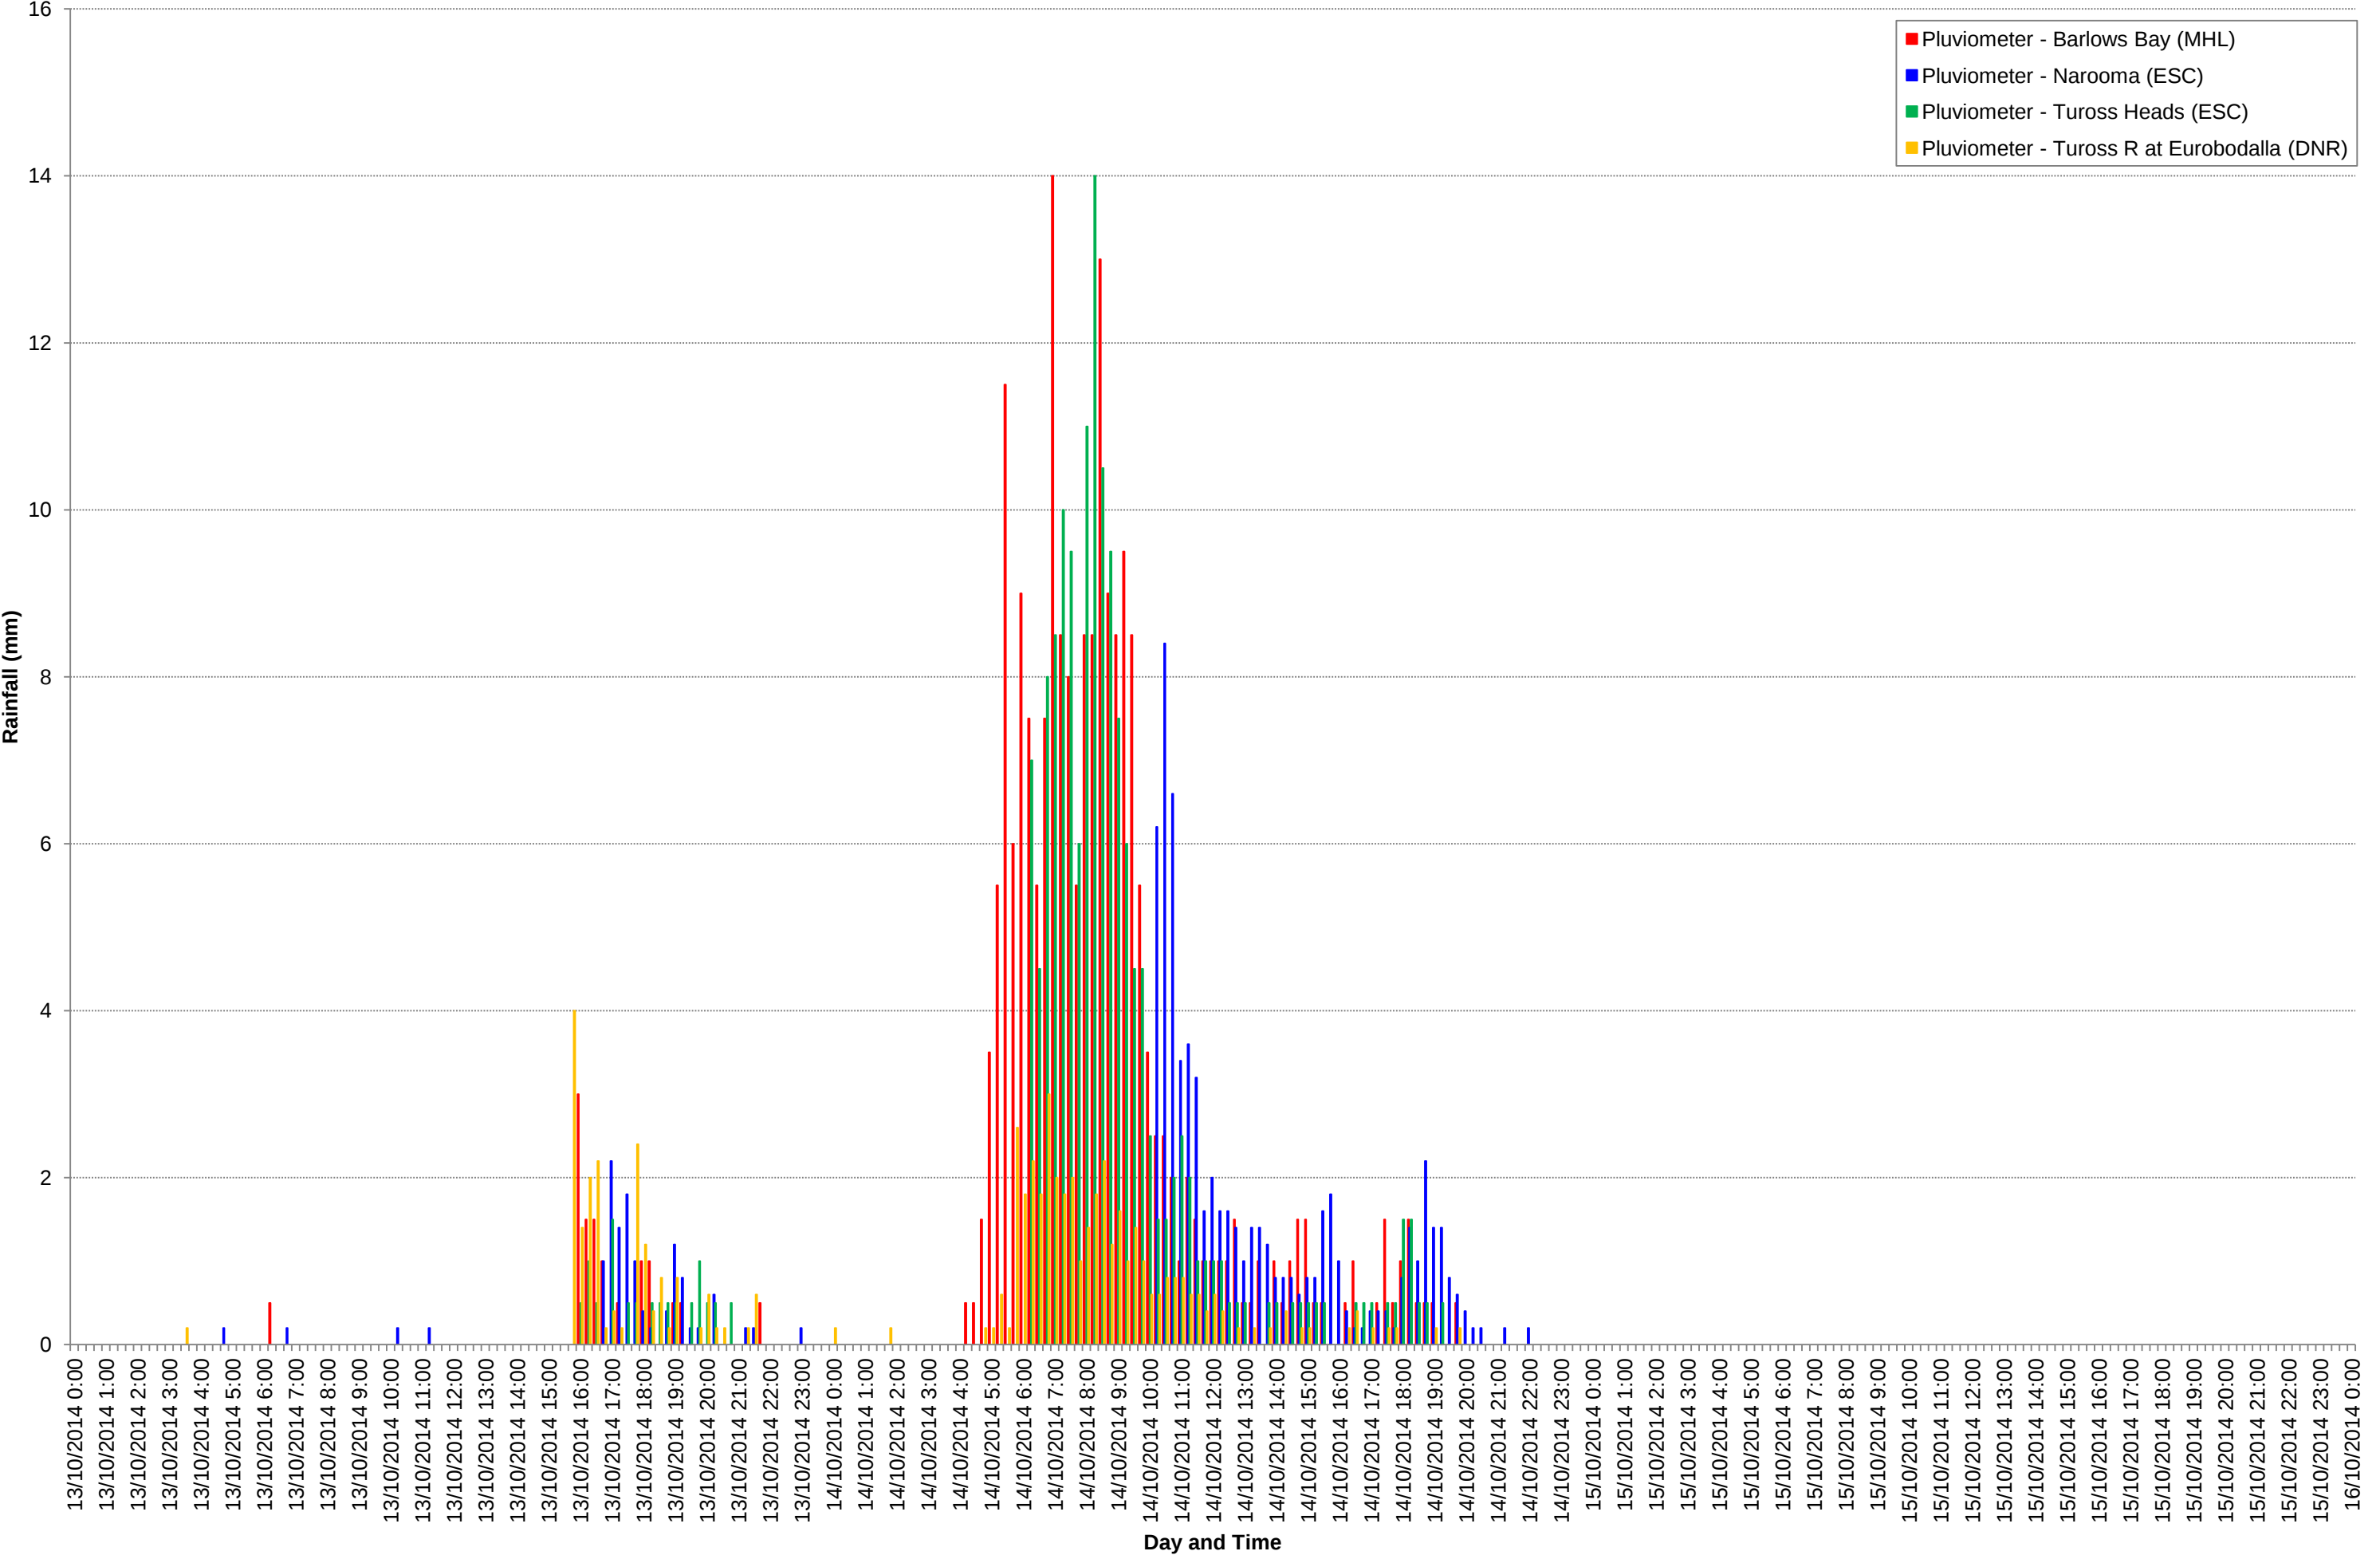
14TH OCTOBER 2014 EVENT  
RAINFALL HYETOGRAPH COMPARISON

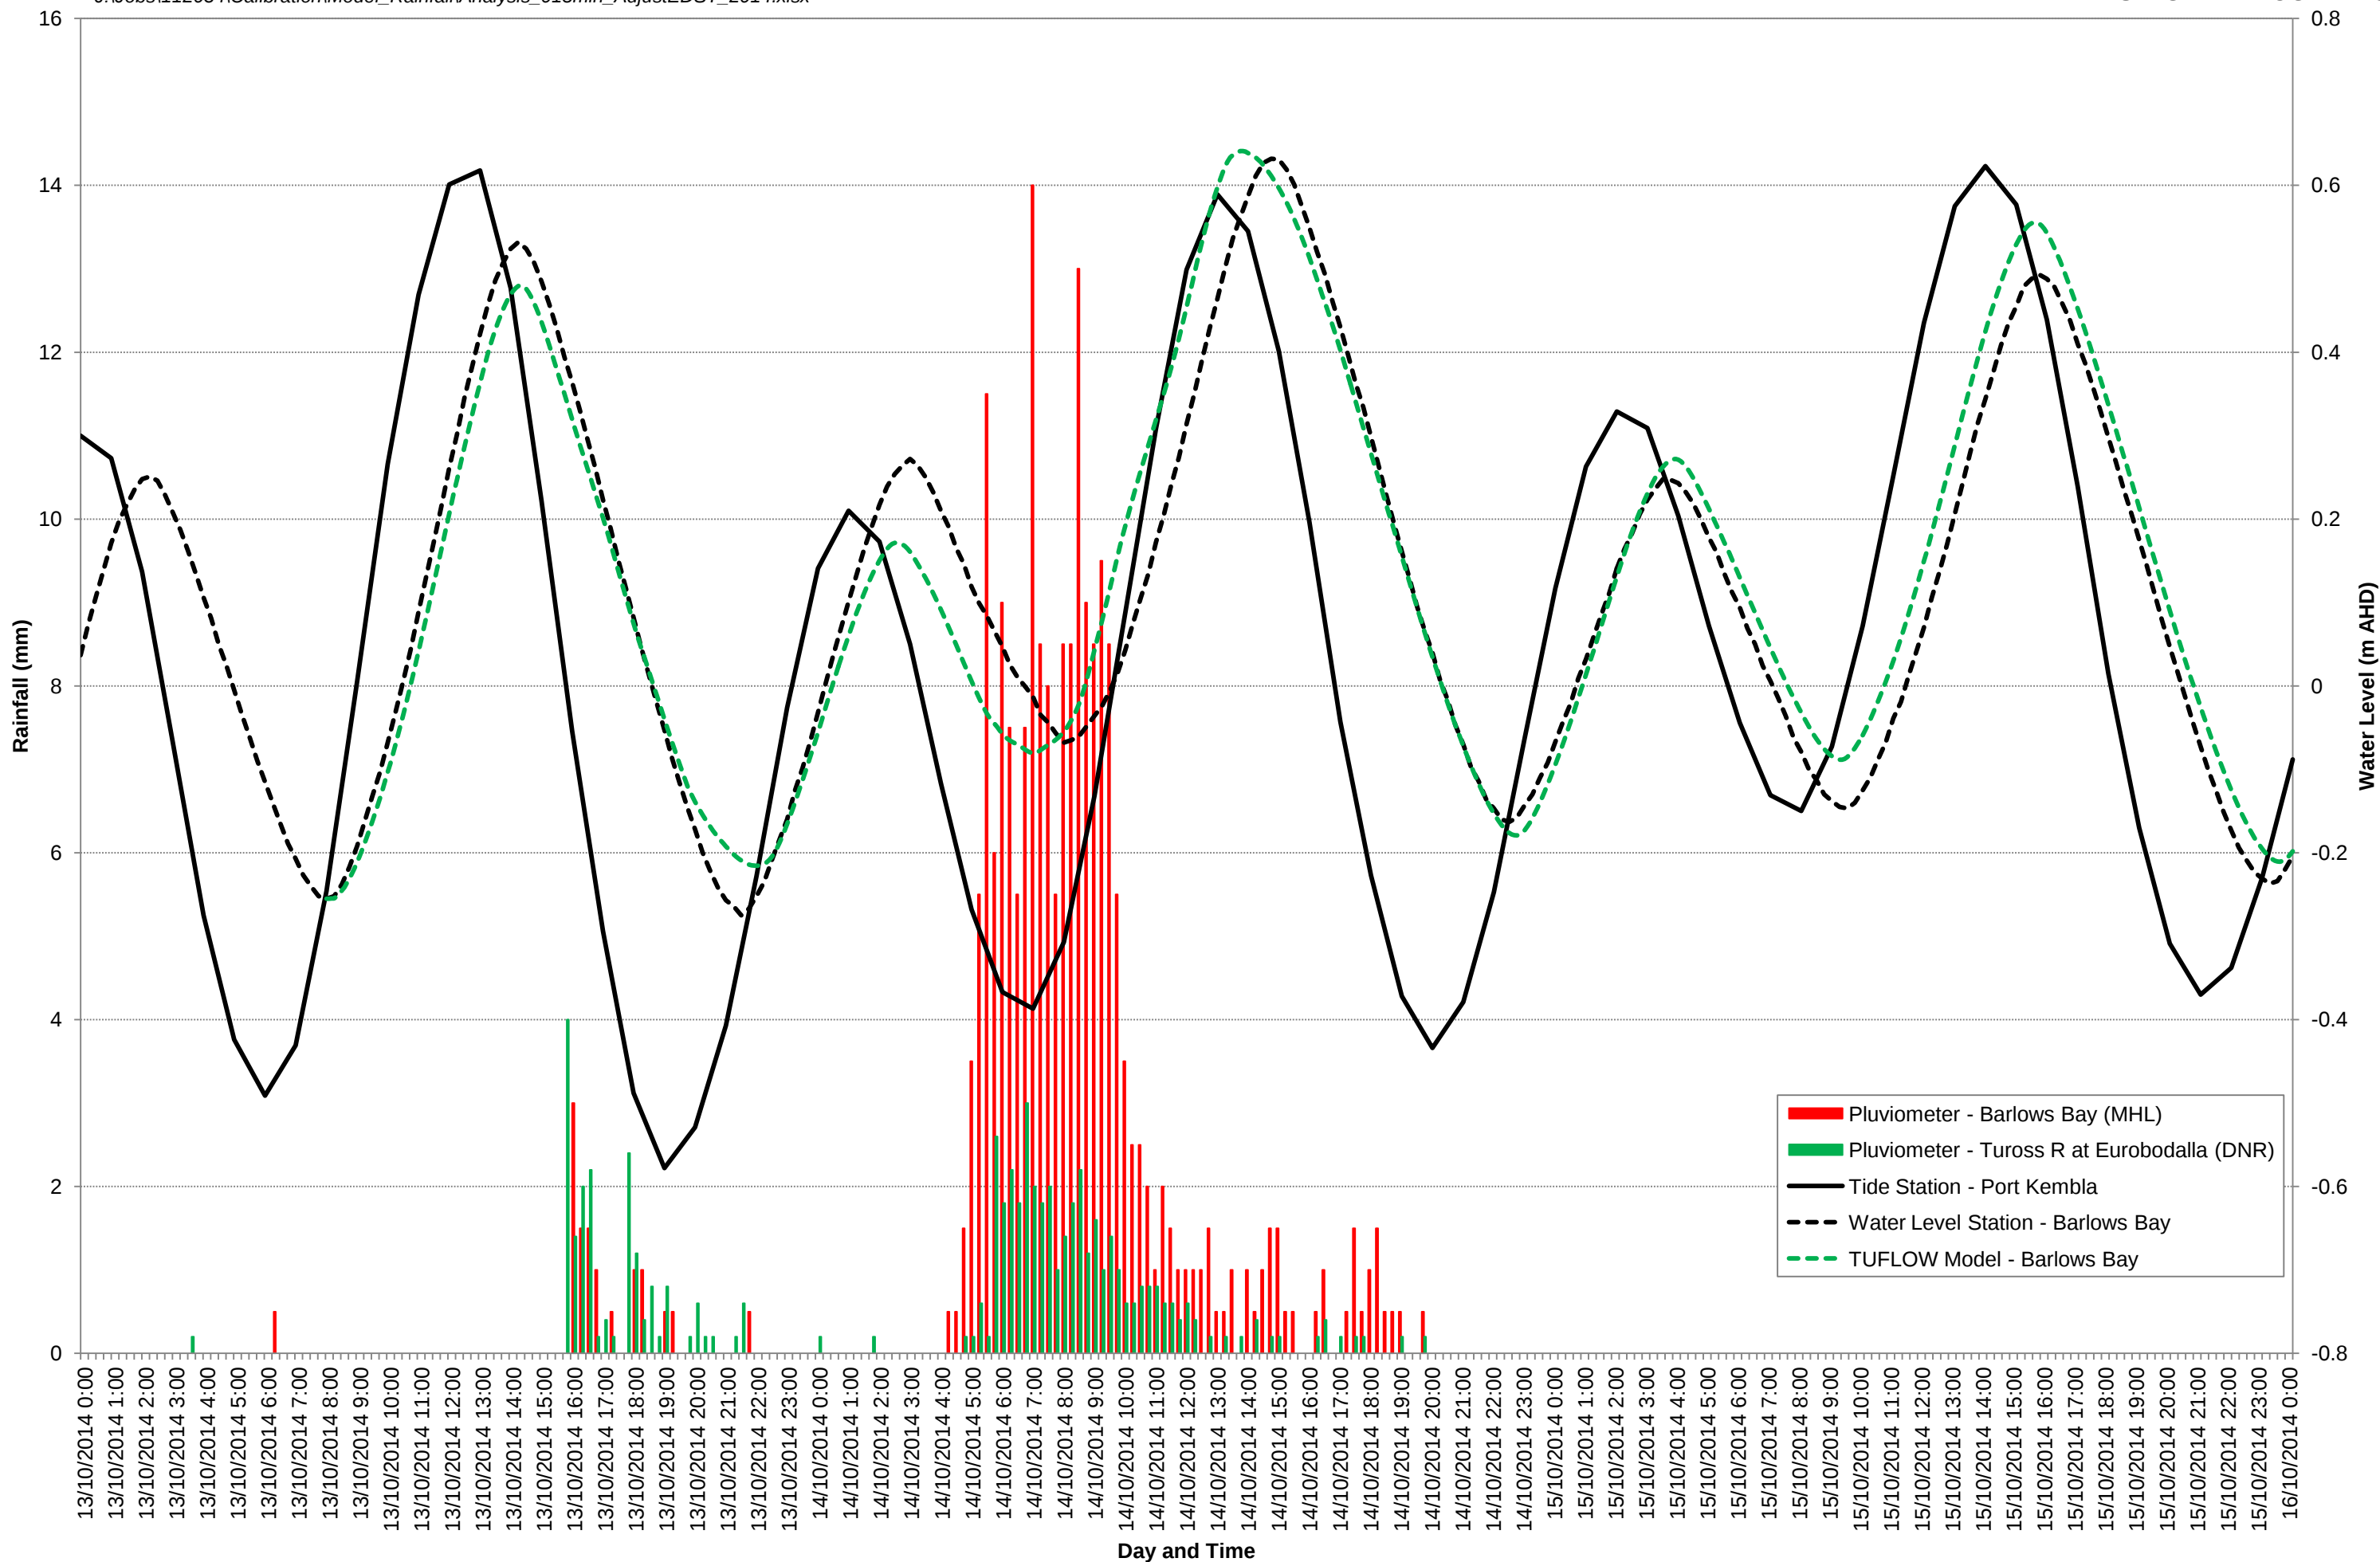
FIGURE E21  
14TH OCTOBER 2014 EVENT  
STAGE HYDROGRAPHS

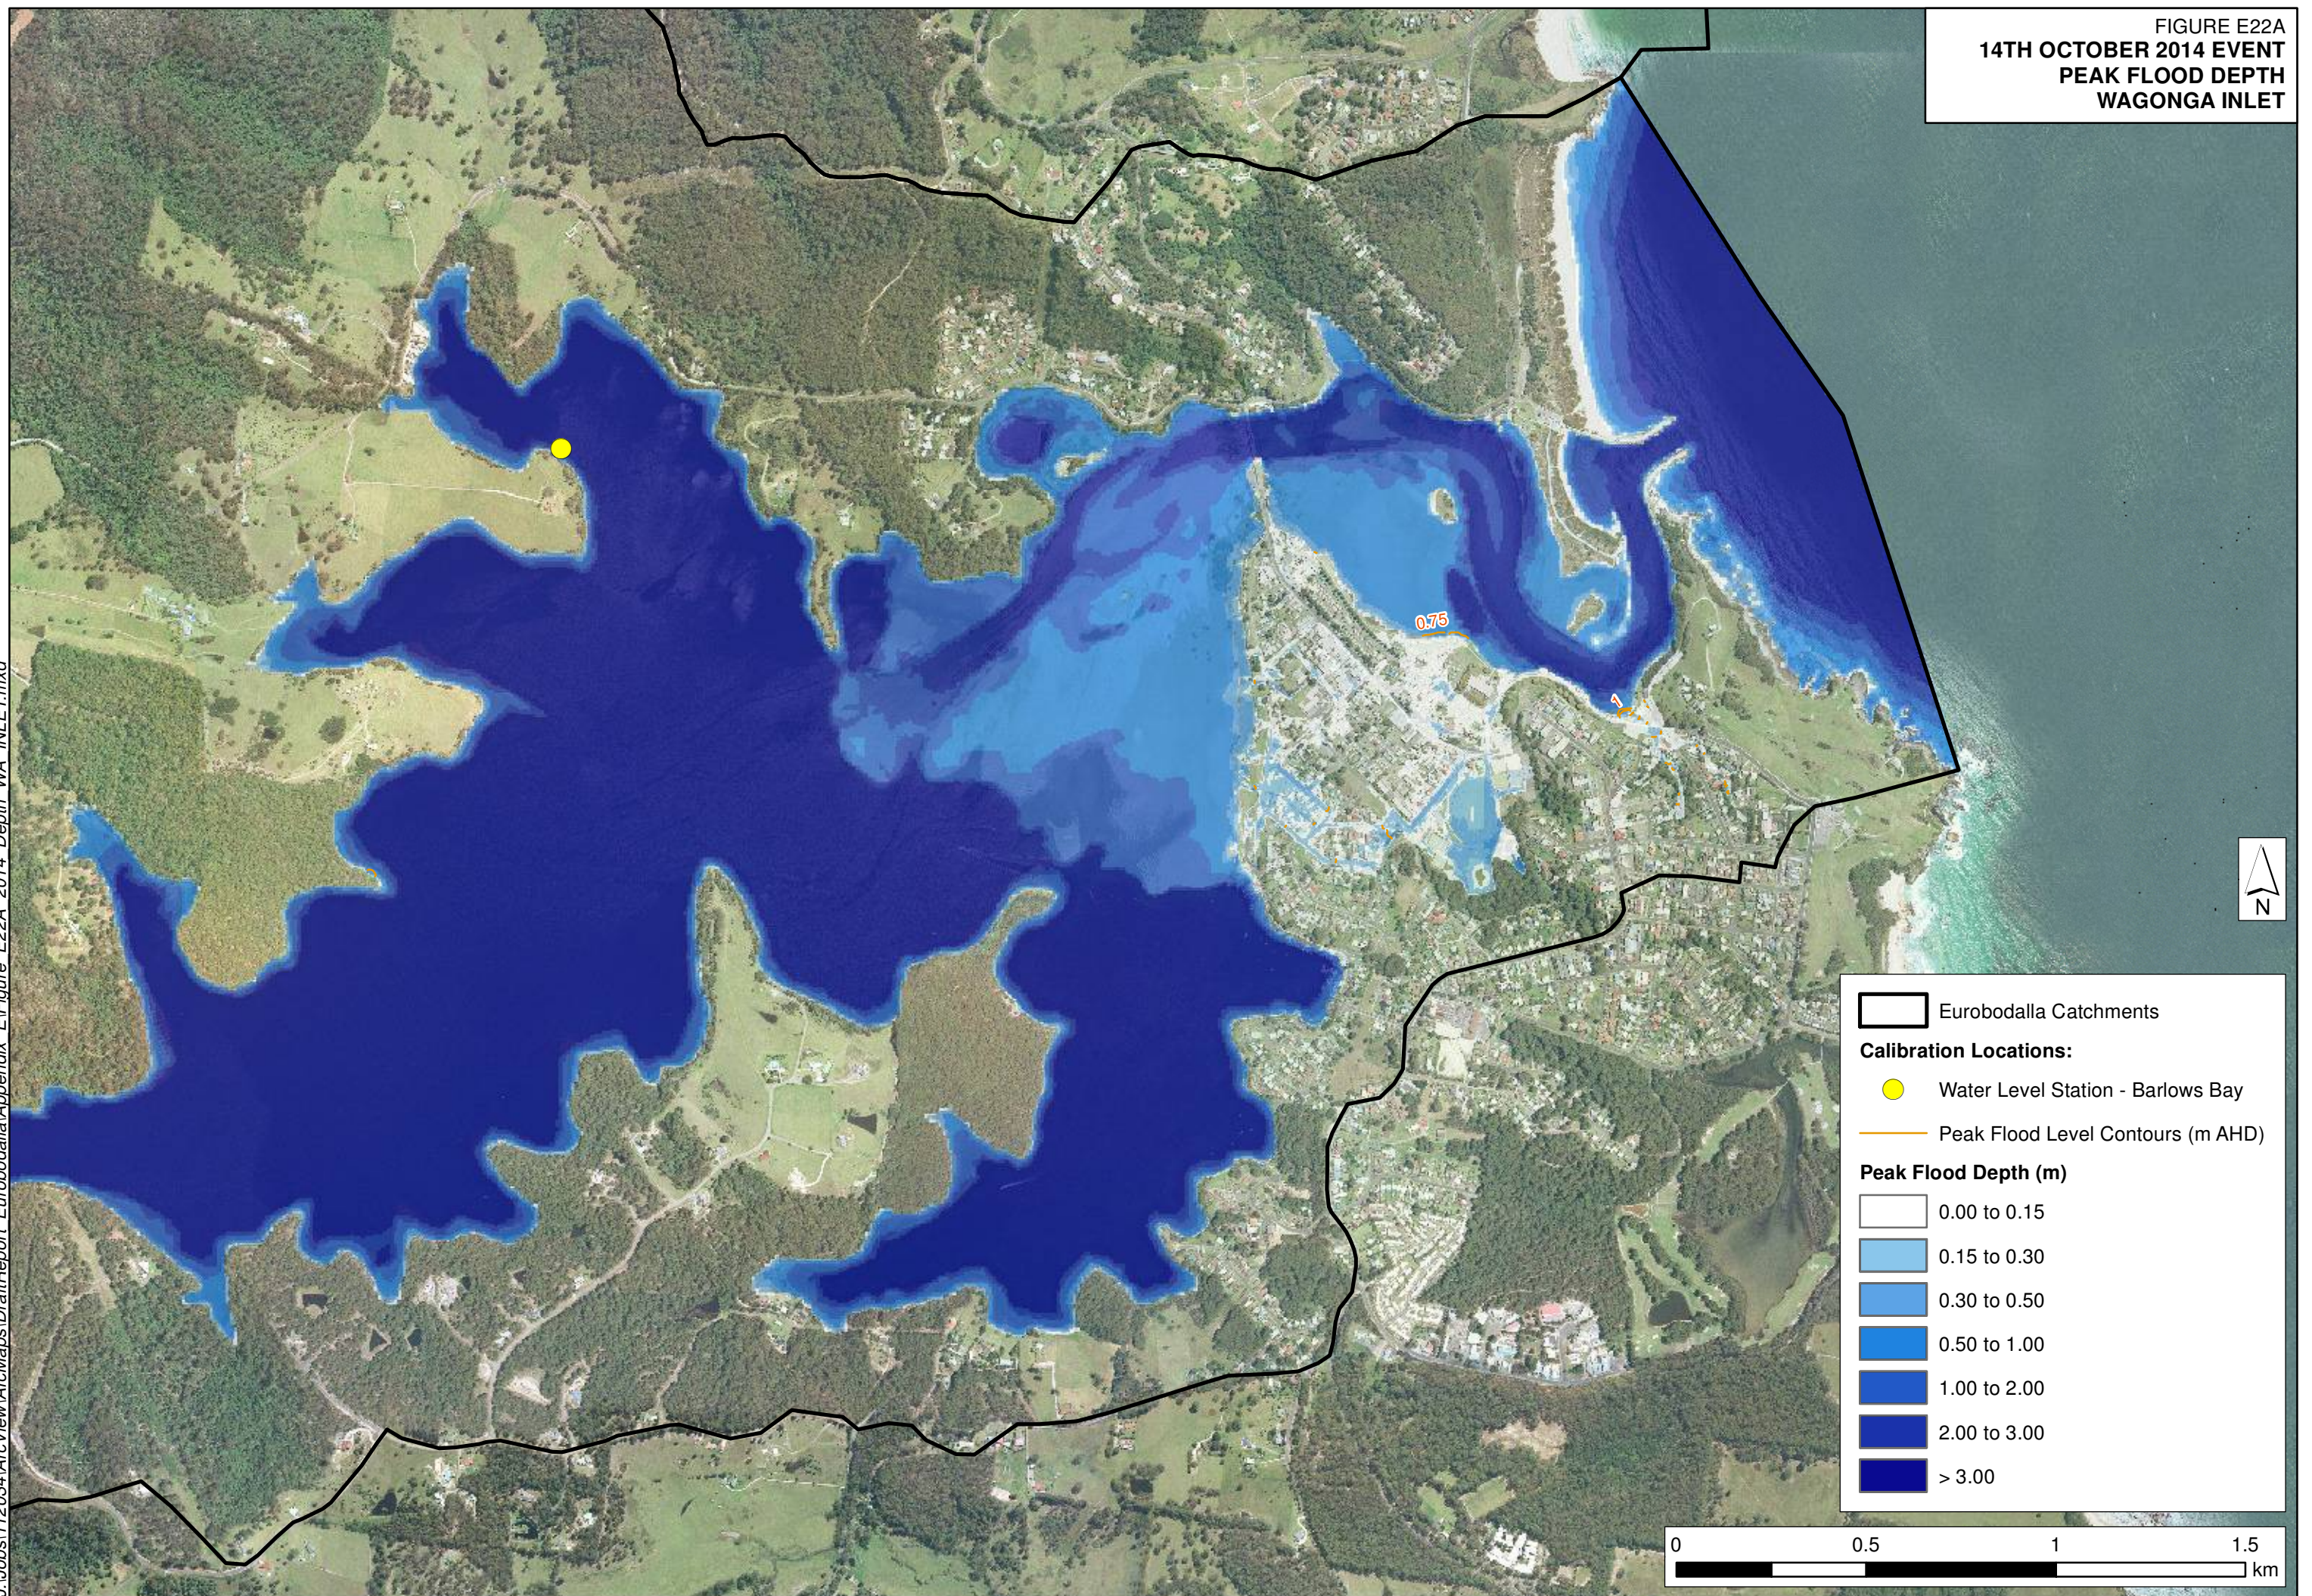
FIGURE E22A  
14TH OCTOBER 2014 EVENT  
PEAK FLOOD DEPTH  
WAGONGA INLET

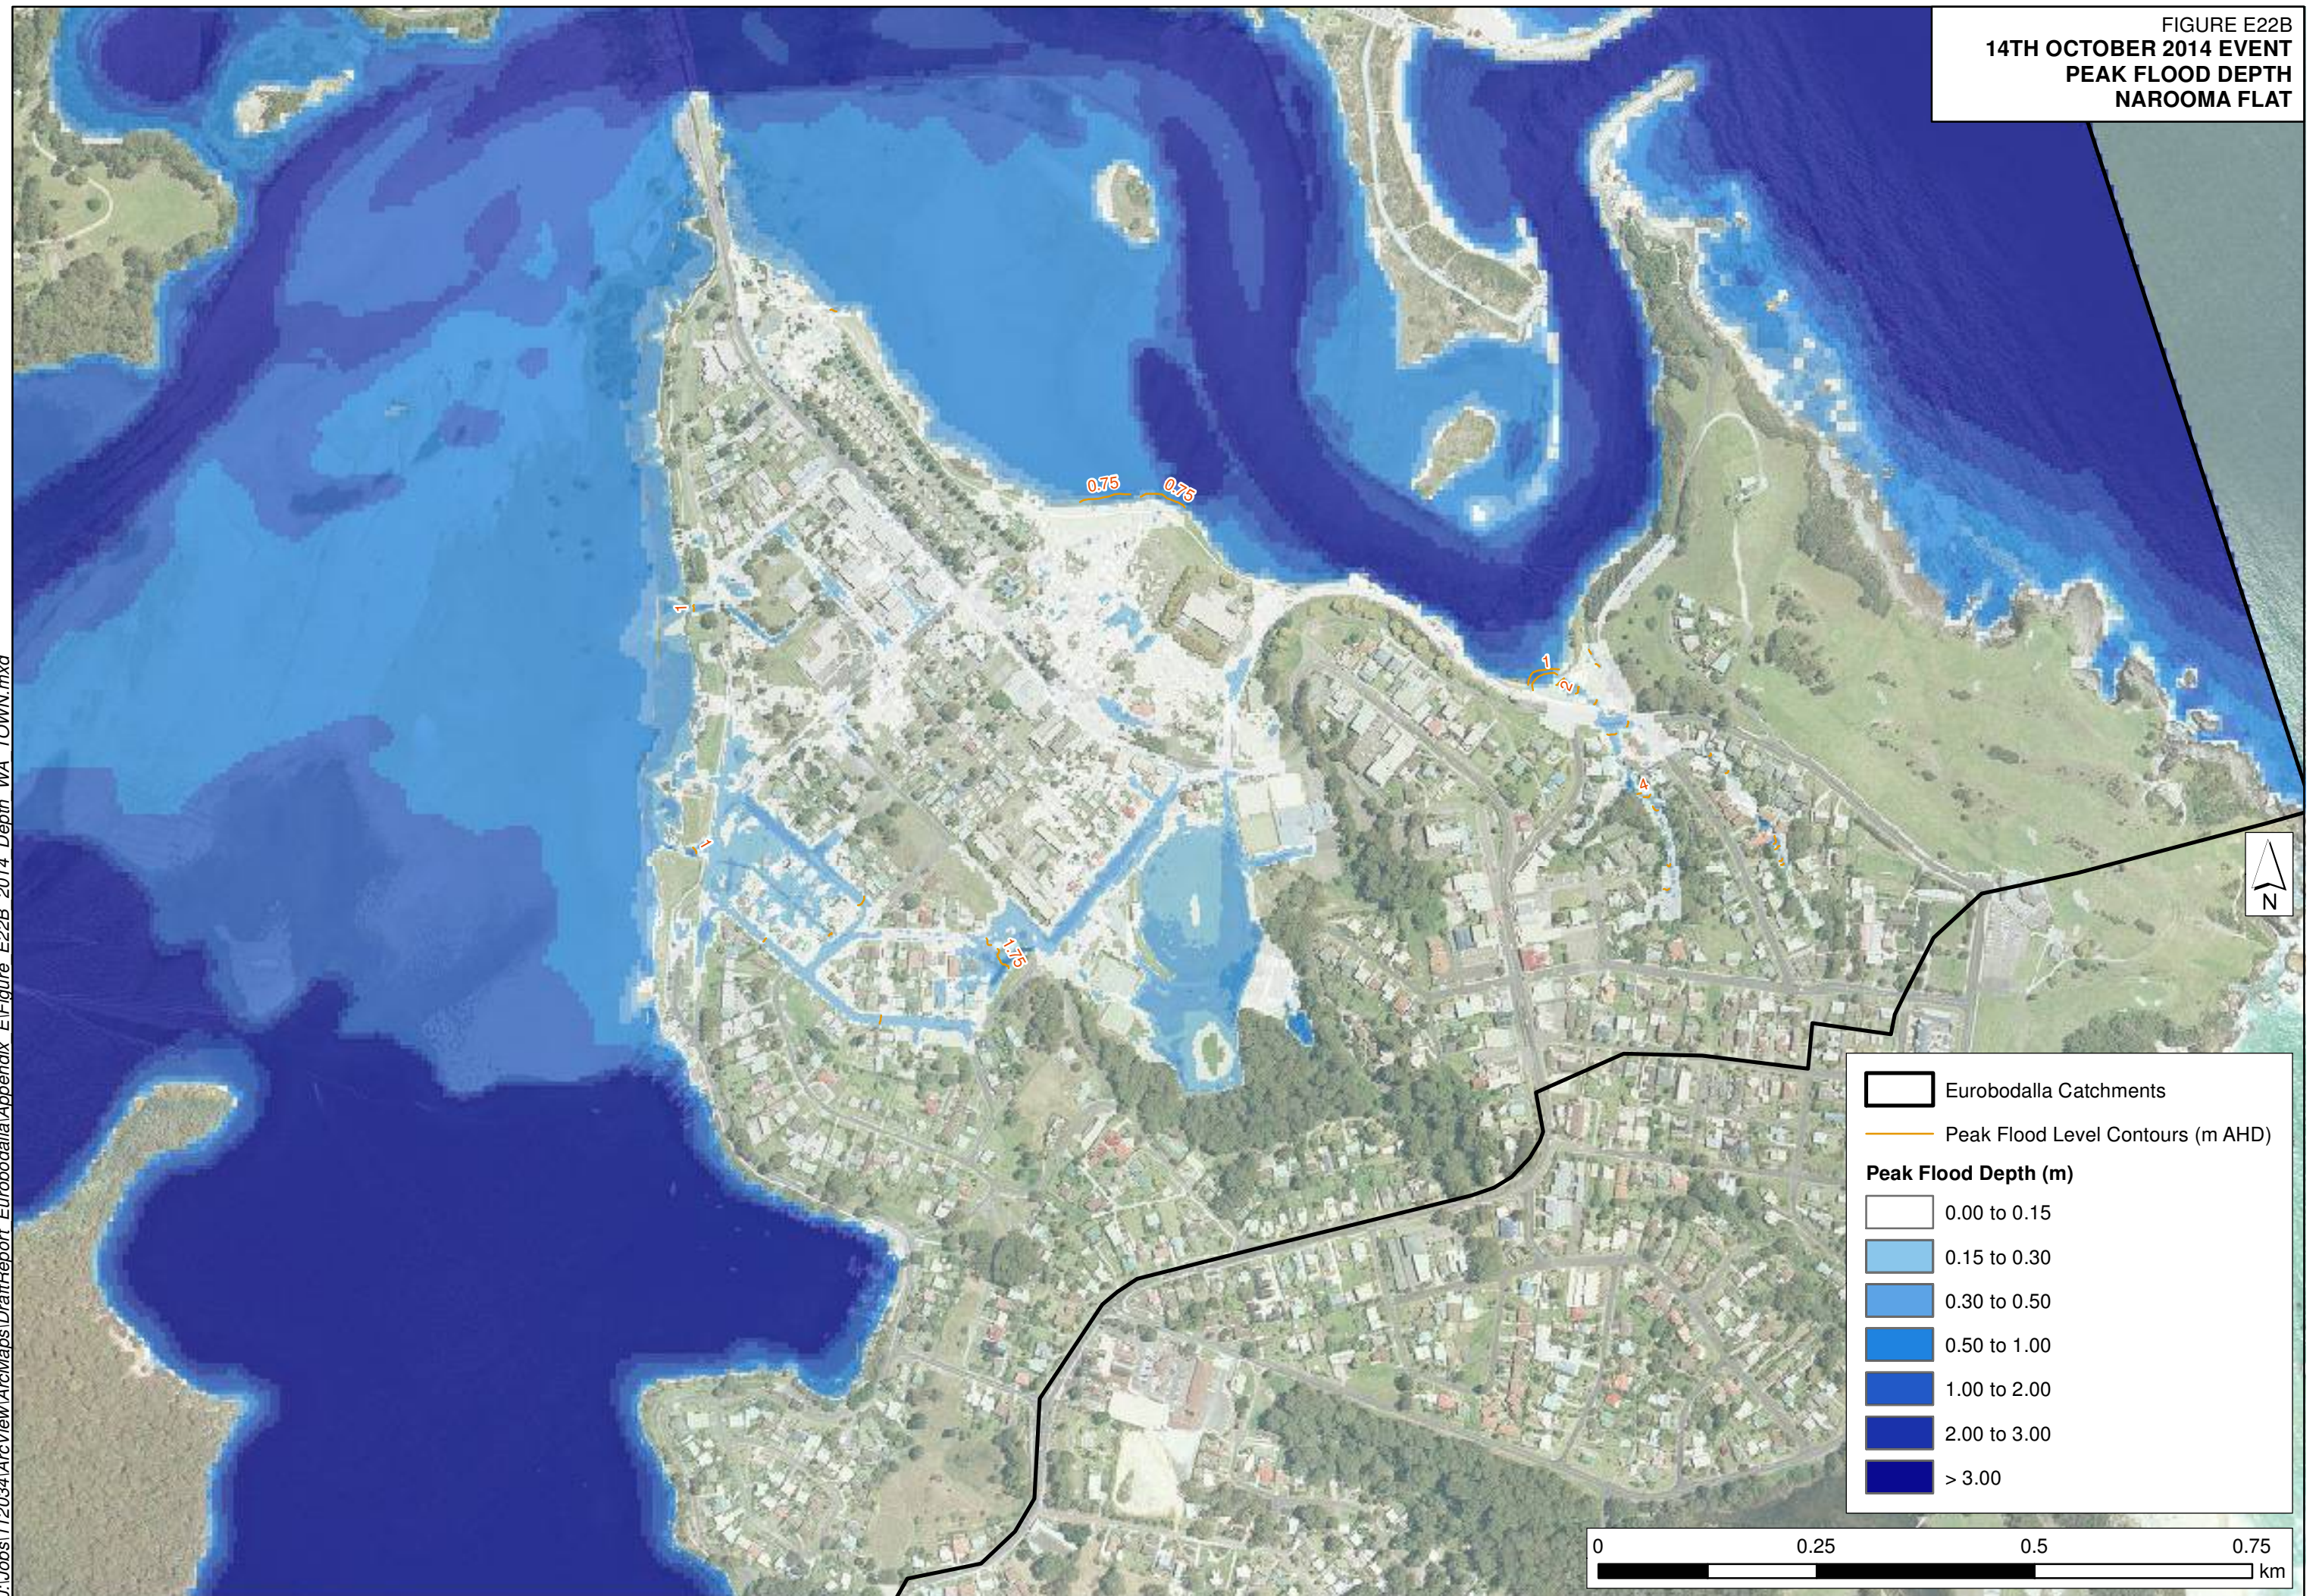
FIGURE E22B  
14TH OCTOBER 2014 EVENT  
PEAK FLOOD DEPTH  
NAROOMA FLAT

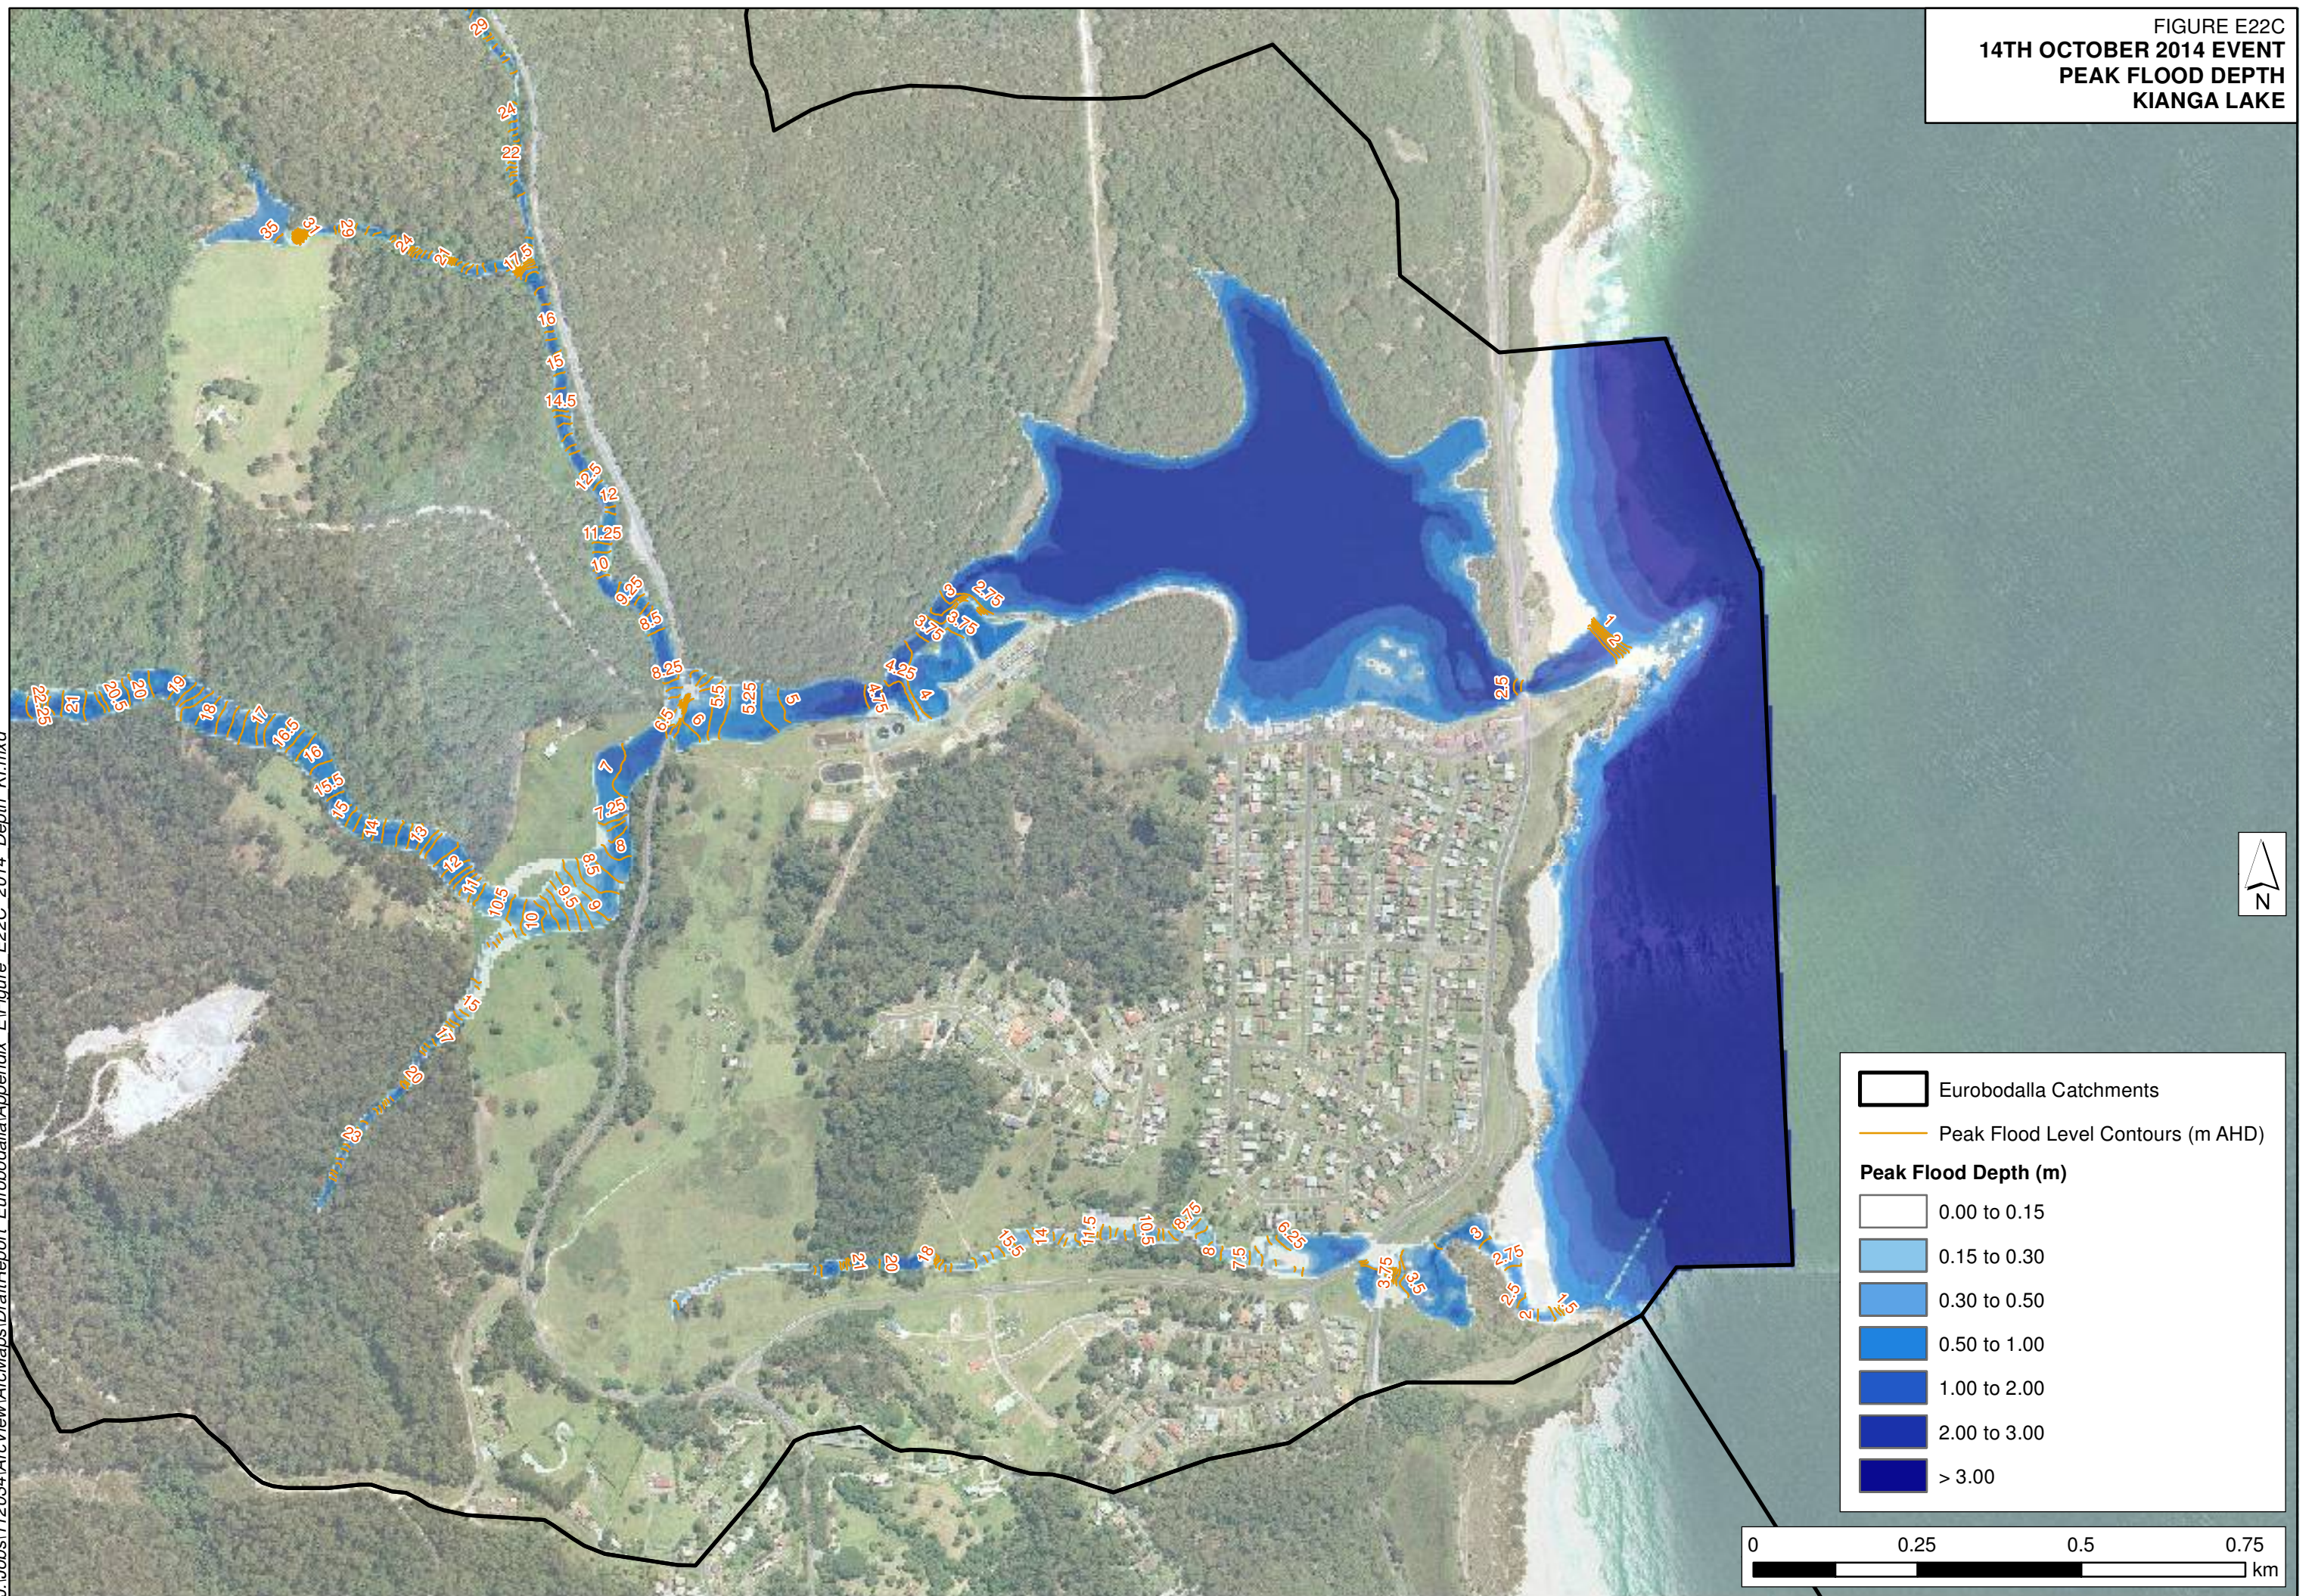
FIGURE E22C  
14TH OCTOBER 2014 EVENT  
PEAK FLOOD DEPTH  
KIANGA LAKE
