**Eurobodalla Catchments**

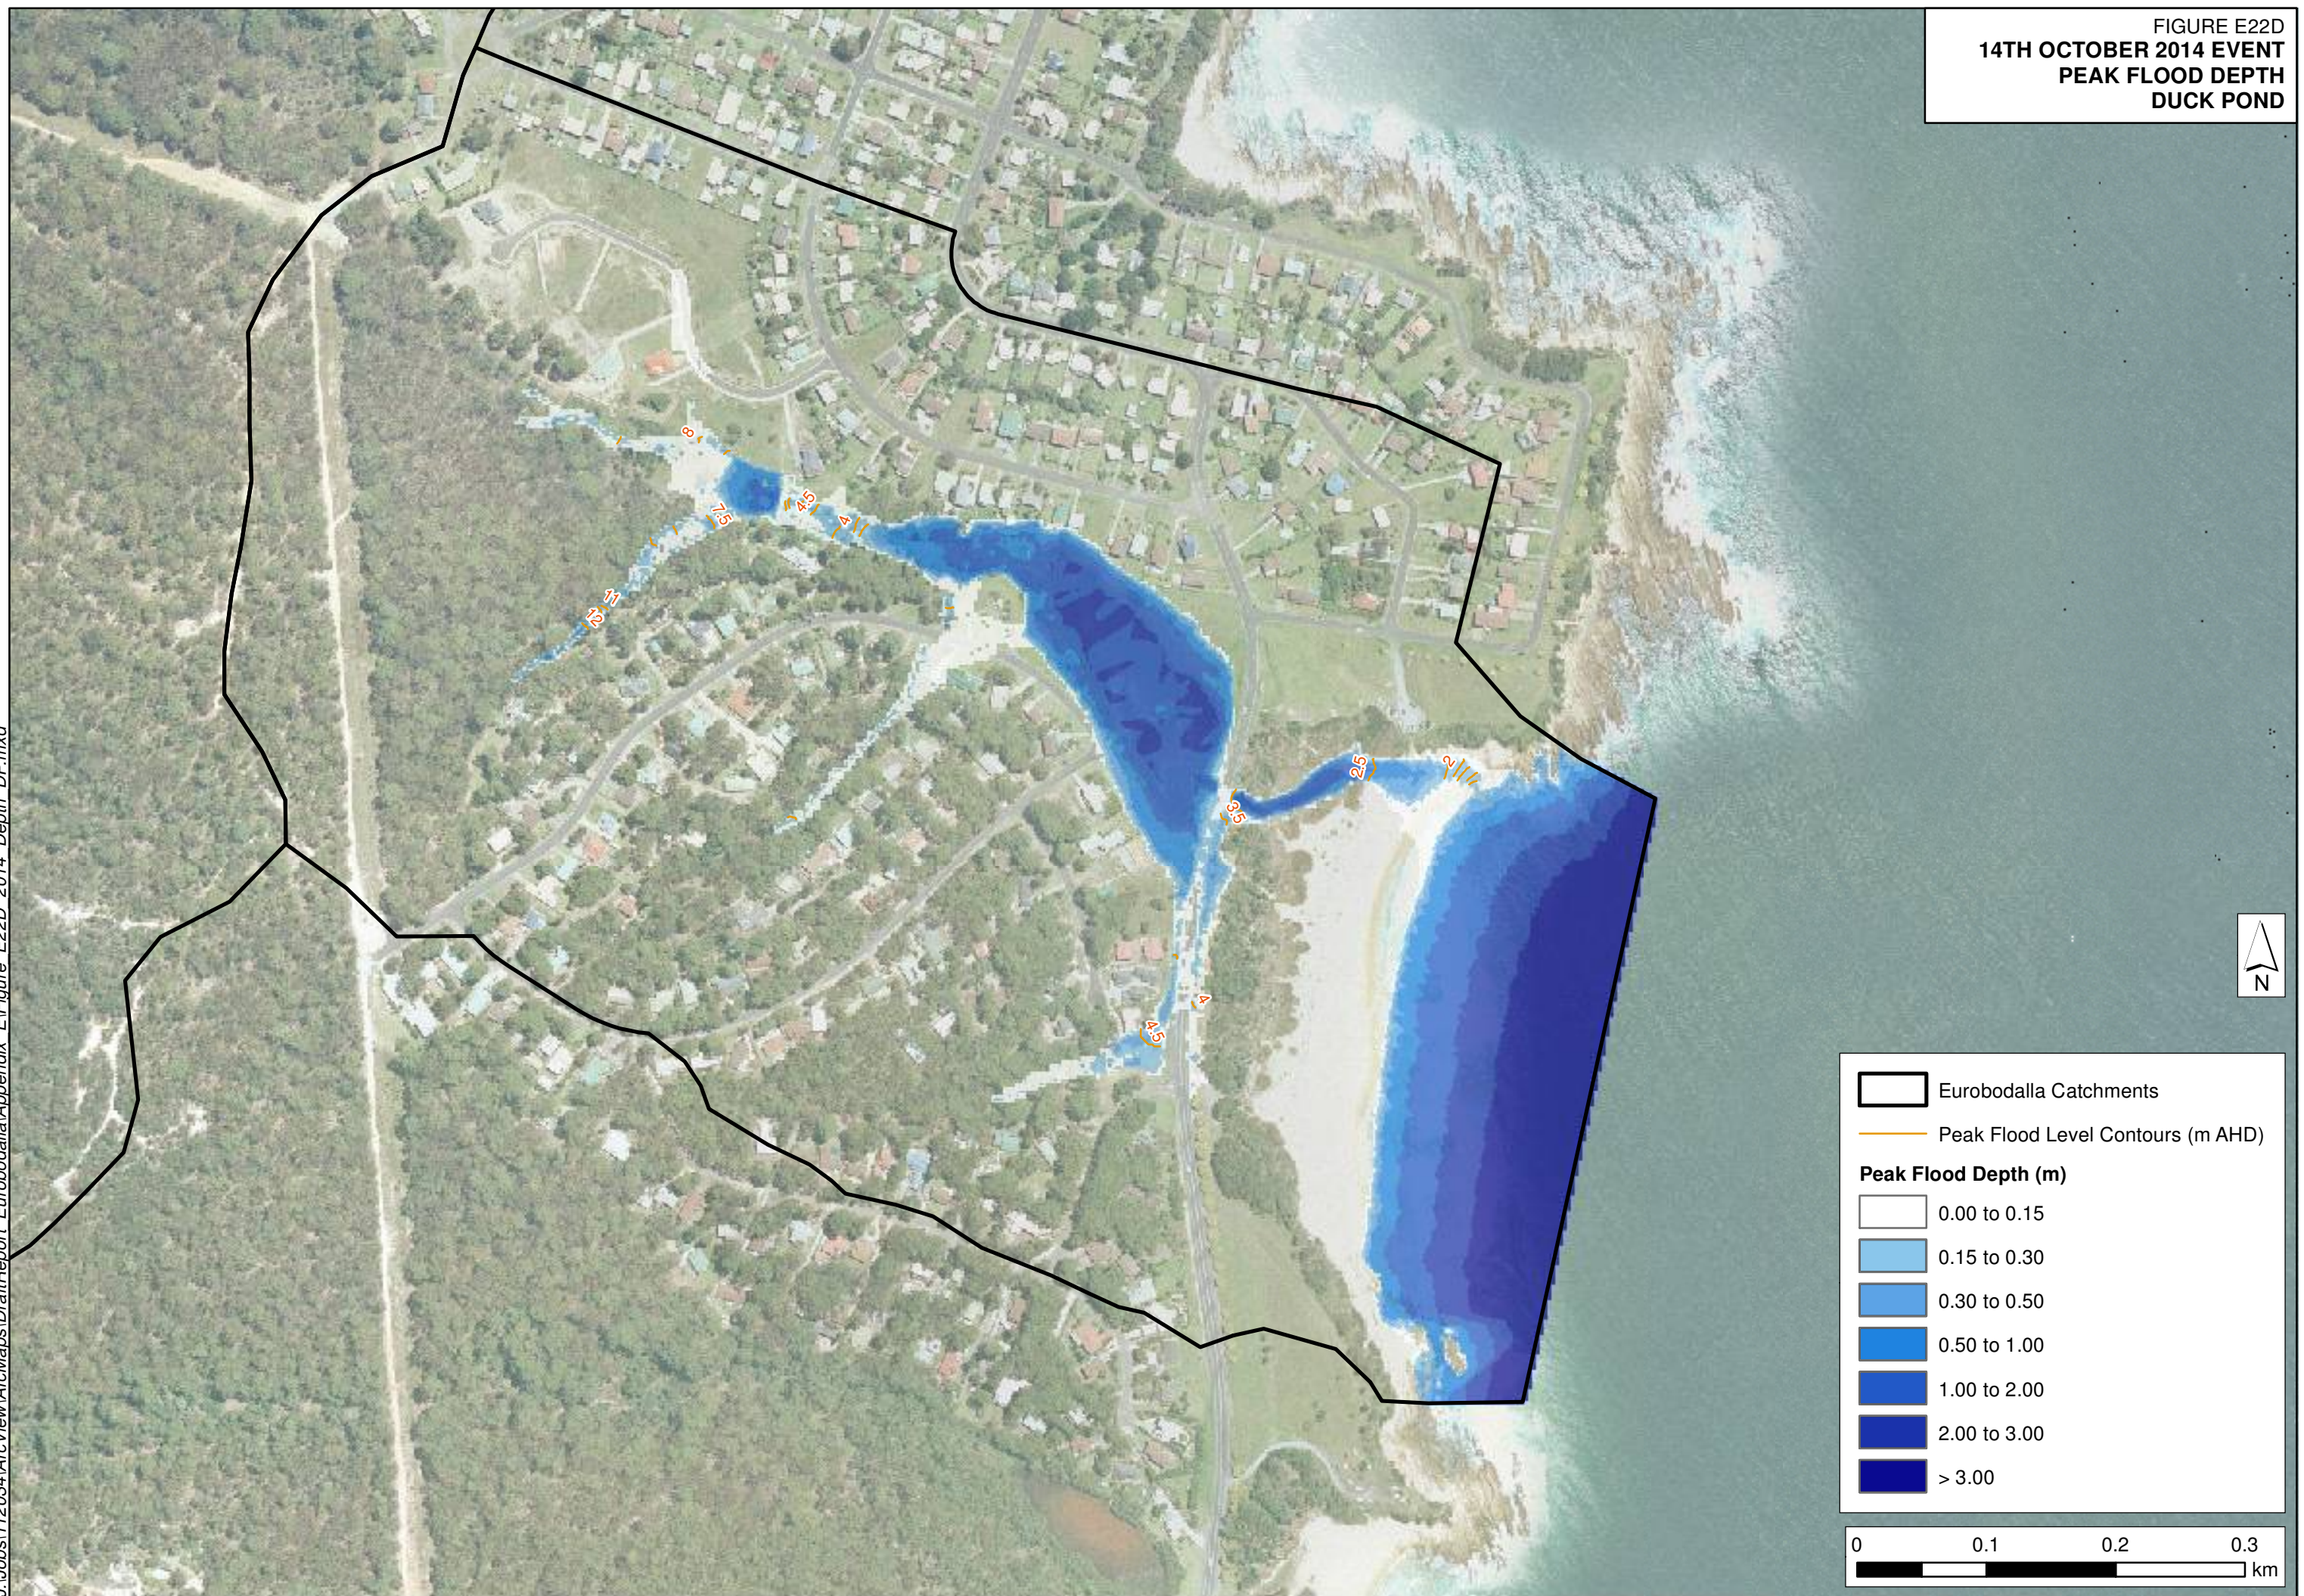
FIGURE E22D  
14TH OCTOBER 2014 EVENT  
PEAK FLOOD DEPTH  
DUCK POND

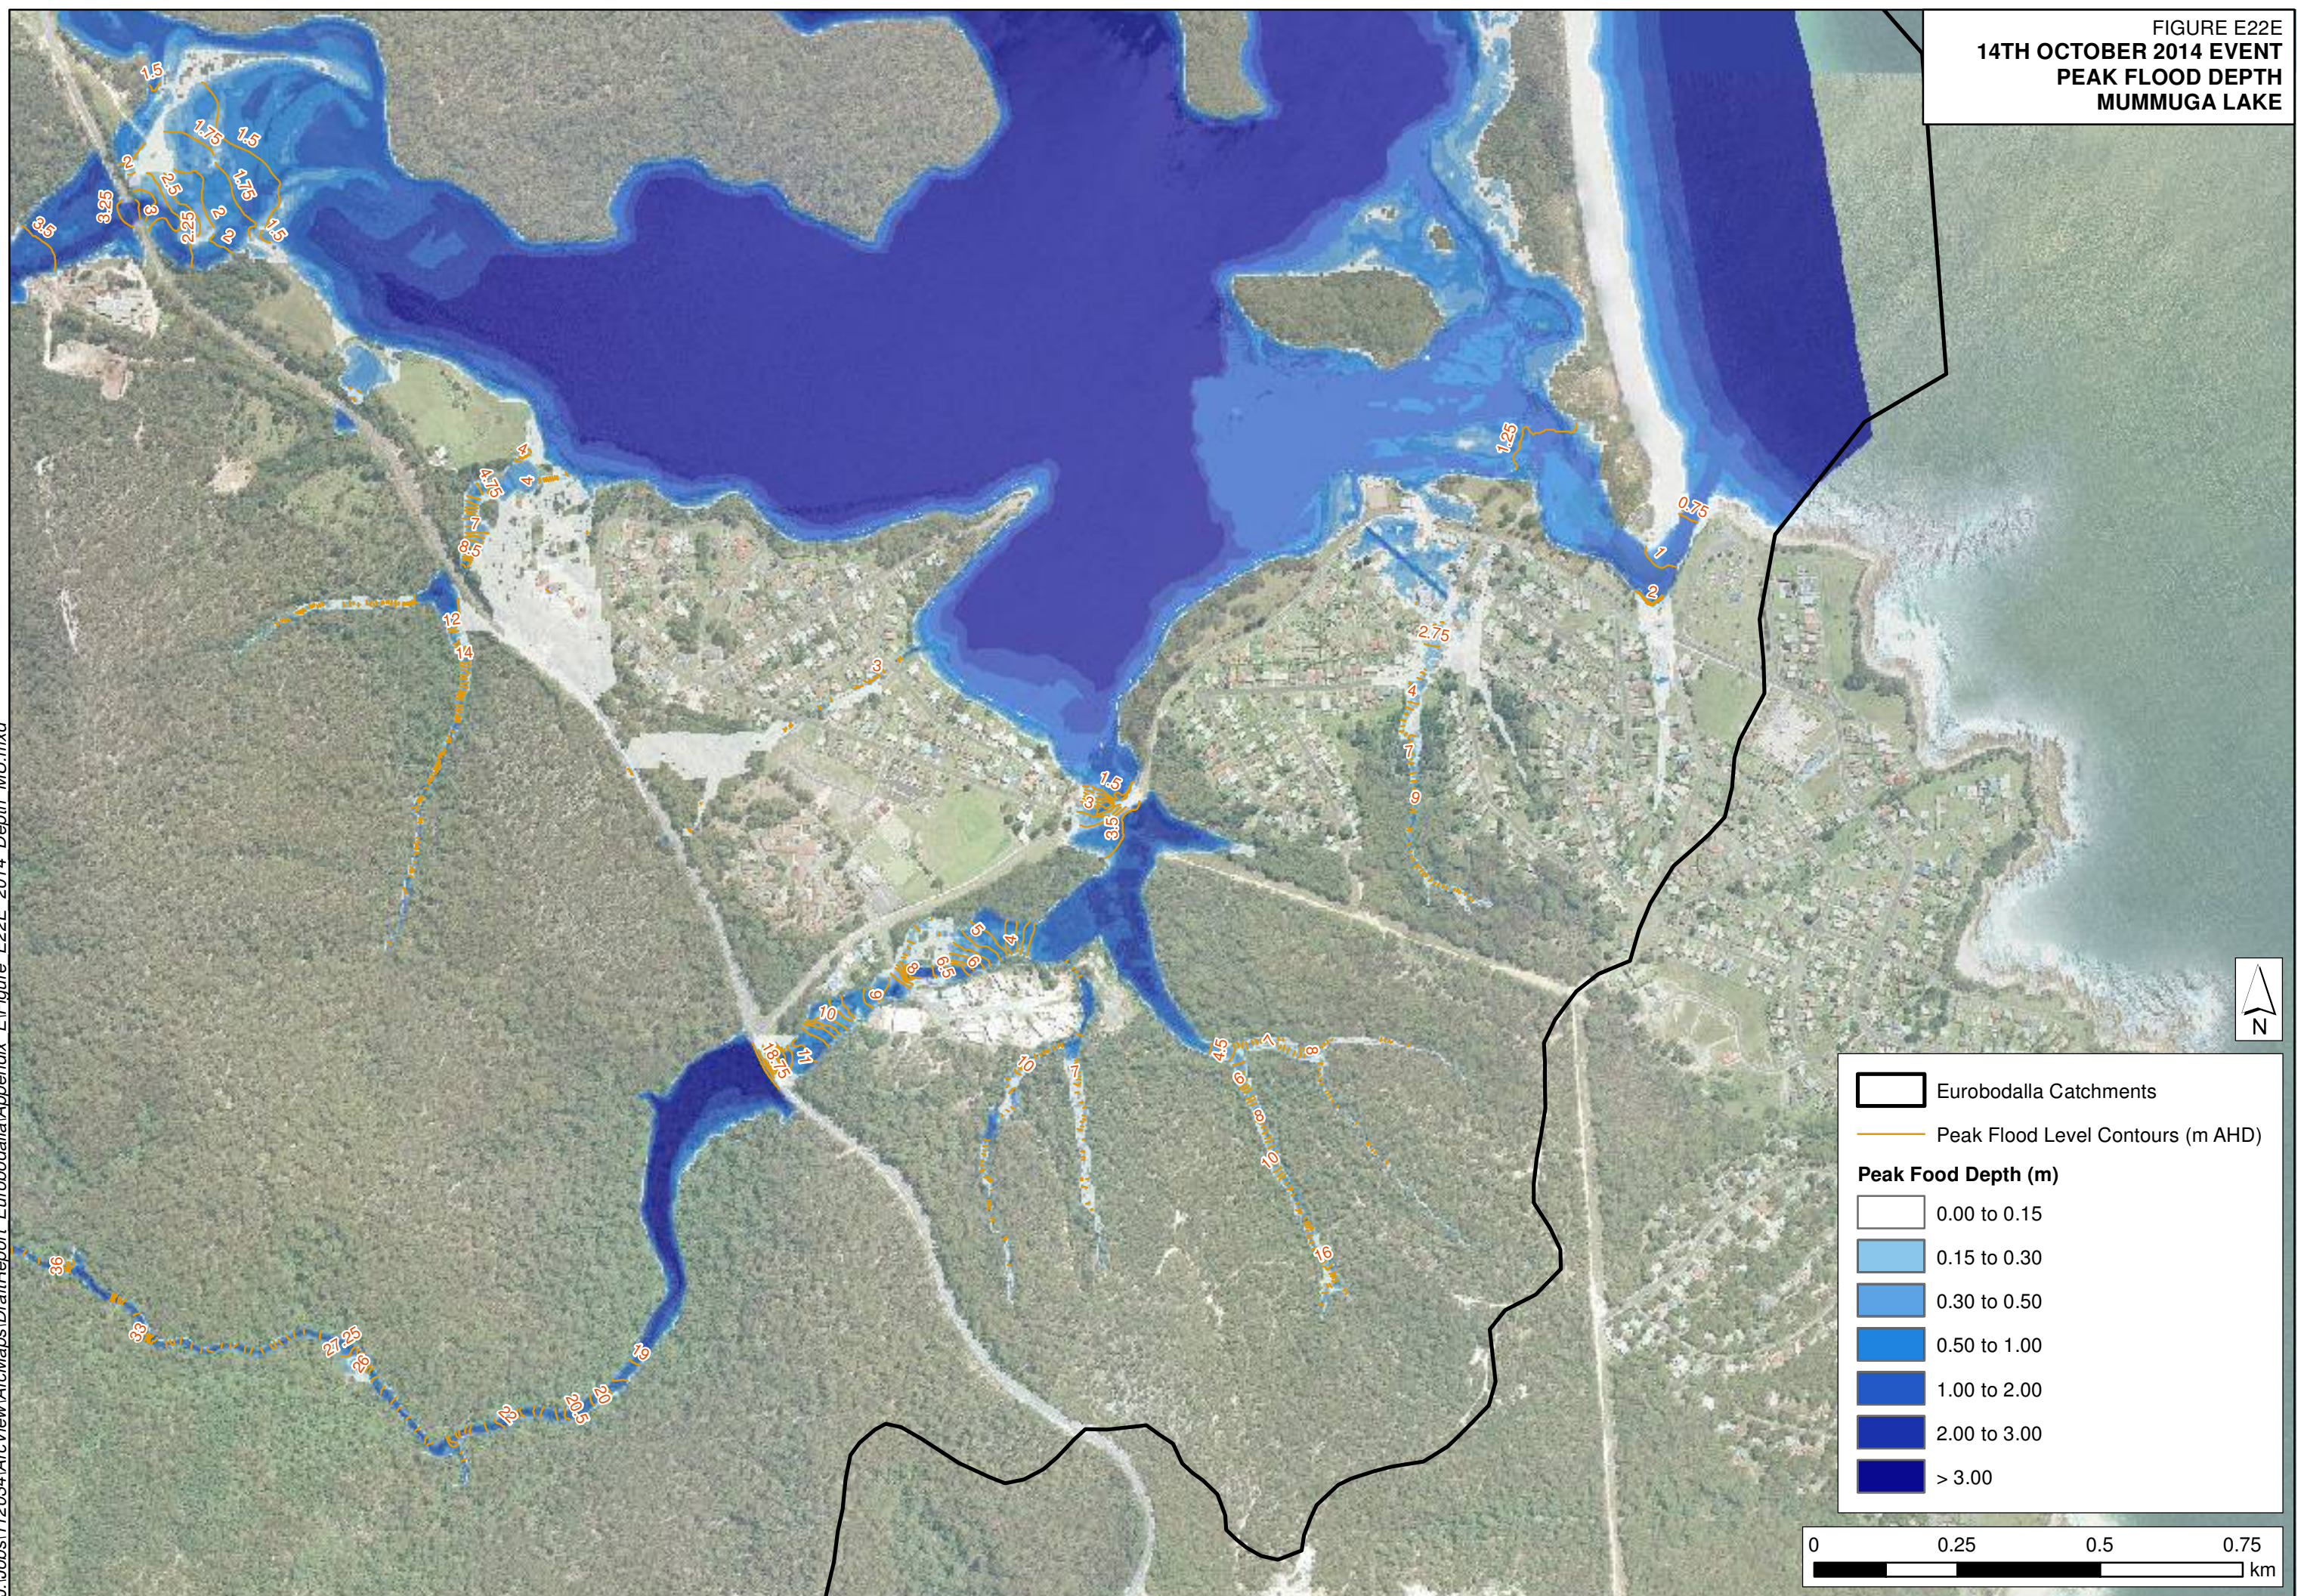
FIGURE E22E  
14TH OCTOBER 2014 EVENT  
PEAK FLOOD DEPTH  
MUMMUGA LAKE
