# CONSERVATION MANAGEMENT PLAN

## POLLOCK'S GENERAL STORE NERRIGUNDAH NSW

Location: 6 – 8 Gulph Street, Nerrigundah NSW

Date: June 2011

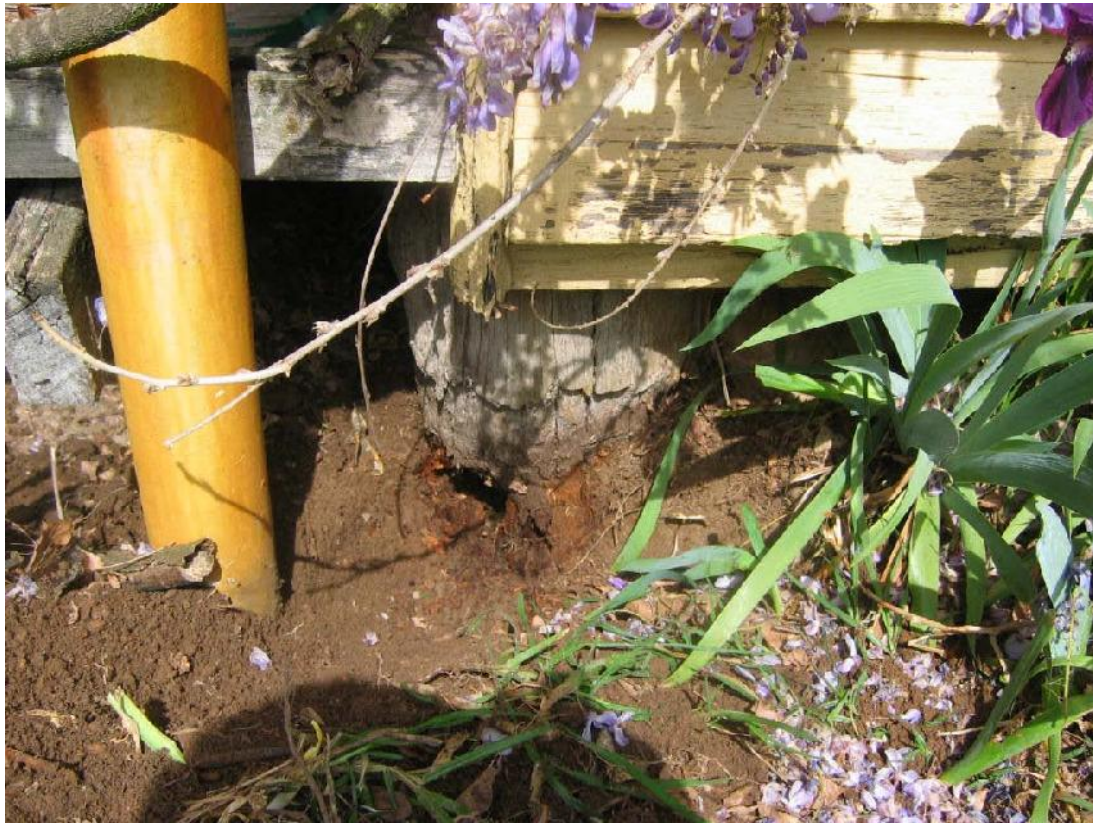
The deteriorated condition of the hardwood piers is demonstrated in these images. Inadequate support provided by the piers resulted in subsidence, the sub-floor structure being, in some cases, left suspended, and twisting of the frame. Undamaged roof framing provided the necessary structural integrity, holding the building together and limiting further structural damage. Roughly laid stone landscaping, shown below the damaged piers, contributes to the retention of on-site moisture and its uneven surface is a hazard to safe travel.

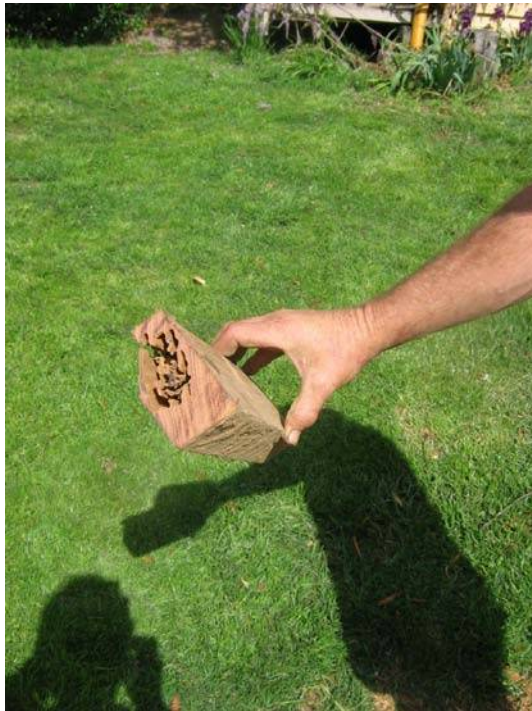
Evidence of termite damage to studs

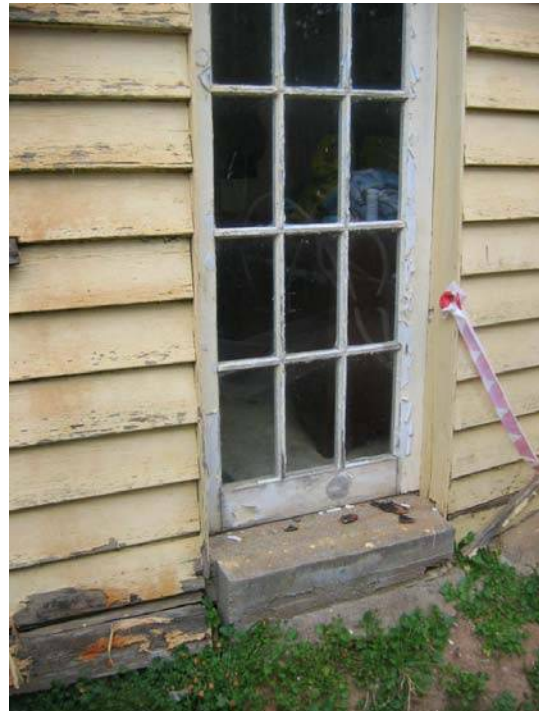
Poor amenity at door threshold

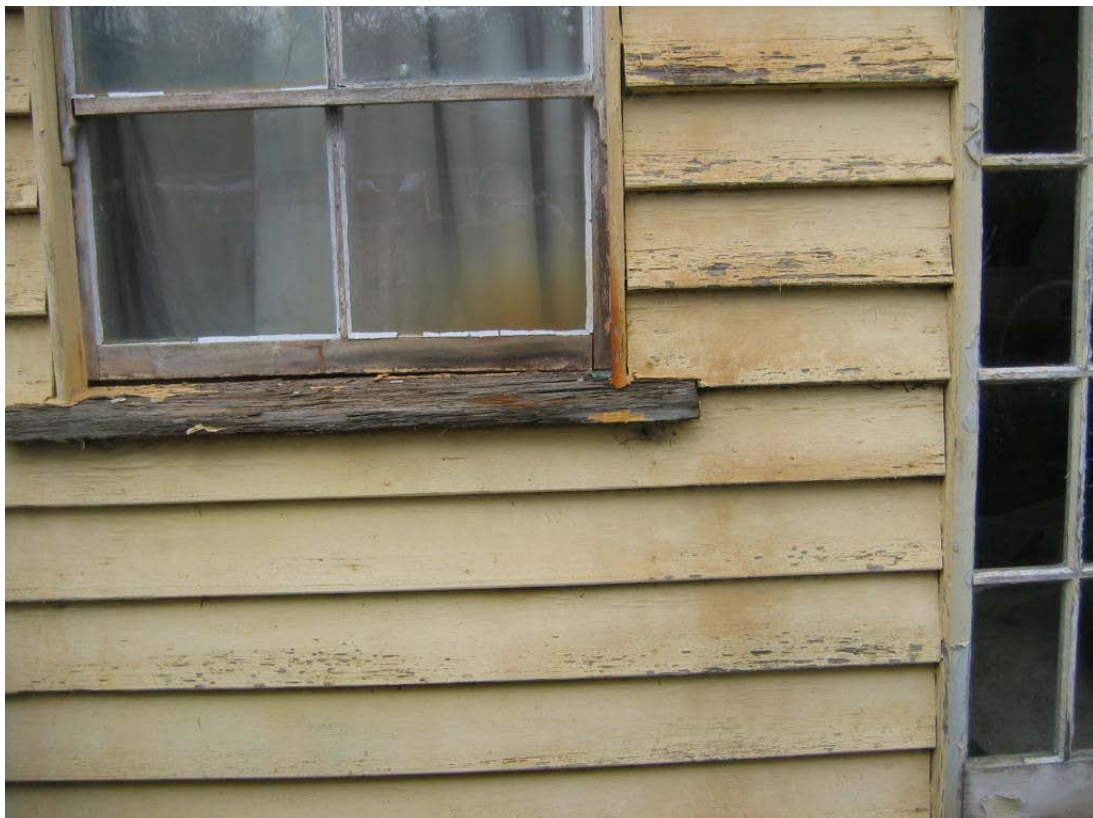
Image below shows deteriorated window, sill and surface protection for wooden and glazed elements.

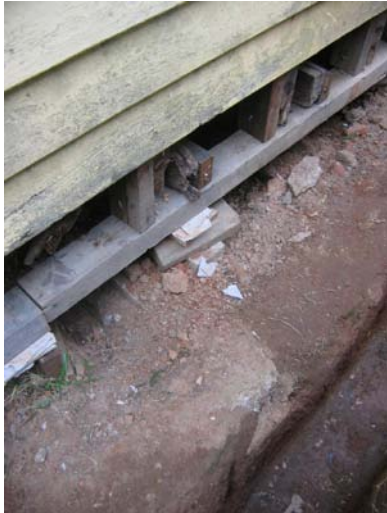
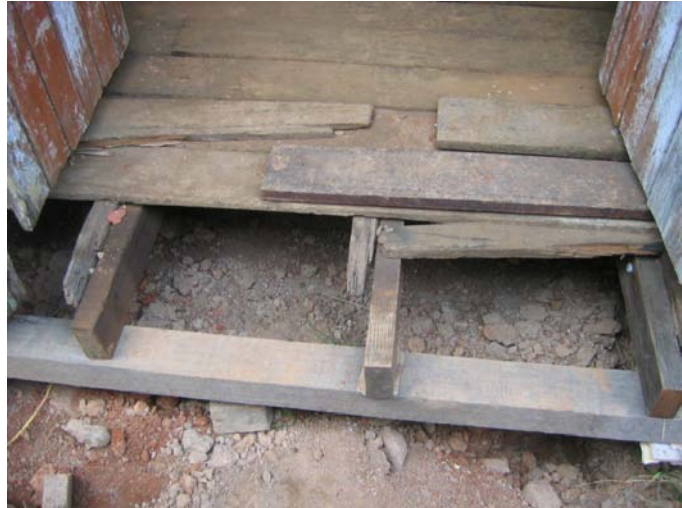
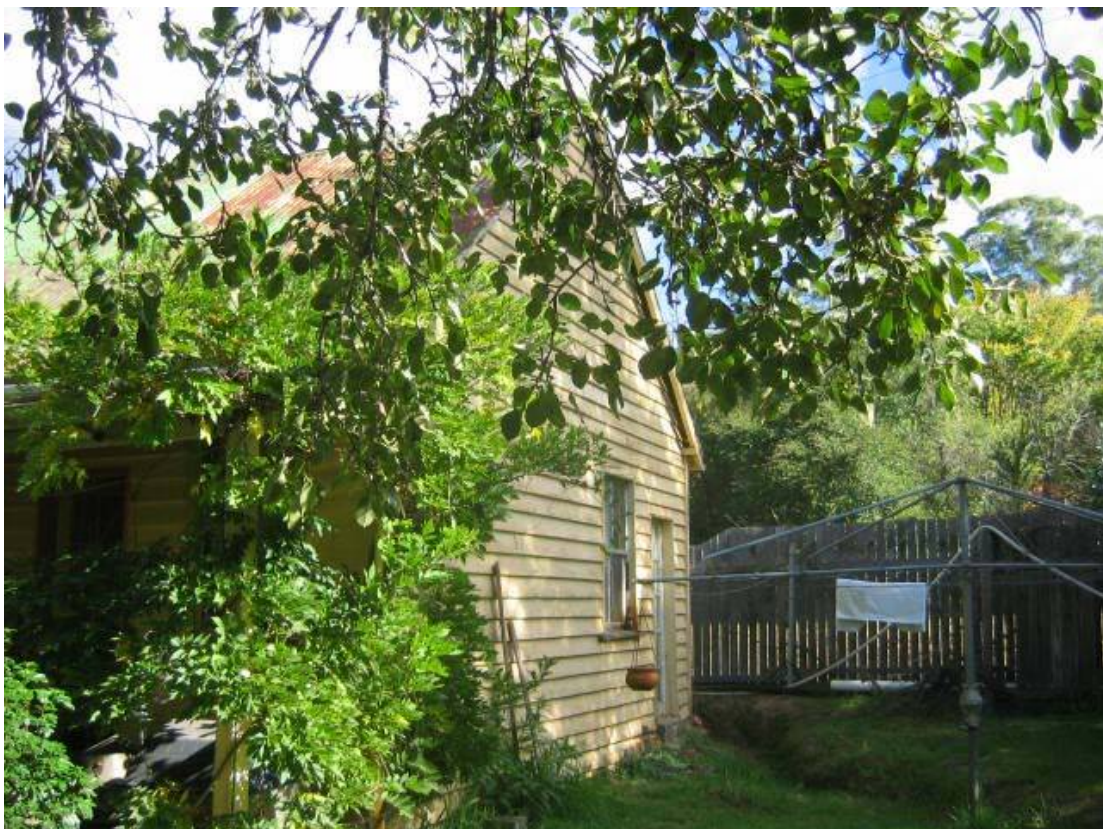
The close proximity of the bearer/bottom plate to the ground is shown above. The image below demonstrates that floor level in the most westerly area of the store is situated below the level of the street, which is located at the base of the paling fence.

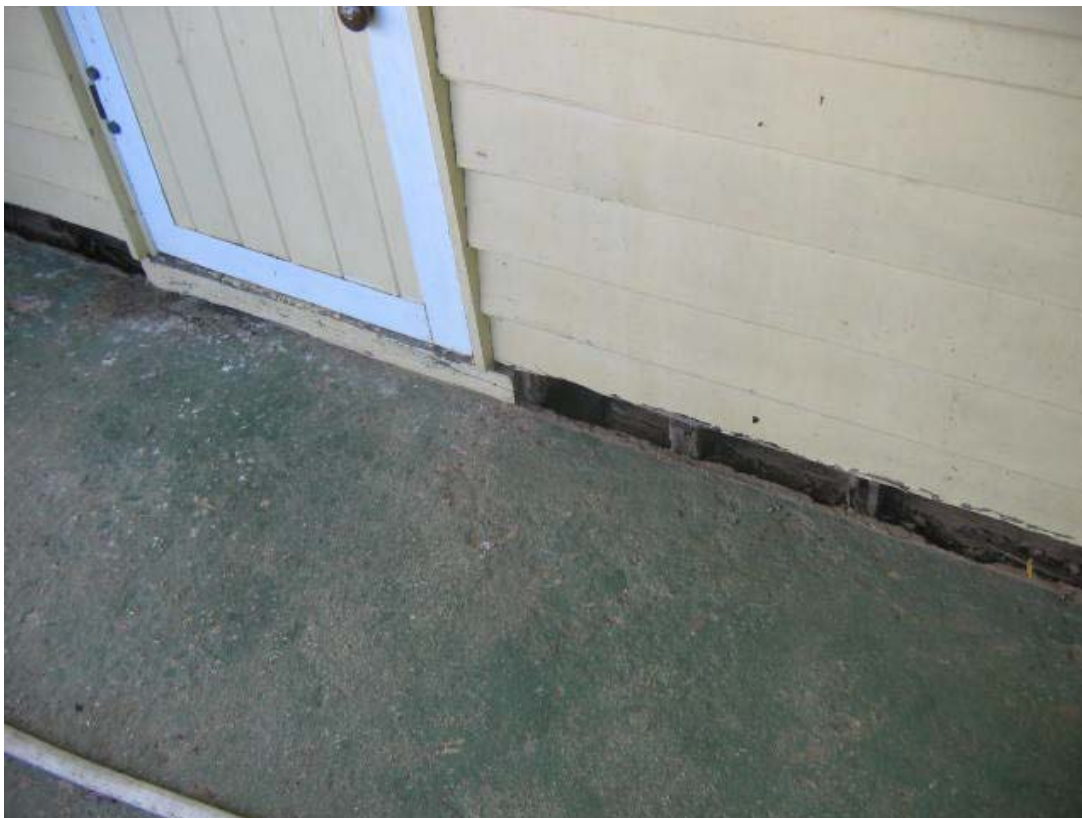
Poor quality concrete at eastern front verandah entrance

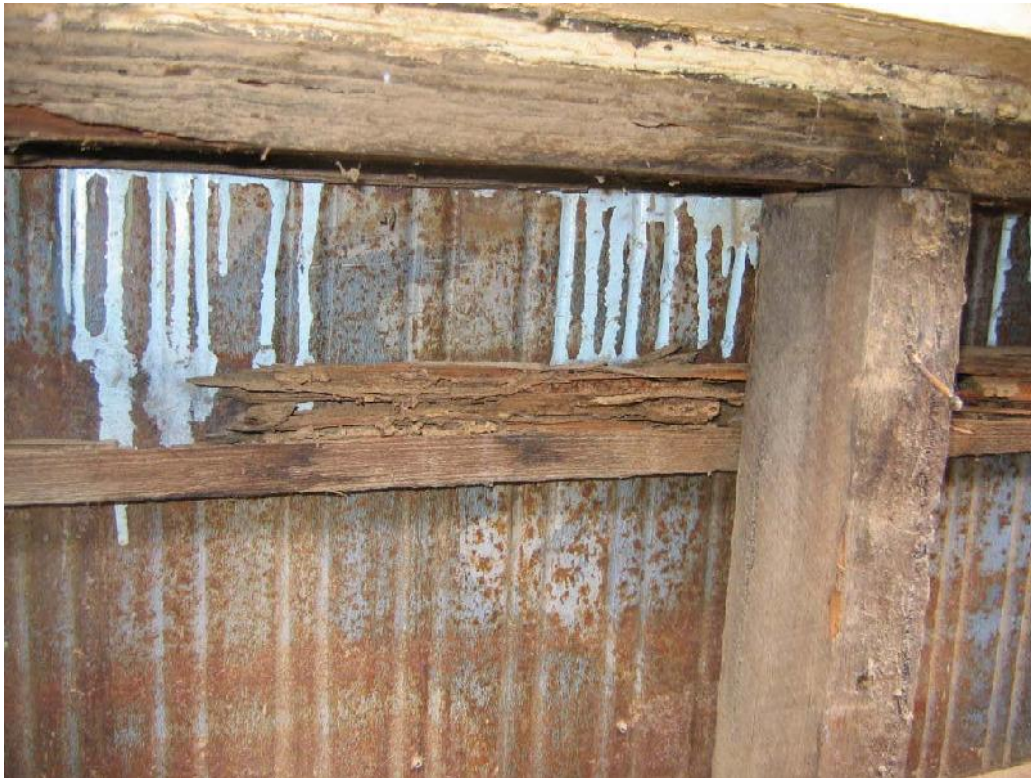
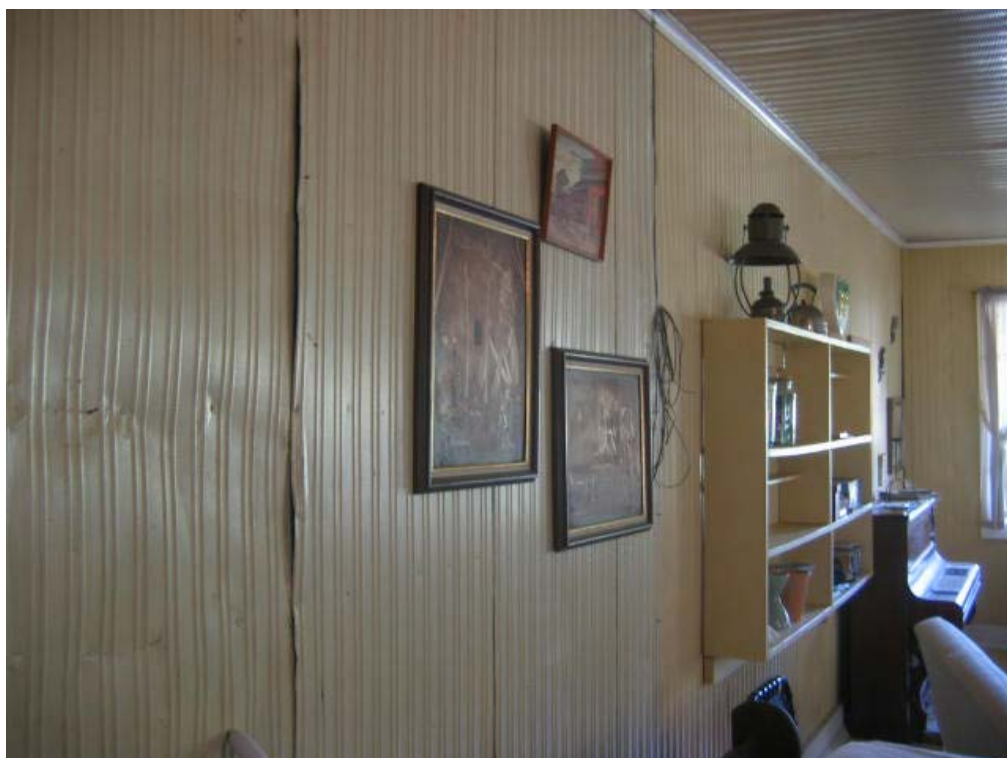
Penetrating damp, rising damp in the fireplace, and termites have combined to cause considerable damage to the structure. This has impacted on the condition of the largely intact, original pressed metal lining and on the internal amenity that the building provides. Damage to the interior lining and evidence of termite infestation of wall battens to which lining is affixed are shown below.

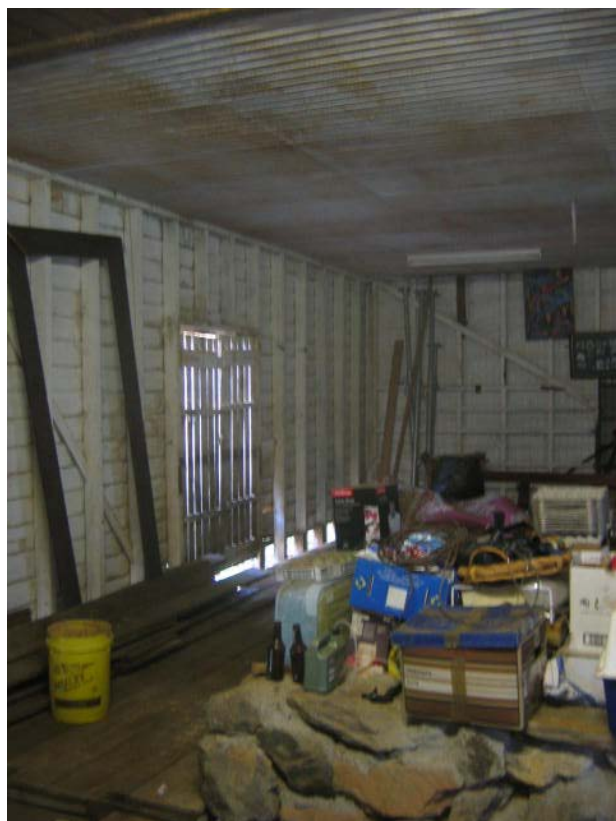
This photo, from the preliminary site visit in May 2010, shows the internal finishes at that time. Both studs and external lining were painted, the room was unlined and it lacked any form of insulation. The internal amenity it provided was therefore limited by this factor. The image also indicates the poor quality of the stonework in the central structure, which also suggests that it was built at a relatively recent time. This structure impedes the free flow of circulation, which is also an argument against it being an original element within the produce store, and it constitutes an unsightly and unsympathetic element in the space. The picket style barn doors are also considered unlikely to be

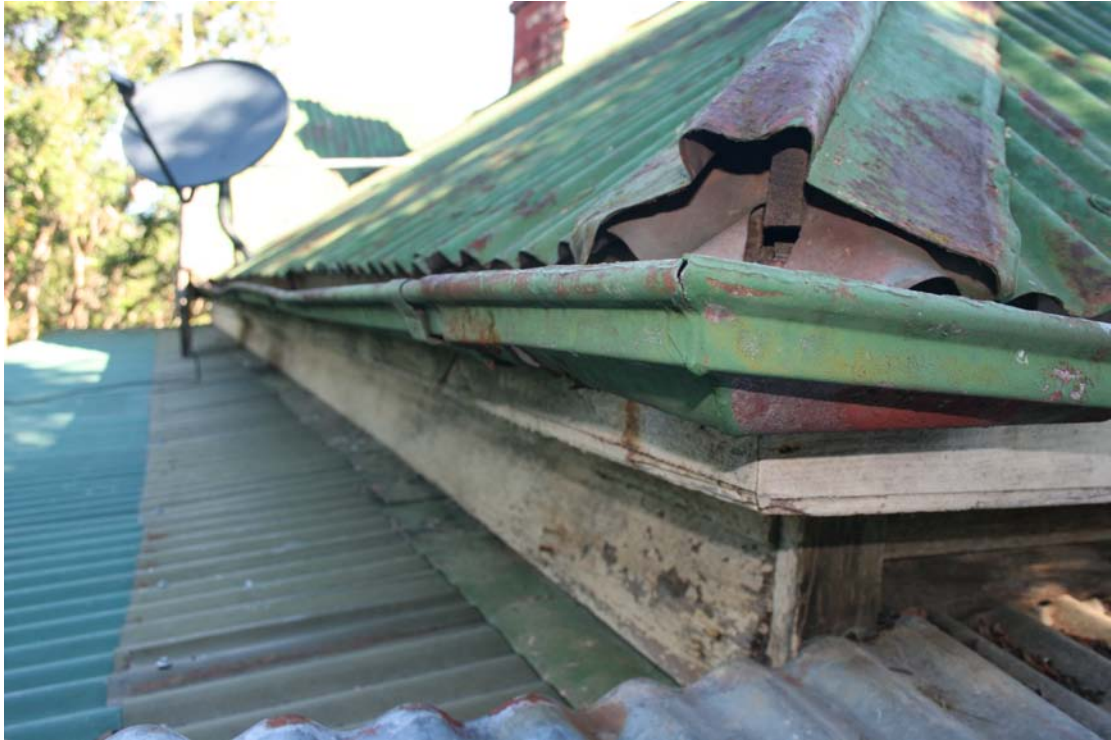
Like the store, roof sheet overlaps are deteriorated but the fabric still performs its protective function adequately. Gutters need replacing and re-grading. Some bull-nosed verandah roof sheets are badly damaged and need to be replaced. This is especially the case in the north-east corner adjacent to the bathroom/laundry structure.

Images show deteriorated gutter, timber elements and corrugated valley tray.

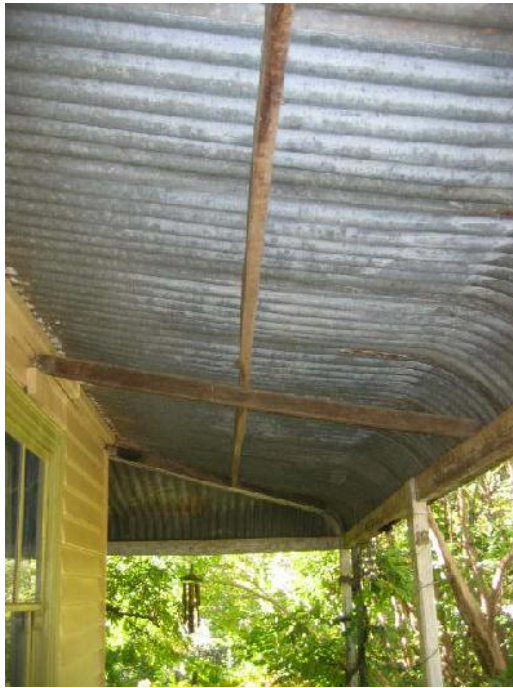
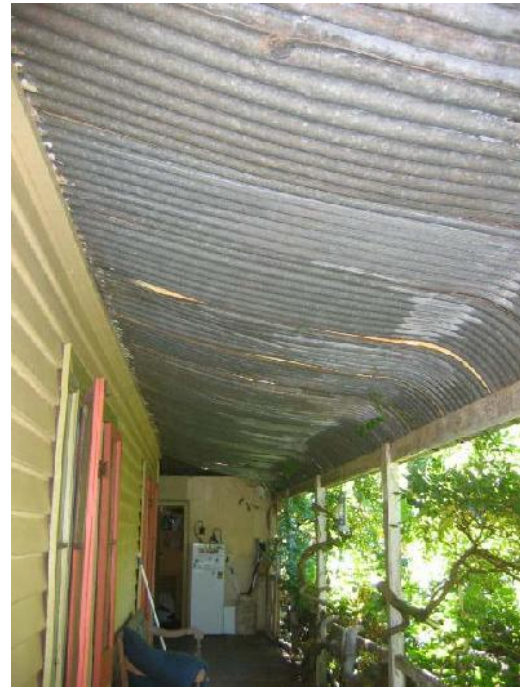
Images of bull-nosed verandah as seen from below. In general, the fabric still performs its protective function adequately, but some sheets need to be replaced, with new galvanized iron bull-nosed sheets, especially those along the eastern verandah as shown above right.

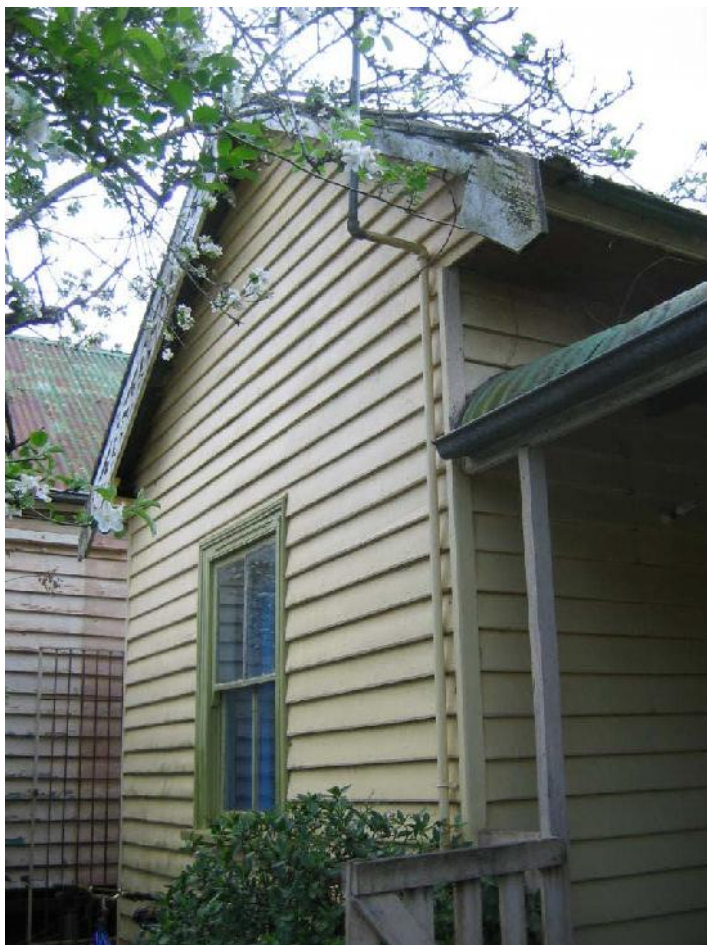
Missing decorative gable element to front bedroom.

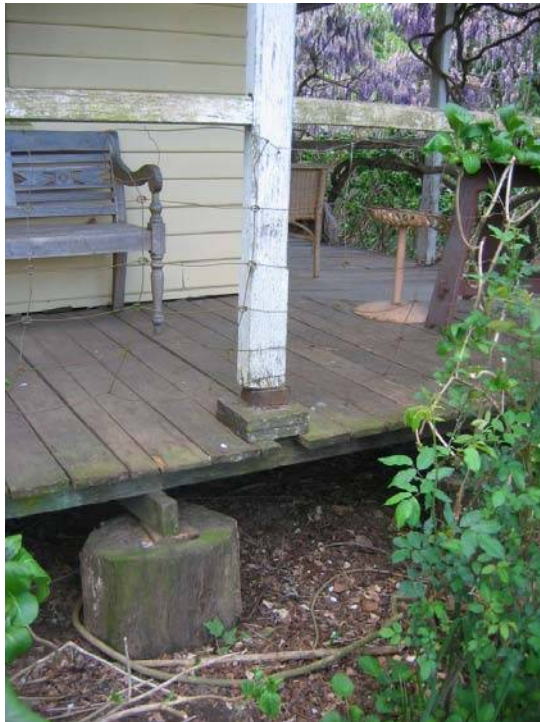
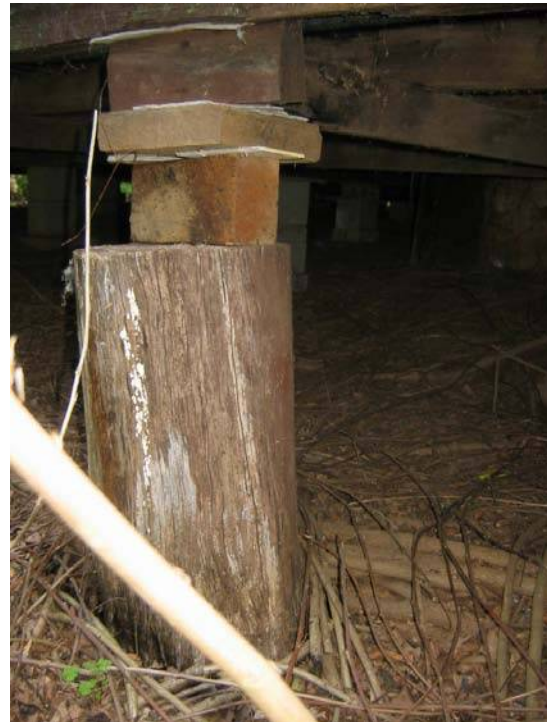
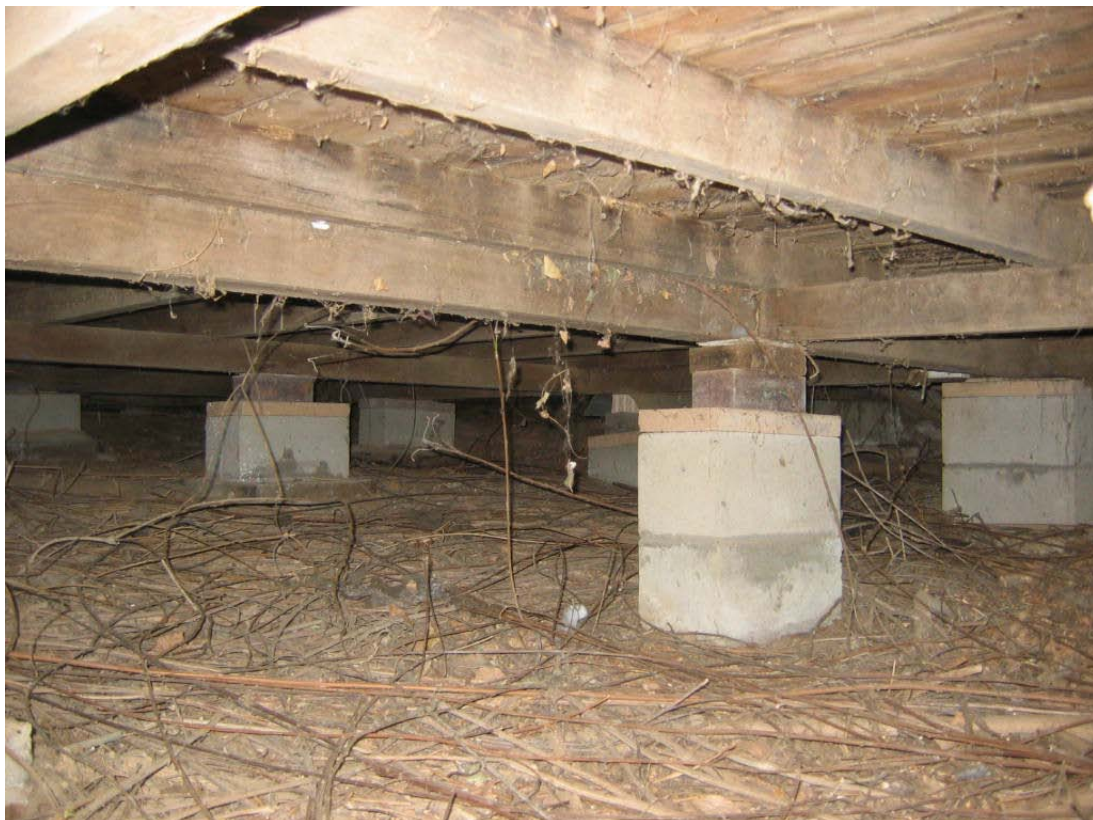
The deteriorated condition and ad hoc fabric substitution of the residence's piers is shown above and below. Ant caps are generally absent and attention will need to be directed towards the close proximity of the ground below the kitchen and former dining room area, where the verandah boards are almost contacting the ground.

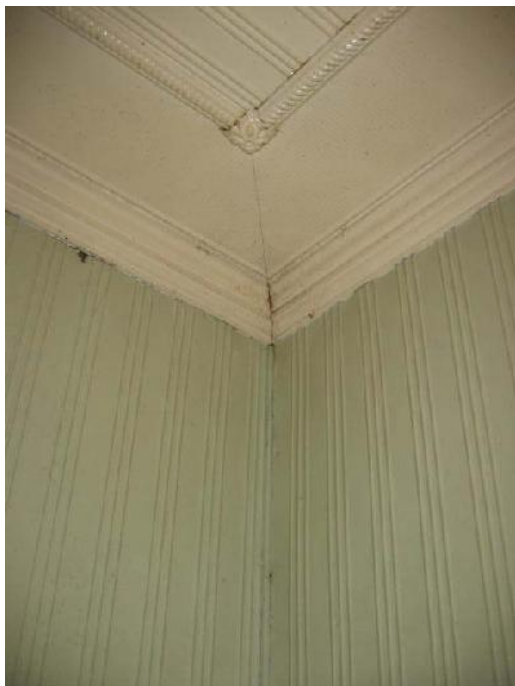
Residential tri-line pattern

An interesting hierarchy in decoration exists between the ornate tri-line and interlocking circular motifs of the residence, the plainer double line of the general store, and the simple single-line of the butchery and maid's quarters, all physically reflective of the differences in social station of the building's early occupants.

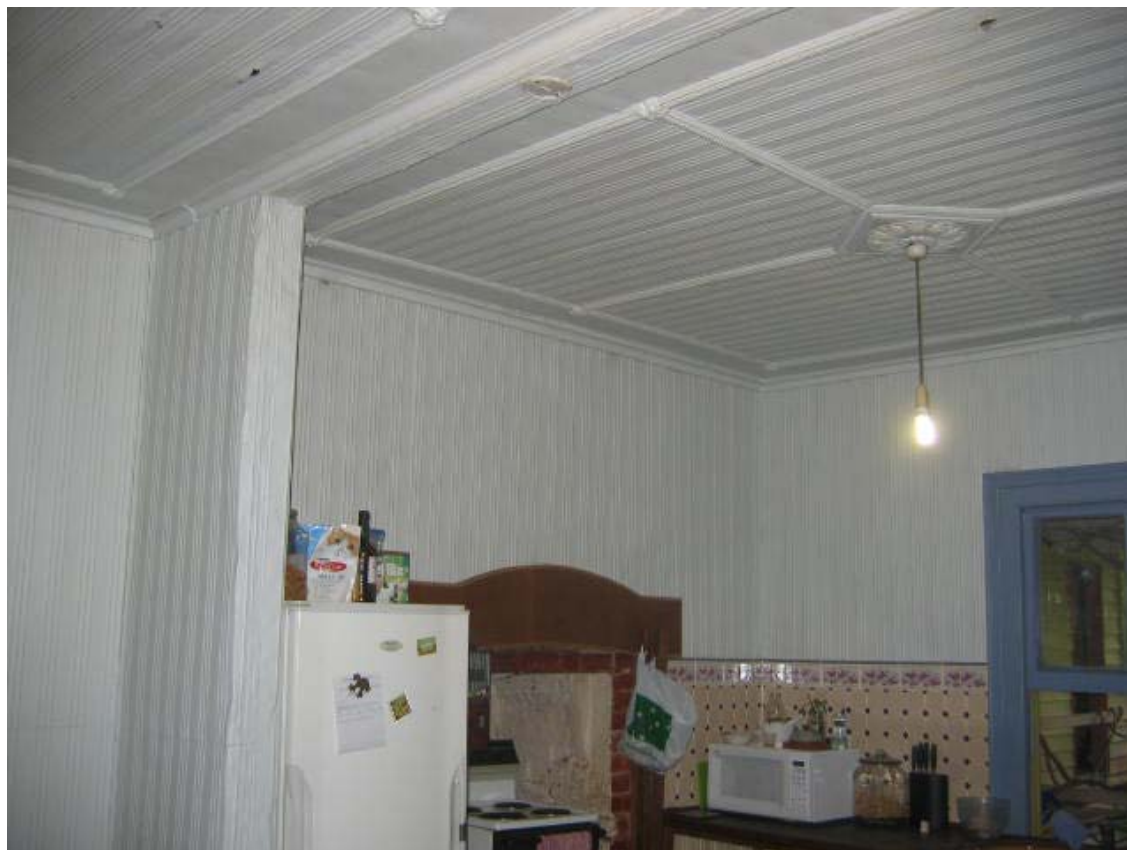
Unsympathetic changes to the internal appearance of the residence are within the kitchen area where most of an original bedroom wall has been removed to enlarge the space, the pressed metal lining having being bent and nailed around the stud at the opening. The recent adaptation of constructing an access passageway through to the store was not built to an adequate standard and this also constitutes an unsympathetic element.

View of the opening that was formed when the rear bedroom was adapted to become a kitchen.
