EUROBODALLA SHIRE COUNCIL

**BATEMANS BAY COASTLINE HAZARD
MANAGEMENT PLAN**

DRAFT FOR PUBLIC EXHIBITION

NOVEMBER 2001

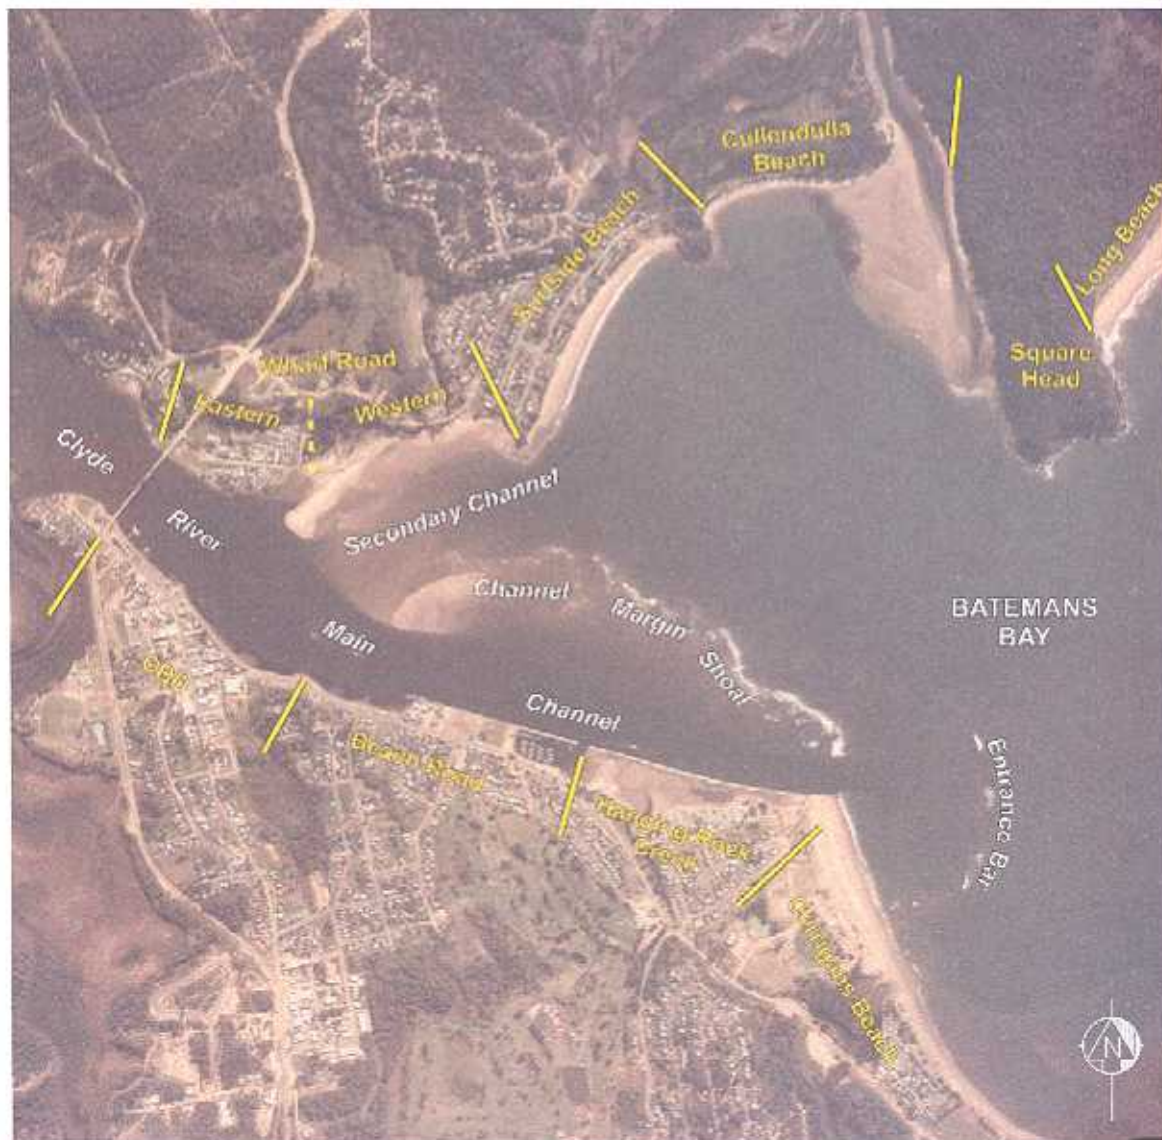
Diagram 3: Inner Foreshore Zone Aerial Photograph

March 1984

Features of Diagram 3:

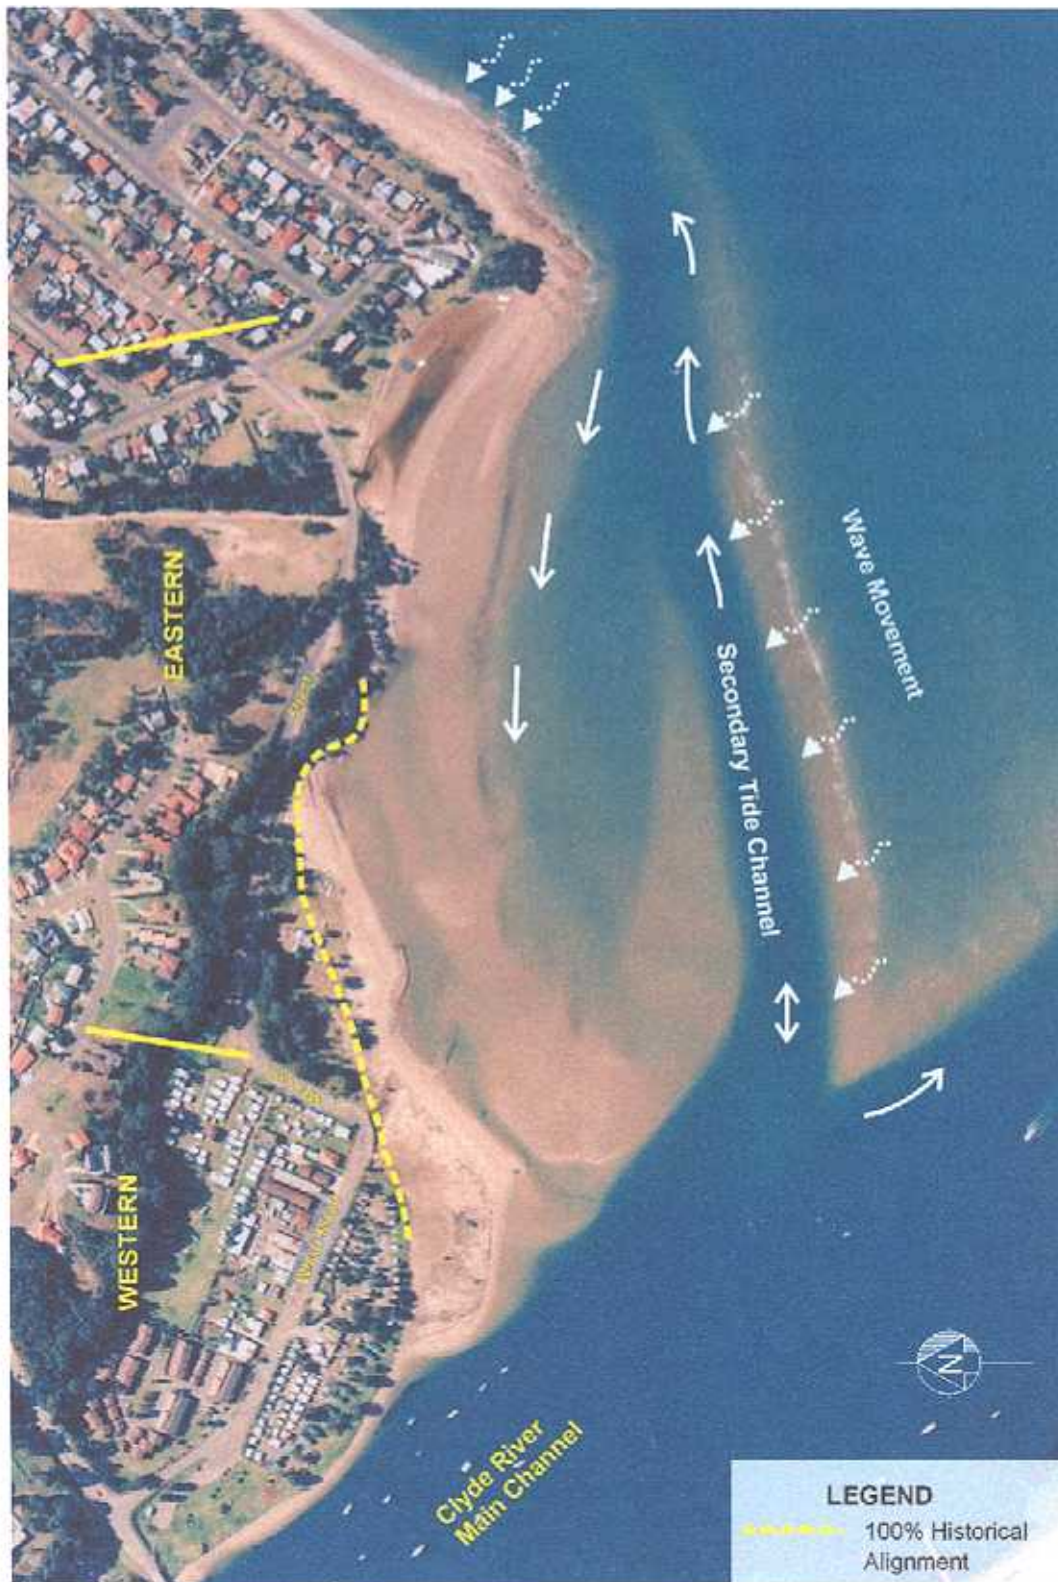
Diagram 4: Wharf Road Foreshore and Historical Alignments

- **Method 1** used a weighting based on the time periods between assessment dates,
- **Method 2** used a weighting based on half the time period for hydrographic charts to reflect their uncertainty,
- **Method 3** also used half for the hydrographic charts, but the weighting was double for the period since the bridge and the existing Wharf Road seawall were constructed to reflect the changed hydrodynamic conditions.

This revised assessment procedure produced significantly different percentage alignments to those produced by WBM (2000) (see Appendix D).

Based on the available information, a constructed physical barrier on the landward side of the 100% line is unlikely to be exposed and so should have minimal adverse impacts on sediment movement (see Diagram 4). A barrier along the 40%, 60% or even the 80% line is likely to be exposed at some stage, and so will have some impact on sediment movement. The nature and extent of these impacts is very difficult to evaluate.
